# 史跡 備中松山城跡本丸復元整備記録

## DOCUMENTATION ON THE RESTORATION WORK AT BITCHU MATSUYAMA CASTLE SITE,a Historic site

**史跡備中松山城跡本丸復元整備工事報告書**

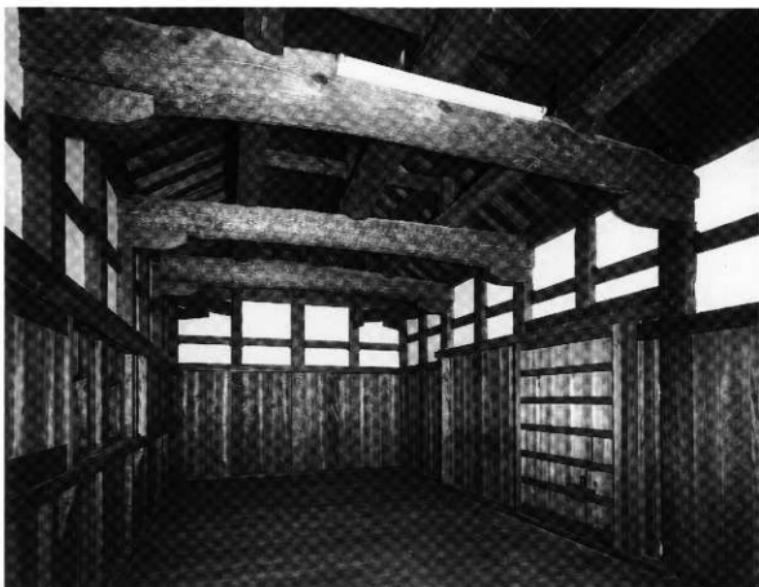
17. 六の平櫓内部北西面全影

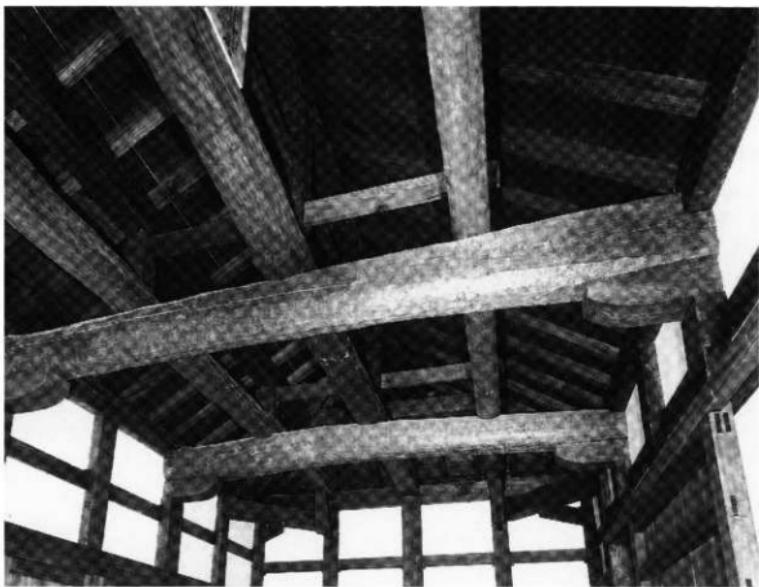
18. 六の平櫓内部小屋見上げ（西面）

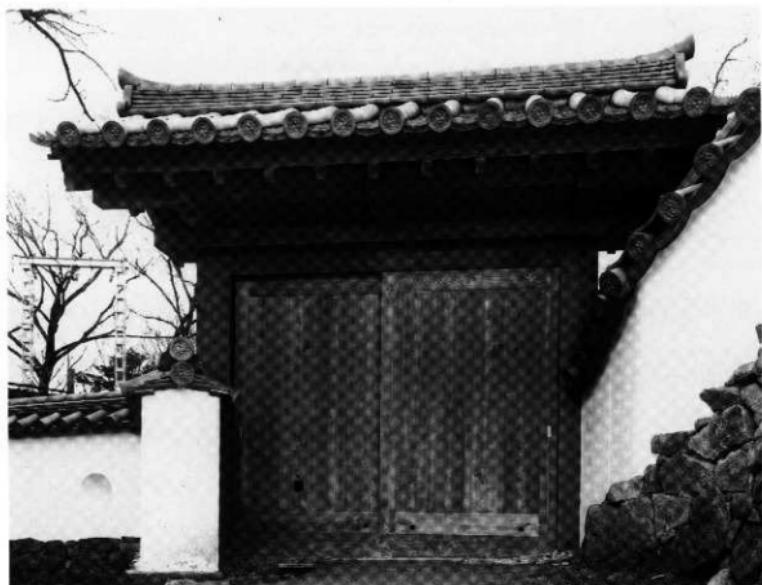
19. 本丸東御門正面（東面）

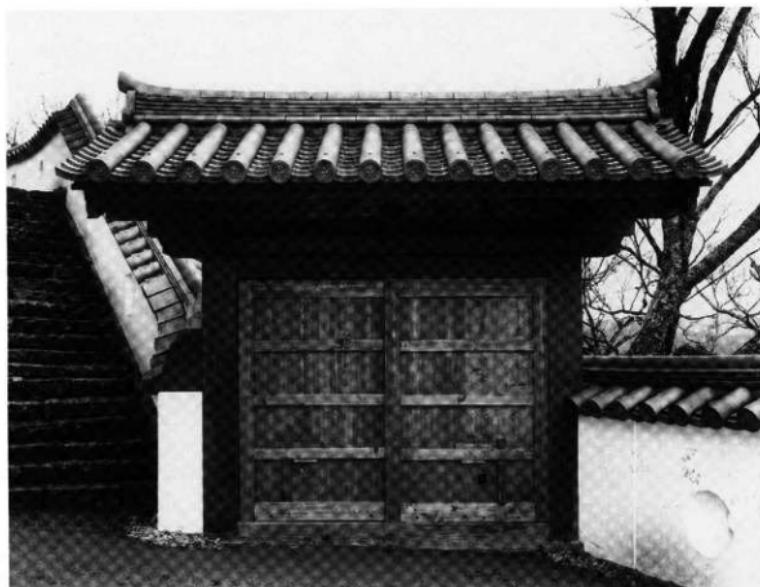
20. 本丸東御門背面（西面）

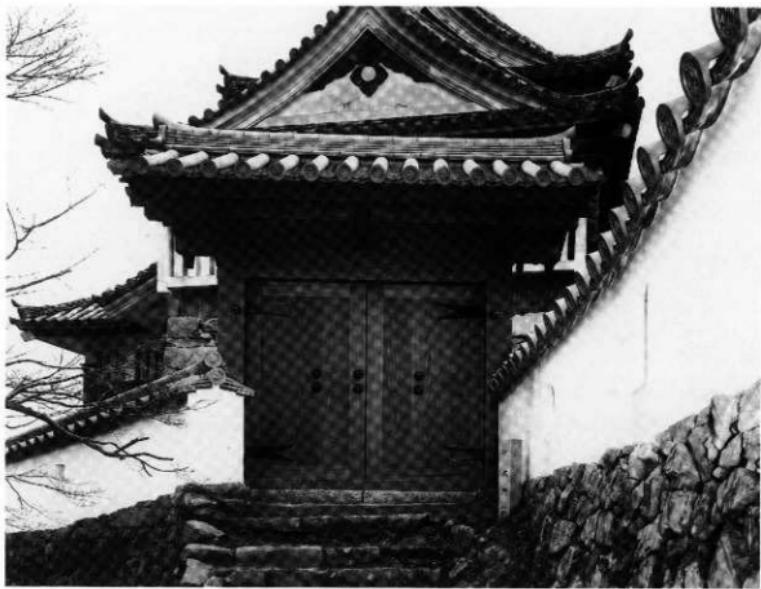
21. 腕木御門正面（北面）

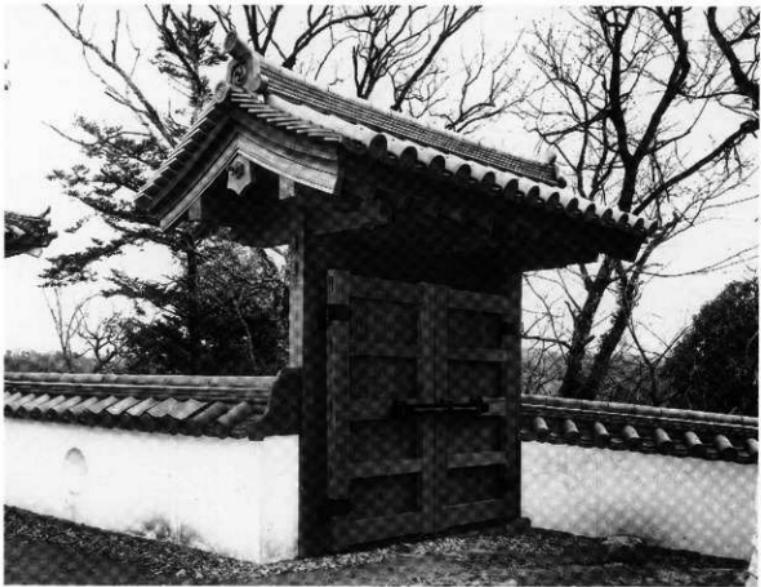
22. 腕木御門背面（南面）

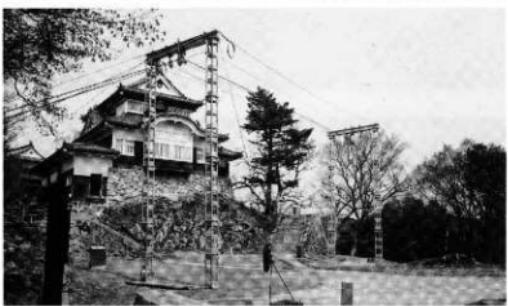
30. 本丸内索道鉄骨橋組立

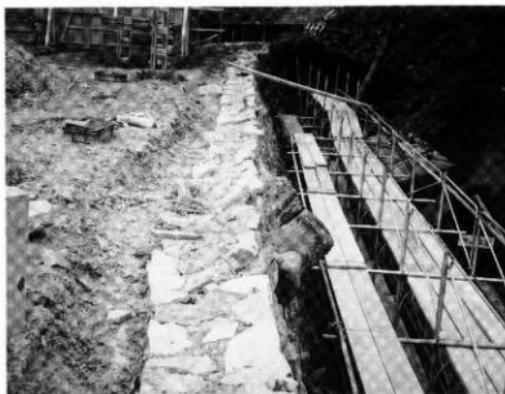
91. 本丸東面石垣の不陸状態  
(樹木の切株が石垣を崩す。)
