## Chapter 1: The 10th Year of the Research and Restoration Project of the Western Prasat Top Site

### Section 1: Survey of the Western Prasat Top site

## Section 3: Reconstruction of the southern sanctuary

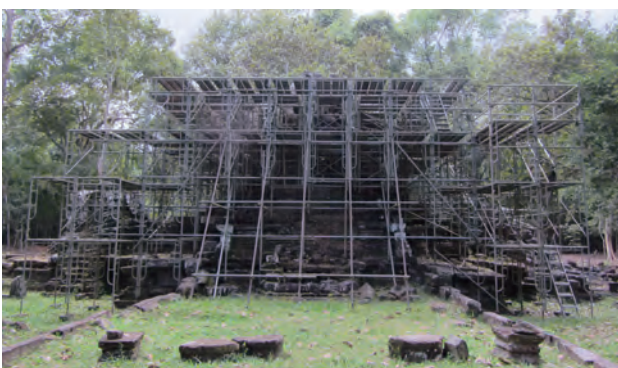
On 26 May 2008, about 40 pieces of stone fell from the east gable of the central sanctuary. It is thought that these stones were destabilised by the felling of trees, which had been growing on the top of the central sanctuary, the year before. The collapse of the stones caused further instability to the entire upper part of the central sanctuary. After urgent consultation with APSARA, and with the cooperation of the Japanese Government's International Angkor Survey (JASA), it was decided to erect a scaffold to support the main body of the sanctuary (Fig. 2).

Fig. 2 View of scaffoldings (view from the east)

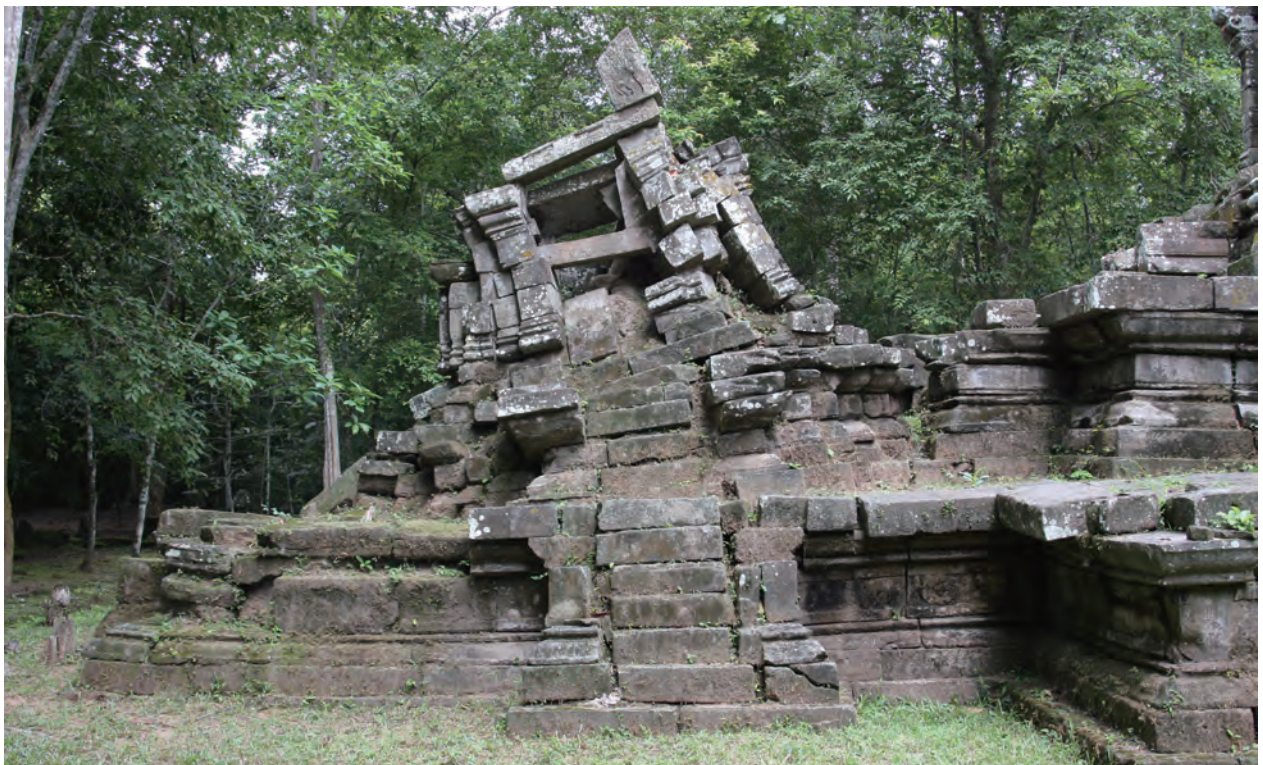
The southern sanctuary consists of the building frame, the upper platform and the lower platform (Fig.4). Most of the roof was lost and the body was tilted 19 degrees to the south. The dismantling of the structure was carried out by a process of drawing plans, numbering the stones, and dismantling one layer at a time, starting from the top. The dismantled parts were then reassembled on a concrete base on the ground and temporarily assembled to check the leveling, positioning and to identify areas of missing stone.

Fig. 4 Southern sanctuary before the restoration (view from the east)

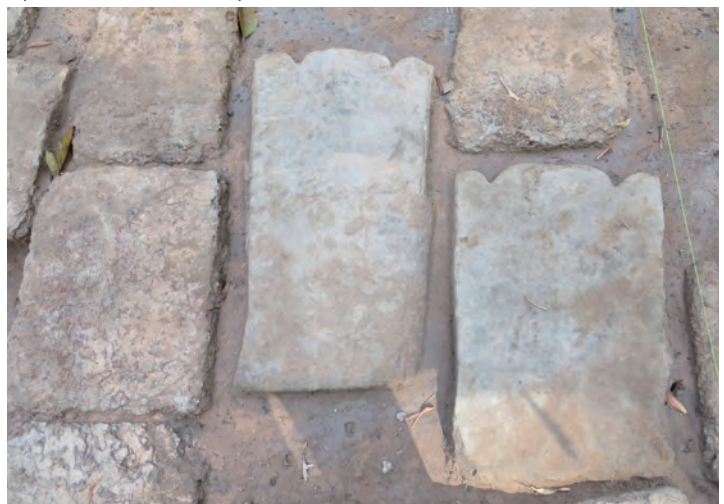
ticular note was the use of a stone known as a *sīma* stone (boundary stone). These stones are usually buried in the ground to demarcate the temple area of Theravāda Buddhist temples, and they are placed at the four cardinal corners of the temple and at the centre of each side. In the southern sanctuary, 12 *sīma* stones were found in the upper part of the platform, followed by two *sīma* stones in the lower platform (Fig. 5). It is thought that the stones were originally used in another temples and were collected as the building materials for the southern sanctuary .

Fig. 5 two *sīma* stones in the lowest level of the lower platform of southern sanctuary (view from the south)

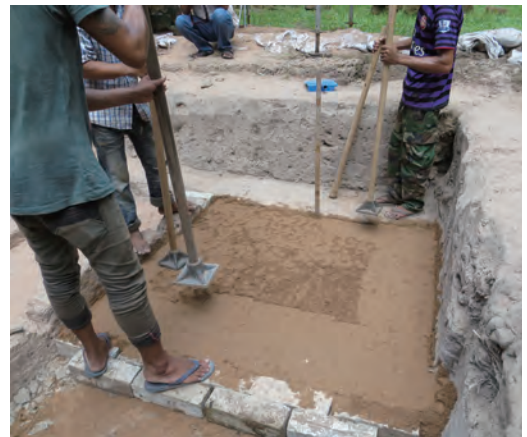
Fig. 8 Compacting the consolidated soil

From October 2014, we started to reconstruct the foundation under the platform. In order to reconstruct the foundation we used consolidated soil determined by the geological survey of the foundation, and the reddish-brown coarse sand layer that had previously filled the foundation (Fig. 8). On 23 September 2015, we held a ceremony for the completion of the reconstruction of the southern sanctuary and successfully completed the research and restoration of the southern sanctuary. The roof of the southern sanctuary was reconstructed up to the girders at the bottom of the gable on the east and north faces (Fig. 9).

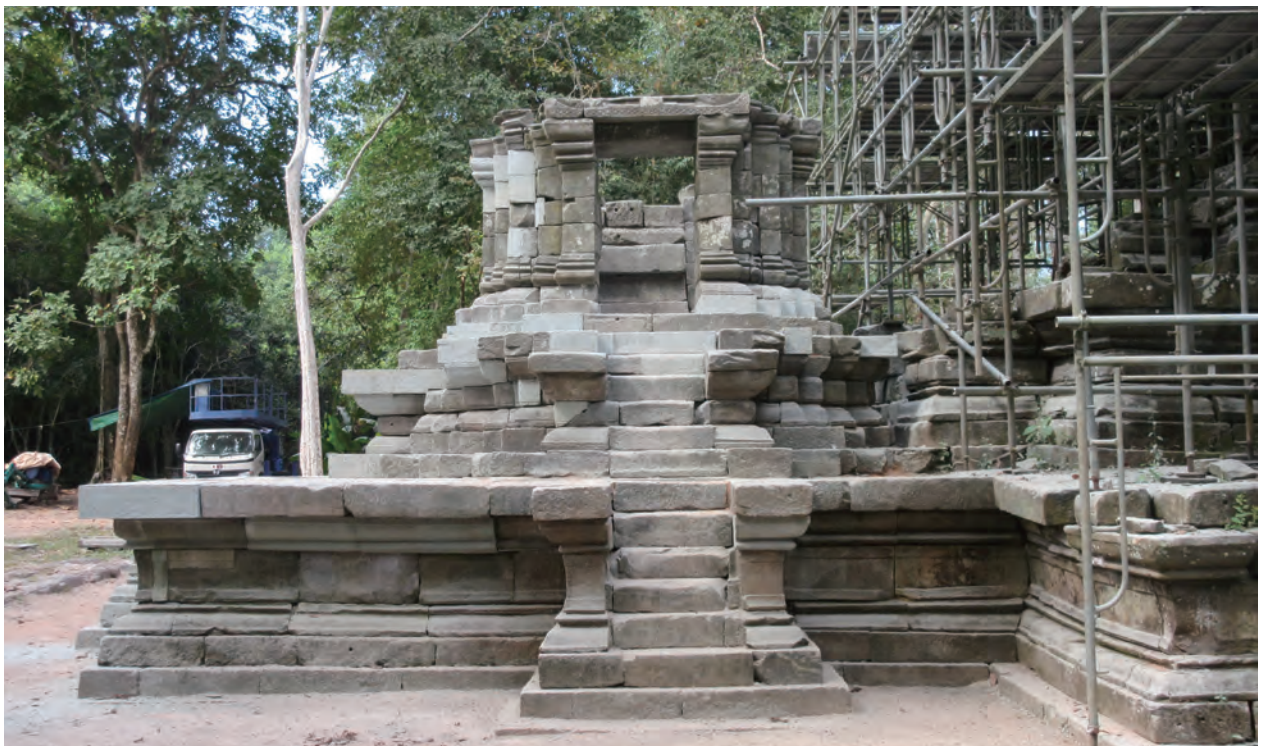
Fig. 9 Reassembled southern sanctuary (view from the east)

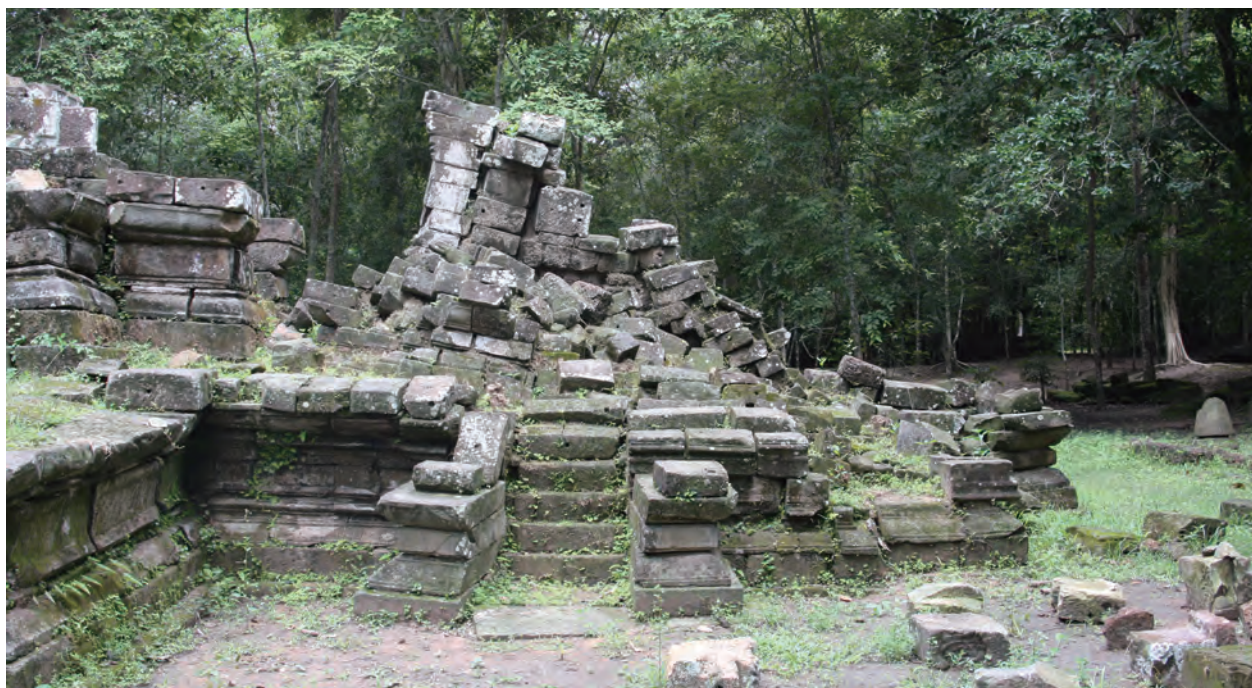
In February 2016 we started the dismantling of the northern sanctuary (Fig. 10). By March we finished the dismantling of the structure and the survey of the scattered stones north of the northern sanctuary. The whole structure of the northern sanctuary had inclined to the north and the collapse of the building frame was more severe than that of the southern sanctuary. Some stones-blocks of the building frame had collapsed and were left as they are, but most of the stone blocks of the building frame had been removed by the EFEO and placed on the ground randomly, especially on the north side of the northern sanctuary. Prior to our reconstruction work, each stone was numbered and drawn, and its original position was estimated in preparation for the reconstruction.

Fig. 10 Northern sanctuary before the reconstruction (view from the east)

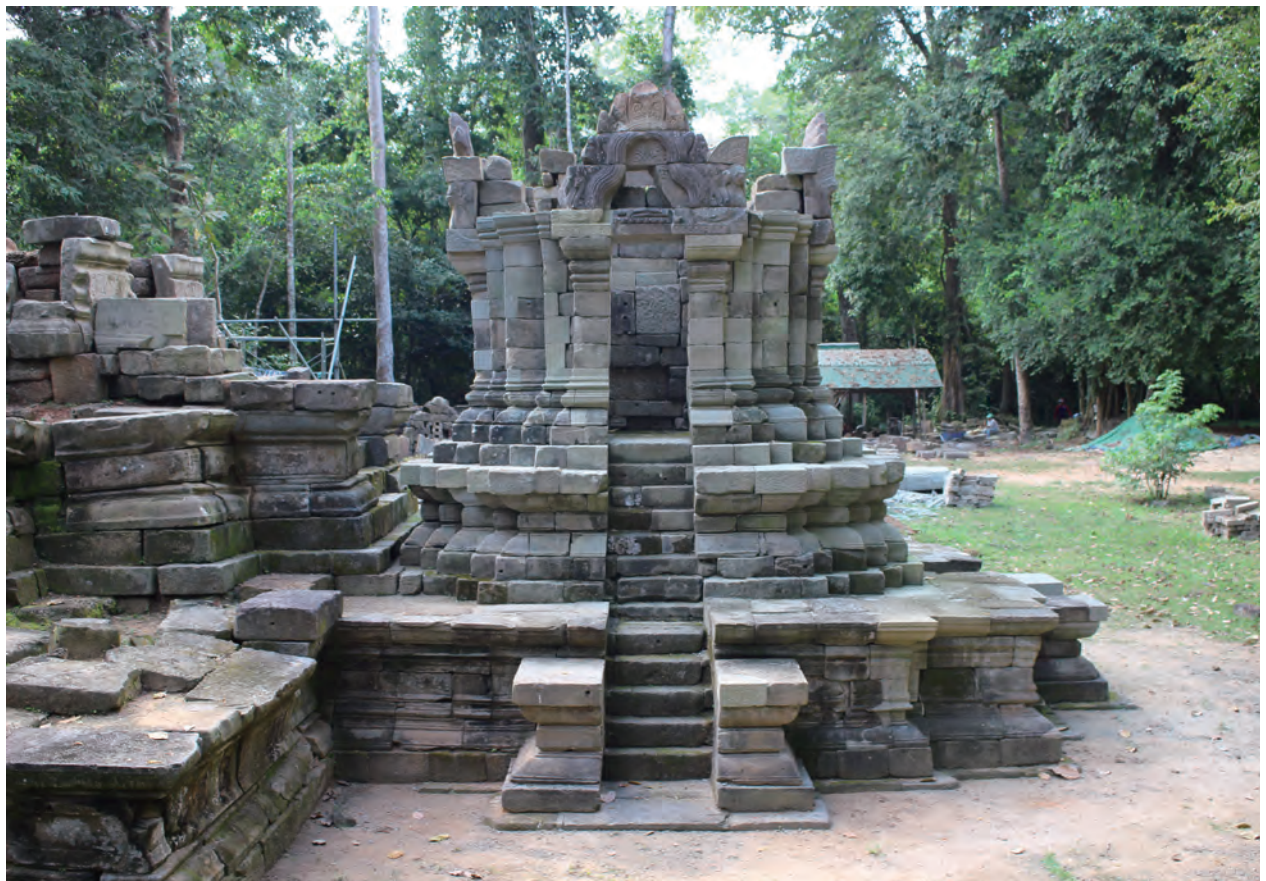
Fig. 19 Reassembled northern sanctuary (view from the east)

southern sanctuary. We searched for scattered stones from the surrounding area. The work was completed in December 2017 (Fig. 19).

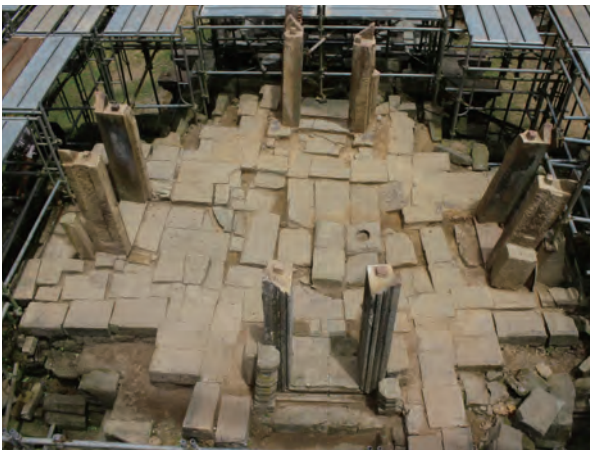
Fig. 21 The topmost layer of the upper platform of the central sanctuary (view from the north)

In August 2018, a survey was carried out on the upper surface of the upper platform. The sandstone paving stones on the surface of the upper platform were found to be uneven due to unequal settlement of the square-shaped stones in the centre, which are thought to have been reused (Fig. 21). When this paving stone was removed, a layer of laterite paving was found, which also showed the presence of a disordered stone in the centre. As a result of excavation, it was found that there were a further three layers of laterite stones under the laterite paving stones, and a vertical hole was dug in the middle of the laterite paving stones. It is thought that this was a looting hole in the centre of the tower—which is often seen in the Angkor monuments—and, modern wire fragments were excavated from this hole. The excavation was continued to a depth of more than 2m, but the hole was still open and it was decided to end the excavation at this point, considering the safety of the investigation and the load-bearing capacity of the platform. The pits were backfilled with sandstone, laterite, and consolidated soil to withstand the upper load.
