Survey and Restoration of Western Prasat Top

Interim Report 10

Reassembly of the Platform of the Central Sanctuary

The Authority for the Protection and Management of Angkor and the Region of Siem Reap
Nara National Research Institute for Cultural Properties

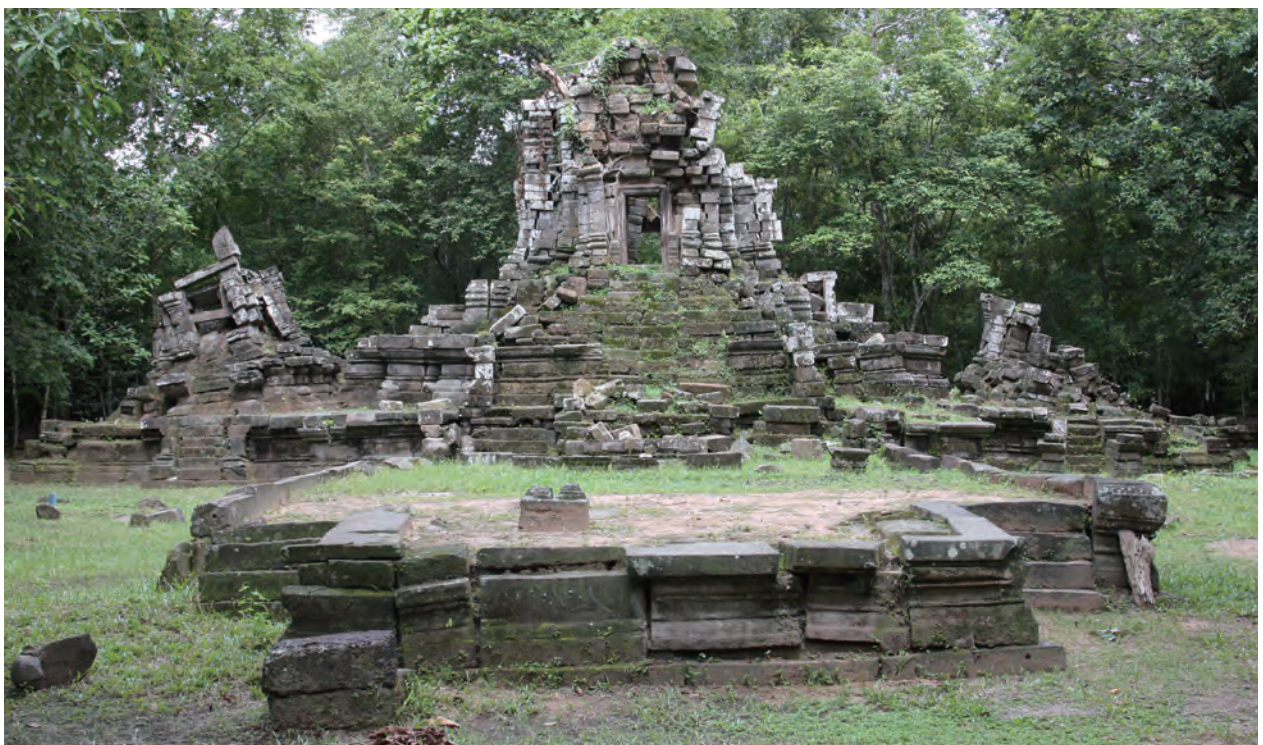
Fig. 1 Western Prasat Top before the restoration (view from the east)

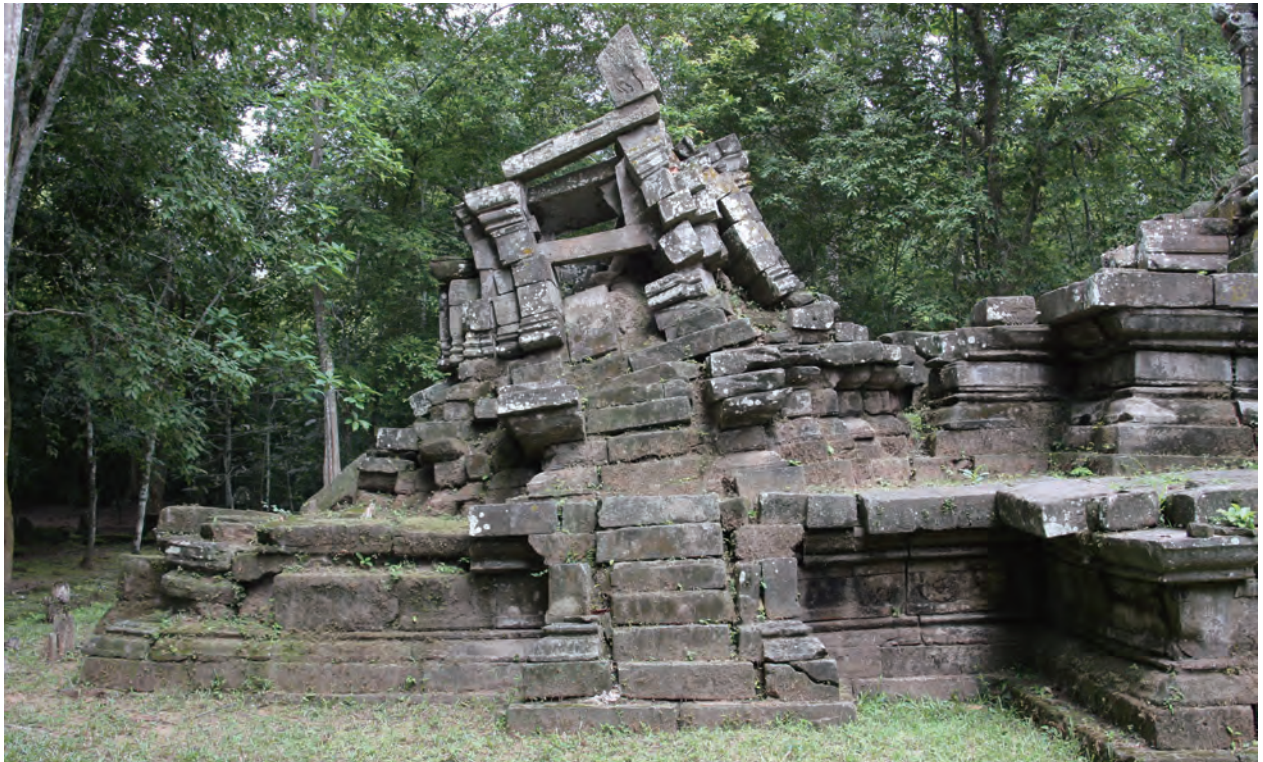
The southern sanctuary consists of the building frame, the upper platform and the lower platform (Fig.4). Most of the roof was lost and the body was tilted 19 degrees to the south. The dismantling of the structure was carried out by a process of drawing plans, numbering the stones, and dismantling one layer at a time, starting from the top. The dismantled parts were then reassembled on a concrete base on the ground and temporarily assembled to check the leveling, positioning and to identify areas of missing stone.

The top surface of the platform was made of sandstone paving stones, but it had sunk more than 20cm, from the centre to the south, due to unequal settlement of the associated fill. When the paving stone layer was dismantled, it was found that the foundation soil was coarse sand. When this soil was excavated, the southern staircase of an earlier platform of the central sanctuary was found in the lower platform of the southern sanctuary (Fig.6). The southern staircase of the lower platform of the central sanctuary was in good condition and did not cause uneven settlement . The southwest corner of the exterior of the platform on the lower part of the southern sanctuary had

Fig. 4 Southern sanctuary before the restoration (view from the east)

collapsed due to age, and the foundation soil eroded out from the gap causing the centre of the platform to sink . On the other hand, the north side of the southern sanctuary which was overlying the southern staircase of the central sanctuary, did not sink . Therefore, it is assumed that the whole structure tilted to the south causing the roof to collapse.

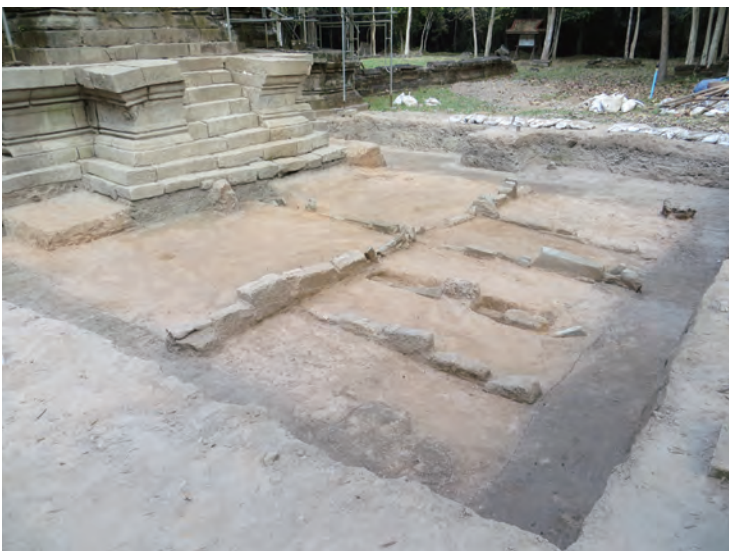
Fig. 7 Unearthed traces of foundation of the southern sanctuary (view from the southwest)

After the dismantling of the lowest level of the platform, the trace of the underground foundation was confirmed from the south side of the lower platform and also the rows of stone blocks were found in the center of the foundation (Fig. 7). These stone rows were made of sandstone or laterite blocks arranged vertically and combined in an east-west-south-west direction. A blackish-brown glazed long-necked jar, unglazed round-bottomed pottery jar, and unglazed long-necked jar were also found just south of the southern line of the underground foundation. This was the end of the dismantle survey, but a sub-trench was cut in a north-south direction to check the depth of some of the underground foundation work, and then the whole area was backfilled and reassembled.

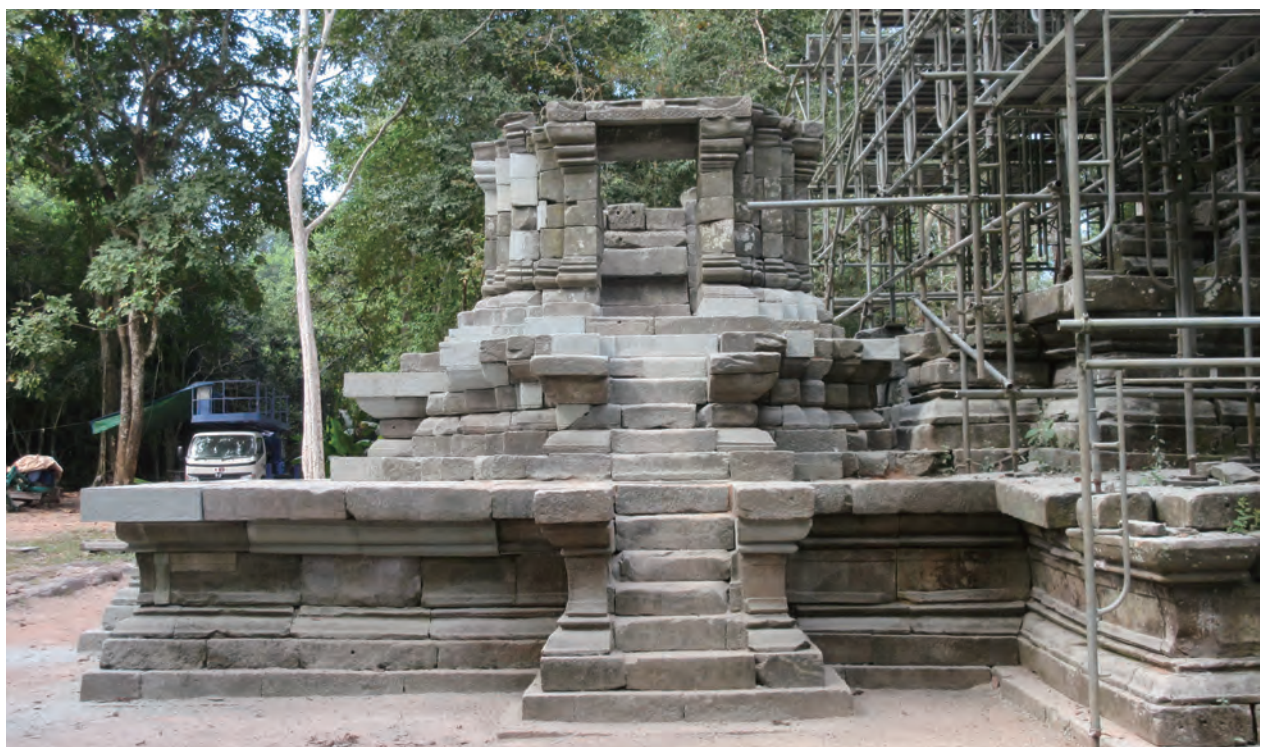
Fig. 9 Reassembled southern sanctuary (view from the east)

From October 2014, we started to reconstruct the foundation under the platform. In order to reconstruct the foundation we used consolidated soil determined by the geological survey of the foundation, and the reddish-brown coarse sand layer that had previously filled the foundation (Fig. 8). On 23 September 2015, we held a ceremony for the completion of the reconstruction of the southern sanctuary and successfully completed the research and restoration of the southern sanctuary. The roof of the southern sanctuary was reconstructed up to the girders at the bottom of the gable on the east and north faces (Fig. 9).

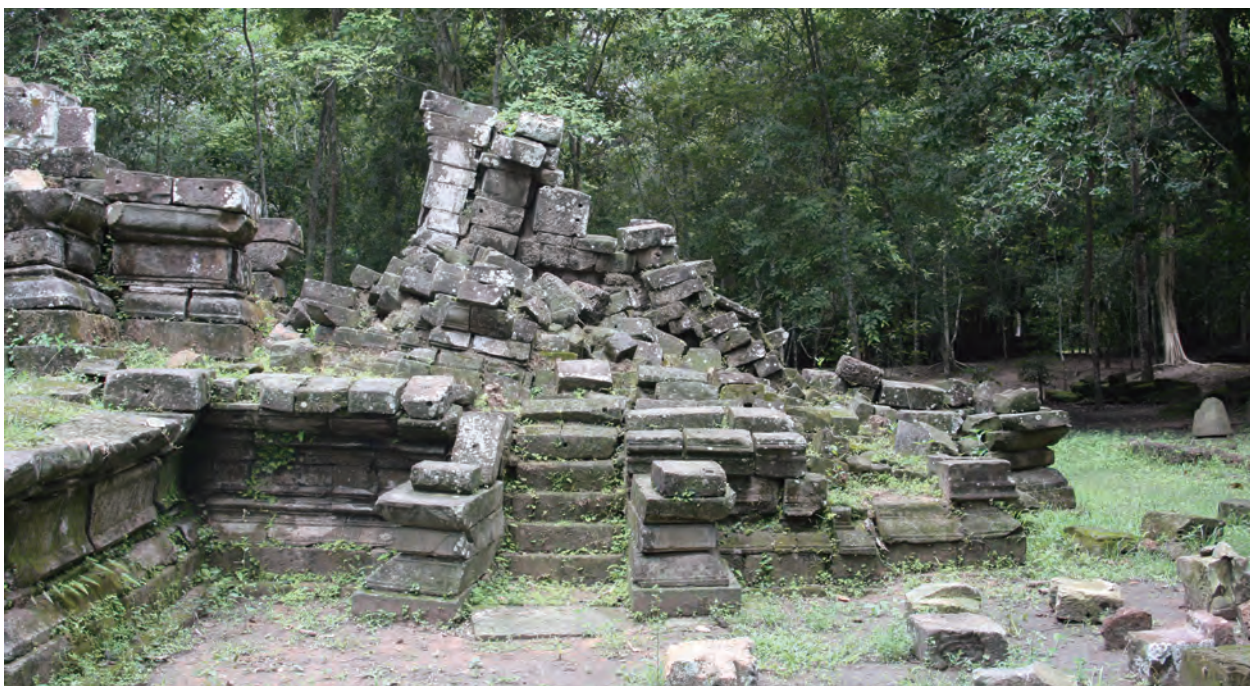
In February 2016 we started the dismantling of the northern sanctuary (Fig. 10). By March we finished the dismantling of the structure and the survey of the scattered stones north of the northern sanctuary. The whole structure of the northern sanctuary had inclined to the north and the collapse of the building frame was more severe than that of the southern sanctuary. Some stones-blocks of the building frame had collapsed and were left as they are, but most of the stone blocks of the building frame had been removed by the EFEO and placed on the ground randomly, especially on the north side of the northern sanctuary. Prior to our reconstruction work, each stone was numbered and drawn, and its original position was estimated in preparation for the reconstruction.

Fig. 10 Northern sanctuary before the reconstruction (view from the east)

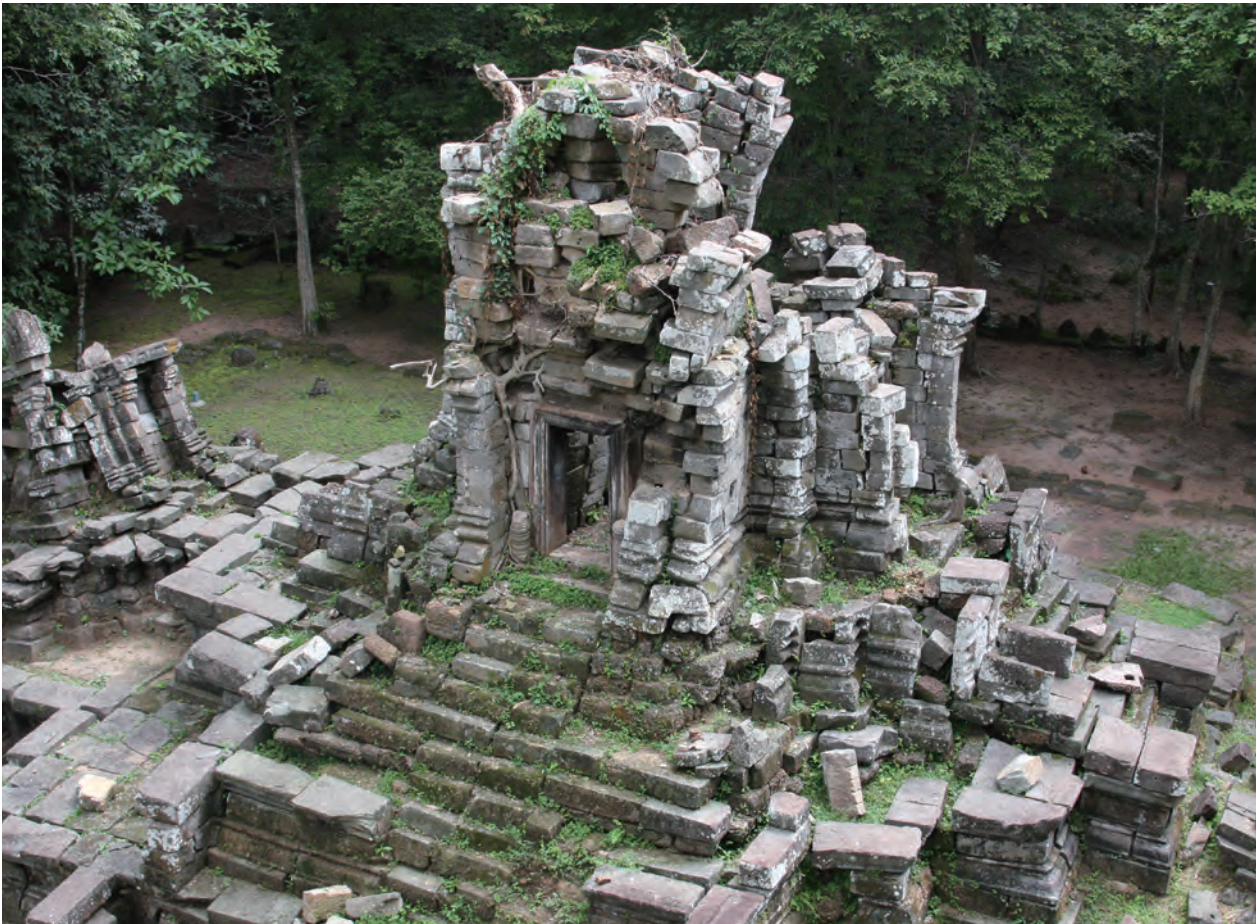
Fig. 20 Central Sanctuary before the restoration (bird-eye view from the northeast)

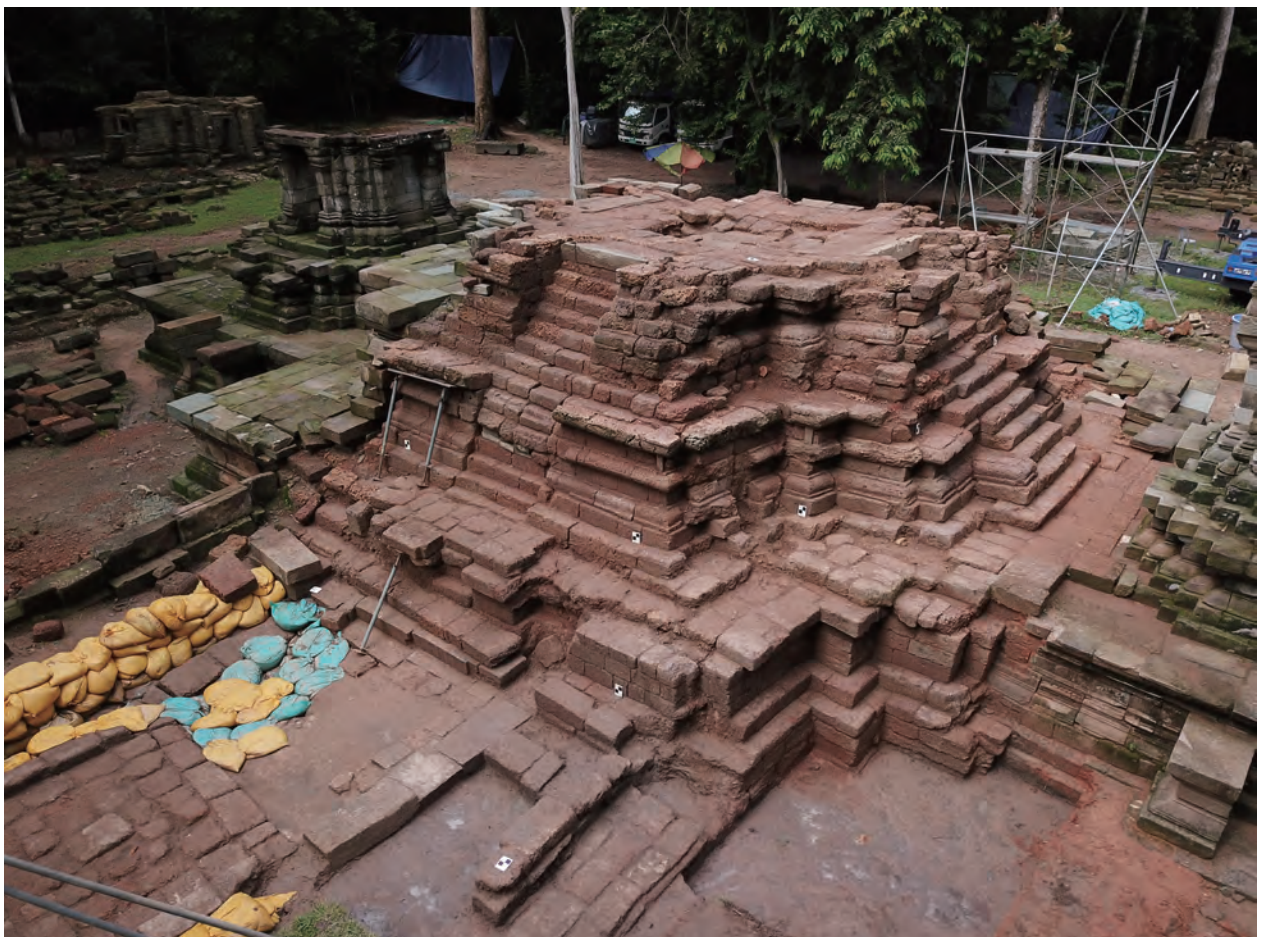
Fig. 23 Laterite platform of the central sanctuary (bird-eye view from the northeast)

As mentioned above, the laterite platform was dismantled in each quarter, and at every stage was photographed and surveyed in 3D (Fig. 23). As a result, it was found that the laterite platform, like the sandstone platform of the exterior, was composed of three tiers: upper platform, middle platform and lower platform. The upper and lower platforms were composed of simple laterite blocks while the middle platform had a carved moulding.

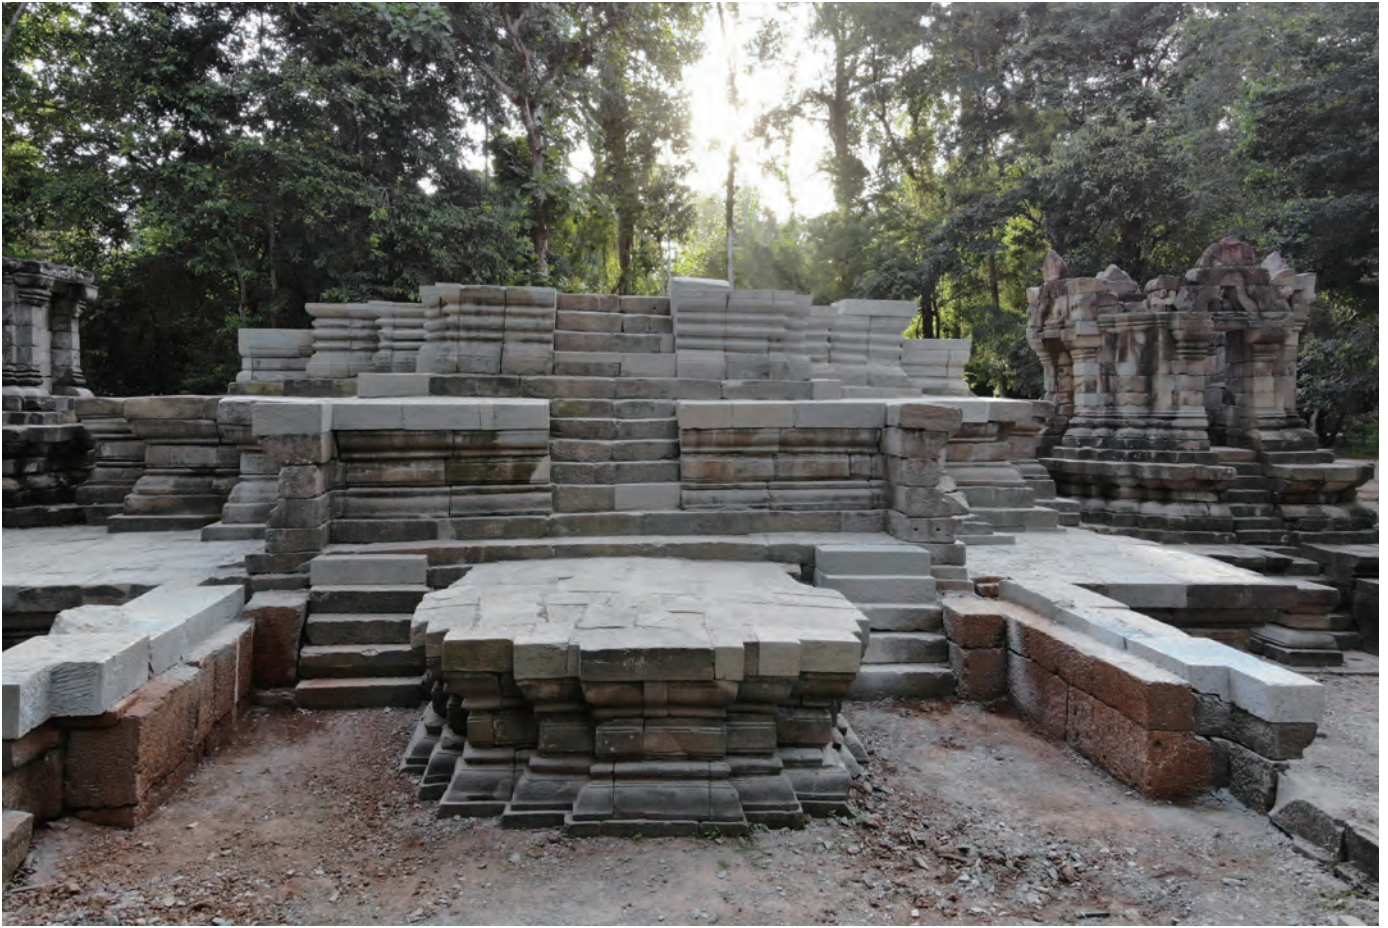
Fig. 26 View of the reassembled platform of the central sanctuary (view from the east)

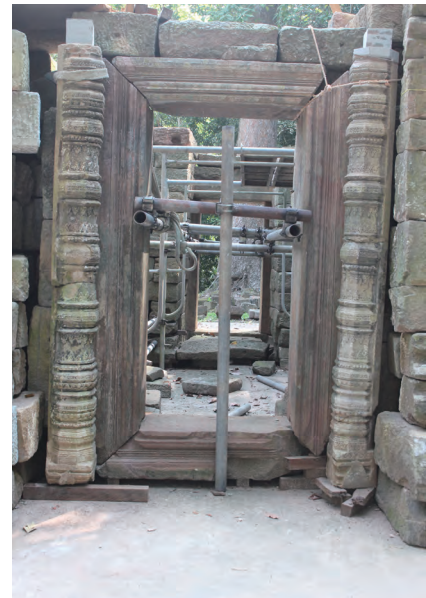
There are also four door frames made of red sandstone blocks. The vertical right and left frames have the same heights, widths and thickness. The lower frame is a little thinner than the other, but is wider. The thickness of the upper frame is not equal to the southern and northern parts. There is a problem with this western door frame. When we reinstalled the four parts together, we found that the upper-south edge of the frame did not fit, while the other three edges fit well into position. There is a small gap between the southern edge of the upper frame and the upper edge of the southern vertical frame. This could be an original mistake or evidence for reused frames from different collections.

Fig.7 Western door frame (during reconstruction)

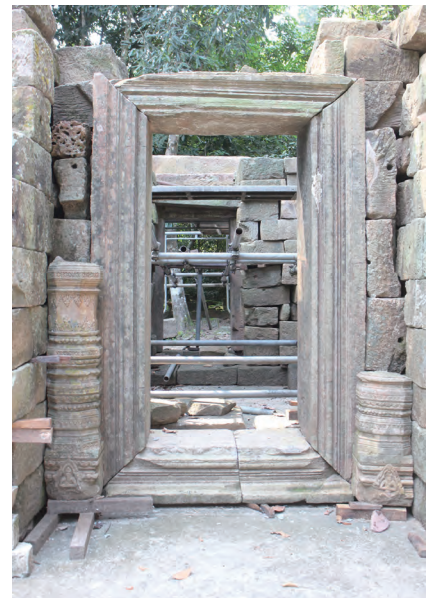
Fig.8 Northern door frame (during reconstruction)

There are five blocks in this frame. The vertical frames are made from red sandstone of the same sizes. The lower frame is made of two blocks of pale-yellow sandstone. These two lower blocks seem to be remade or reused to connect with the vertical frames, because their tenons are not fixed to the mortises of the vertical frames. The problem is related to the size of the mortises, which are bigger than the tenons. So, the constructors had to add a block or keystone for fixing the space or gap of the tenons and mortises. Actually, we found a small block of laterite inside this space. Also, the western block of these lower frames had broken at the edge and was originally fixed by adding another piece. The upper frame was made of grey sandstone, similar to the lower frame of the southern door. This grey sandstone block is very poor and fragile. It broke into parts, but these parts can be repaired and used again.

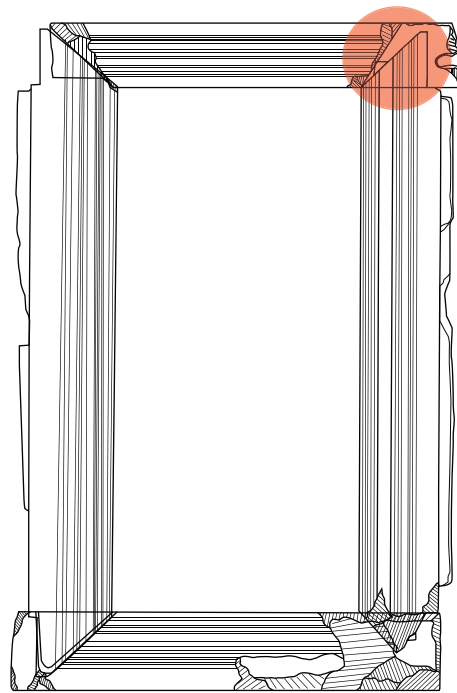
Fig.18 Drawing of the western door (red indicates unstable position)

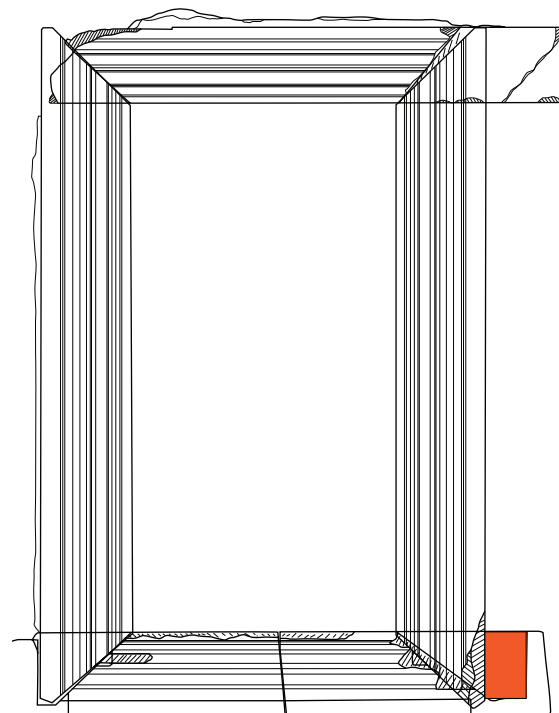
Fig.19 Drawing of the northern door (red indicates the position where it was broken before the restoration)

the southern door were made of grey sandstone blocks while the other is made from red sandstone. These two grey frames are bigger and thicker than the other frames. This indicates that these two grey sandstone frames were newly made to add to the broken red sandstone frames. The upper frame of the northern door, the block cut and set up on both vertical frames, had a decorated side that was chiseled and sloped to the eastern side to match the heights of the colonnettes and lintel. Another point relates to the lower frame of the northern door. There is normally a single block on the lower frame for each door, but the lower frame of the northern door has two blocks. Also, the southeast corner of the western block was broken before it was installed. This is known from the additional piece of stone added to the broken edge. One more problem concerns the mortise of the western block: the hole is bigger than the tenon of the vertical frame. Another block of laterite was inserted into the space of the mortise to stabilize the vertical frame.

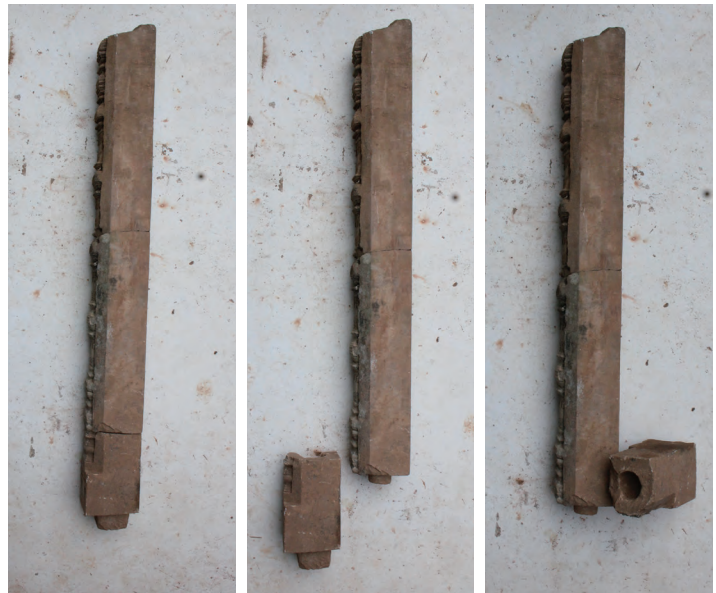
There are eight colonnettes in this sanctuary. But they are not the same sizes or heights. The colonnettes of the eastern door and western doors are the same size but different heights. The colonnettes of the southern and northern doors are also the same size but bigger than the eastern and western doors. However, the corners of all these colonnettes are not the same sizes or numbers. Normally, the colonnettes are divided into three main parts: head, body and bottom (Fig.24). The colonnettes of the eastern, western and southern doors retain their original sizes and parts. The colonnettes of the northern door cut the head-part to conform to the height of the door frames. Interestingly, we have found that the southern colonnette of the western door was repaired before installation. This was confirmed when we dismantled it. The lower part was probably, and accidentally, broken but another piece measuring about 38cm high (Fig.20) was added. The original

Fig.20 Colonnettes from the western door- southern side
