Survey and Restoration of Western Prasat Top

Interim Report 10

Reassembly of the Platform of the Central Sanctuary

Nara National Research Institute for Cultural Properties

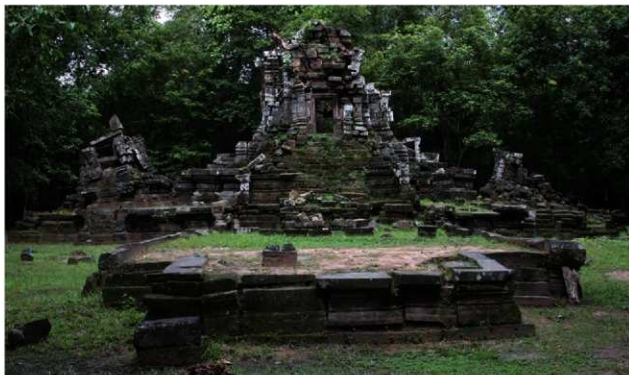
Fig. 1 Western Prasat Top before the restoration (view from the east)

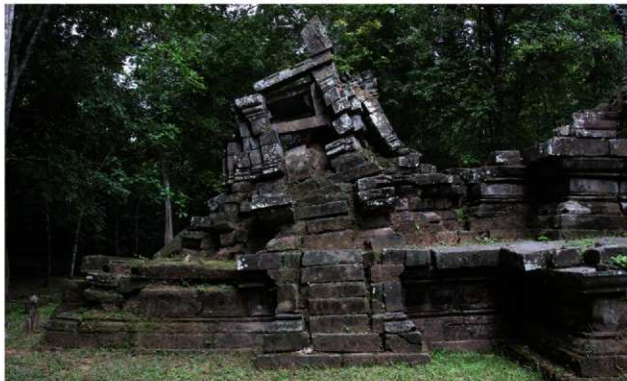
The top surface of the platform was made of sandstone paving stones, but it had sunk more than 20cm, from the centre to the south, due to unequal settlement of the associated fill. When the paving stone layer was dismantled, it was found that the foundation soil was coarse sand. When this soil was excavated, the southern staircase of an earlier platform of the central sanctuary was found in the lower platform of the southern sanctuary (Fig.6). The southern staircase of the lower platform of the central sanctuary was in good condition and did not cause uneven settlement . The southwest corner of the exterior of the platform on the lower part of the southern sanctuary had

Fig. 4 Southern sanctuary before the restoration (view from the east)

collapsed due to age, and the foundation soil eroded out from the gap causing the centre of the platform to sink . On the other hand, the north side of the southern sanctuary which was overlying the southern staircase of the central sanctuary, did not sink . Therefore, it is assumed that the whole structure tilted to the south causing the roof to collapse.

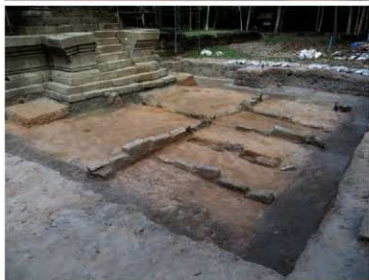
Fig. 7 Unearthed traces of the foundation of the southern sanctuary (view from the southwest)

After the dismantling of the lowest level of the platform, the trace of the underground foundation was confirmed from the south side of the lower platform and also the rows of stone blocks were found in the center of the foundation (Fig. 7). These stone rows were made of sandstone or laterite blocks arranged vertically and combined in an east-west-south-west direction. A blackish-brown glazed long-necked jar, unglazed round-bottomed pottery jar, and unglazed long-necked jar were also found just south of the southern line of the underground foundation. This was the end of the dismantle survey, but a sub-trench was cut in a north-south direction to check the depth of some of the underground foundation work, and then the whole area was backfilled and reassembled.

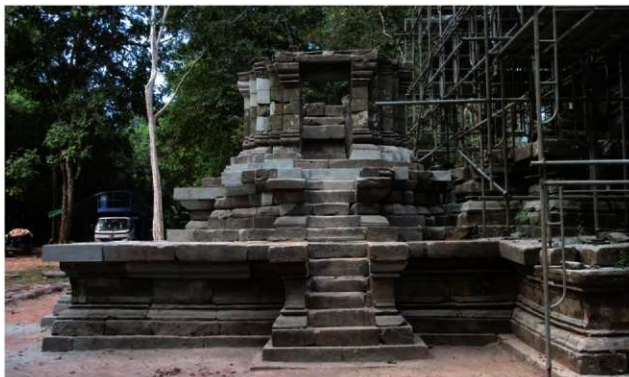
Fig. 9 Reassembled southern sanctuary (view from the east)

From October 2014, we started to reconstruct the foundation under the platform. In order to reconstruct the foundation we used consolidated soil determined by the geological survey of the foundation, and the reddish-brown coarse sand layer that had previously filled the foundation (Fig. 8). On 23 September 2015, we held a ceremony for the completion of the reconstruction of the southern sanctuary and successfully completed the research and restoration of the southern sanctuary. The roof of the southern sanctuary was reconstructed up to the girders at the bottom of the gable on the east and north faces (Fig. 9).

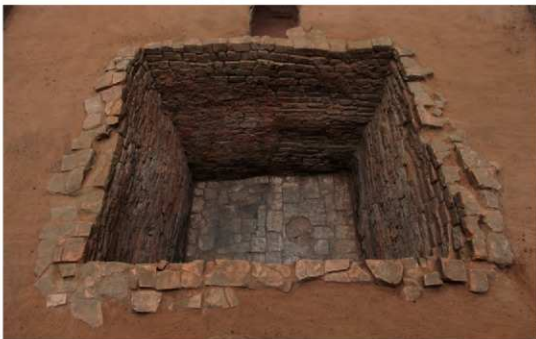
Fig. 13 Unearthed underground brick chamber (view from the south)

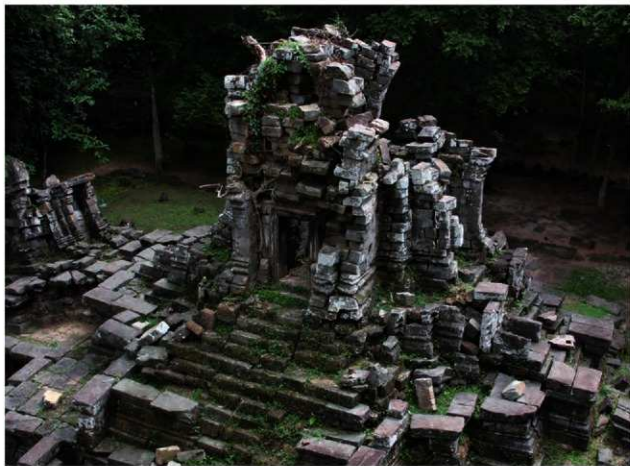
Fig. 20 Central Sanctuary before the restoration (bird-eye view from the northeast)

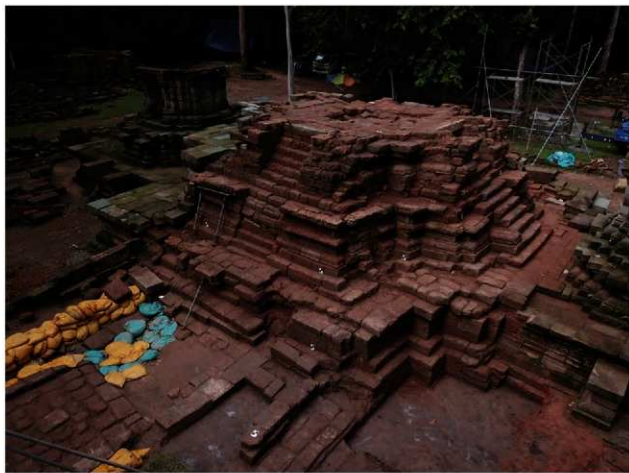
Fig. 23 Laterite platform of the central sanctuary (bird-eye view from the northeast)

As mentioned above, the laterite platform was dismantled in each quarter, and at every stage was photographed and surveyed in 3D (Fig. 23). As a result, it was found that the laterite platform, like the sandstone platform of the exterior, was composed of three tiers: upper platform, middle platform and lower platform. The upper and lower platforms were composed of simple laterite blocks while the middle platform had a carved moulding.

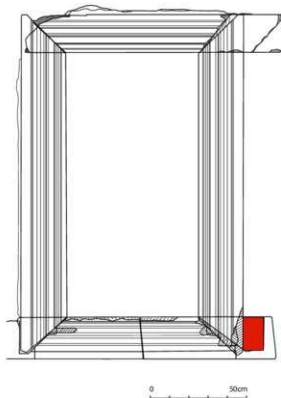
sandstone frames were made at the same time and the grey one added when the old one (i.e., red sandstone) was either broken or disappeared. Additionally, the grey sandstone is very big and thick but its quality is poor and fragile. It had already broken into many small pieces before we dismantled it. One problem has been observed with this door. When we reinstalled these four frames, we found that the left vertical frame and the upper frame were not fixed in position. The upper frame is about 2cm out of alignment, forming a crooked line.

Fig.19 Drawing of the northern door (red indicates the position where it was broken before the restoration)

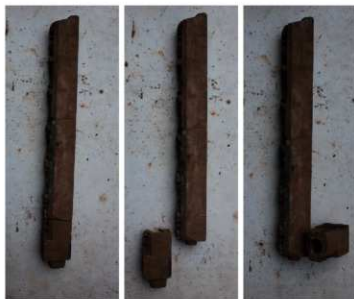
There are eight colonnettes in this sanctuary. But they are not the same sizes or heights. The colonnettes of the eastern door and western doors are the same size but different heights. The colonnettes of the southern and northern doors are also the same size but bigger than the eastern and western doors. However, the corners of all these colonnettes are not the same sizes or numbers. Normally, the colonnettes are divided into three main parts: head, body and bottom (Fig.24). The colonnettes of the eastern, western and southern doors retain their original sizes and parts. The colonnettes of the northern door cut the head-part to conform to the height of the door frames. Interestingly, we have found that the southern colonnette of the western door was repaired before installation. This was confirmed when we dismantled it. The lower part was probably, and accidentally, broken but another piece measuring about 38cm high (Fig.20) was added. The original

Fig.20 Colonnettes from the western door- southern side
