## Chapter 3 Restoration Work

### Section 1 Restoration of the South Stairways of the Central Sanctuary

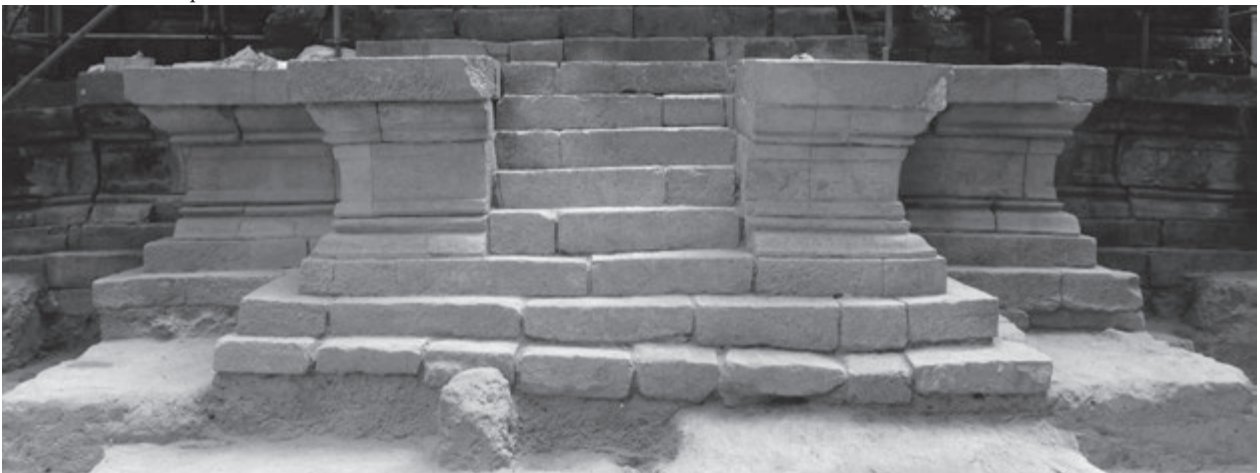
Fig. 37: South stairways of the Central Sanctuary after restoration

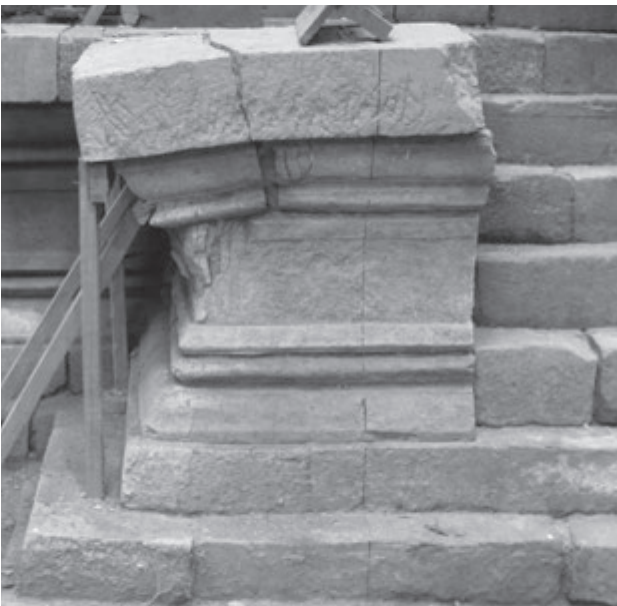
The west half of SN133N18 shown in Fig. 38 was broken, so the original block was bonded together. SN137 behind it was also broken in the southwest corner, but unlike SN133, it was broken into small pieces, so it was bonded using new materials. Immediately below SN133, the stone block with moldings that was found among the edging stones of N19, was used as it is, as the stone itself was only minimally damaged. The N20 stone panel displayed a special state of damage in the southwest corner as shown in Fig. 39, so that portion was replaced with new material. On the west side of the stone panel, as shown in Fig. 41, details of the moldings were damaged and the stone was cracked into three pieces. Judging that sufficient strength cannot be restored even if the block is bonded, it was replaced with a new material.

Fig. 38: Before restoration

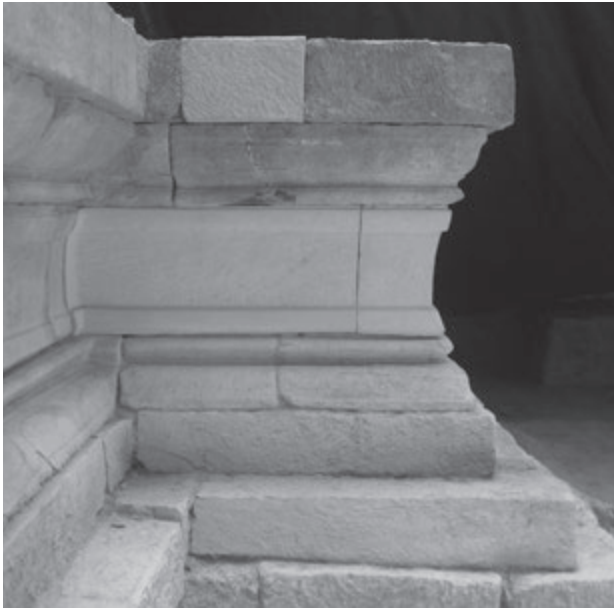
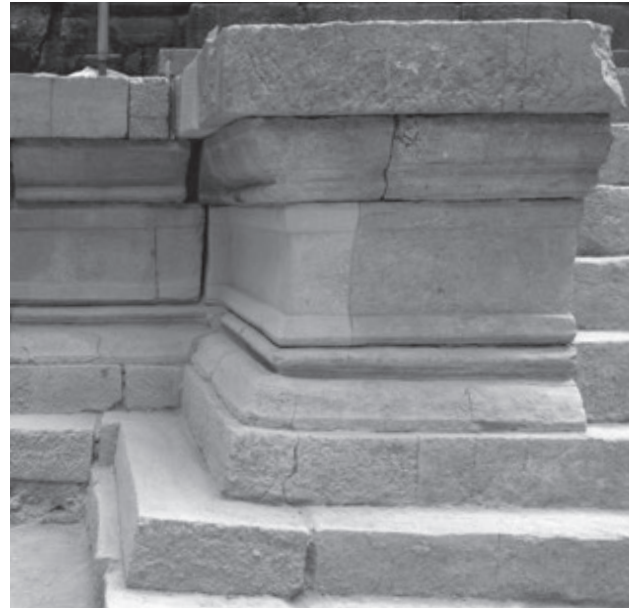
Fig. 40: South stairways of the Central Sanctuary after restoration (Left: west side, Right: south side)

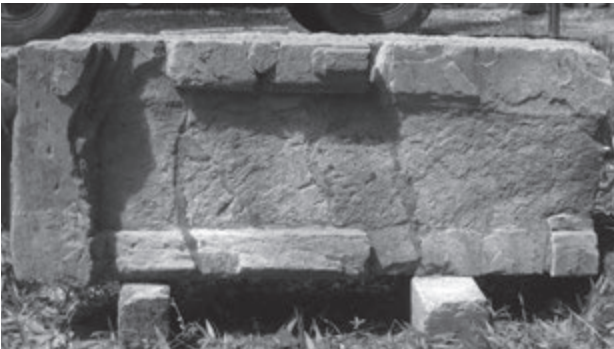
Fig. 41: South stairways of the Central Sanctuary original stone of the west side of N20

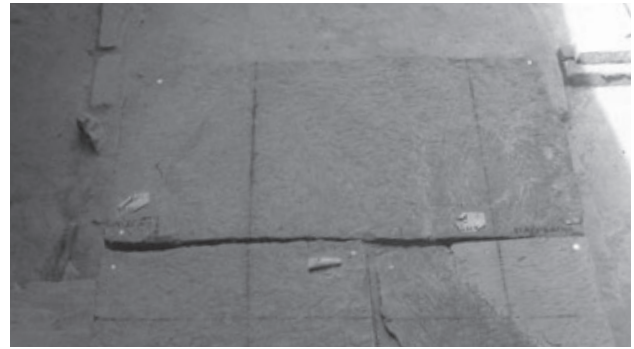
Fig. 42: South stairways of the Central Sanctuary view of the west top surface after restoration

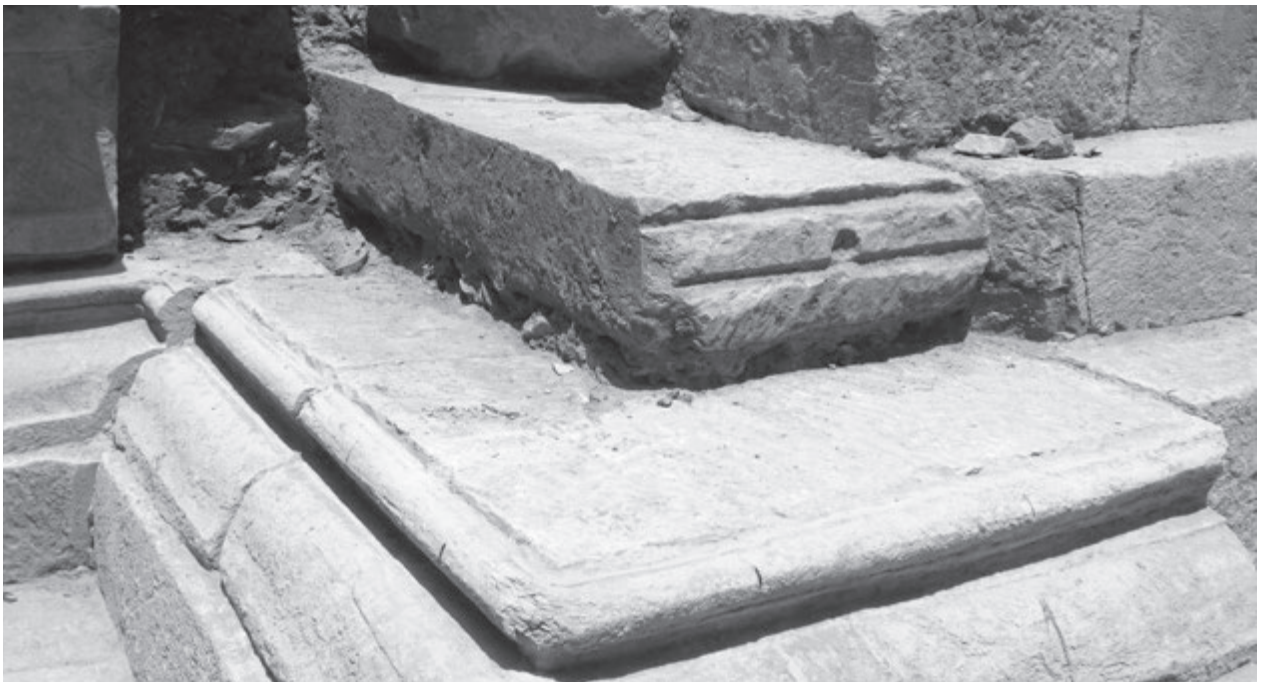
Accompanying this restoration work, part of the south stairways of the Central Sanctuary was dismantled, and a diverted sandstone was discovered, as shown in Fig. 43. The fact that it resembles the diverted blocks found in N21 and N23, as will be discussed later, is a source of interest.

Fig. 43: South stairways of the Central Sanctuary diverted stone blocks on the inner side of the west sleeve area
