MORIOKA CASTLE SITE I

MORIOKA CITY OFFICE

Report of Stone Wall Restoration Work

盛岡城跡 I
— 第1期保存整備事業報告書 —

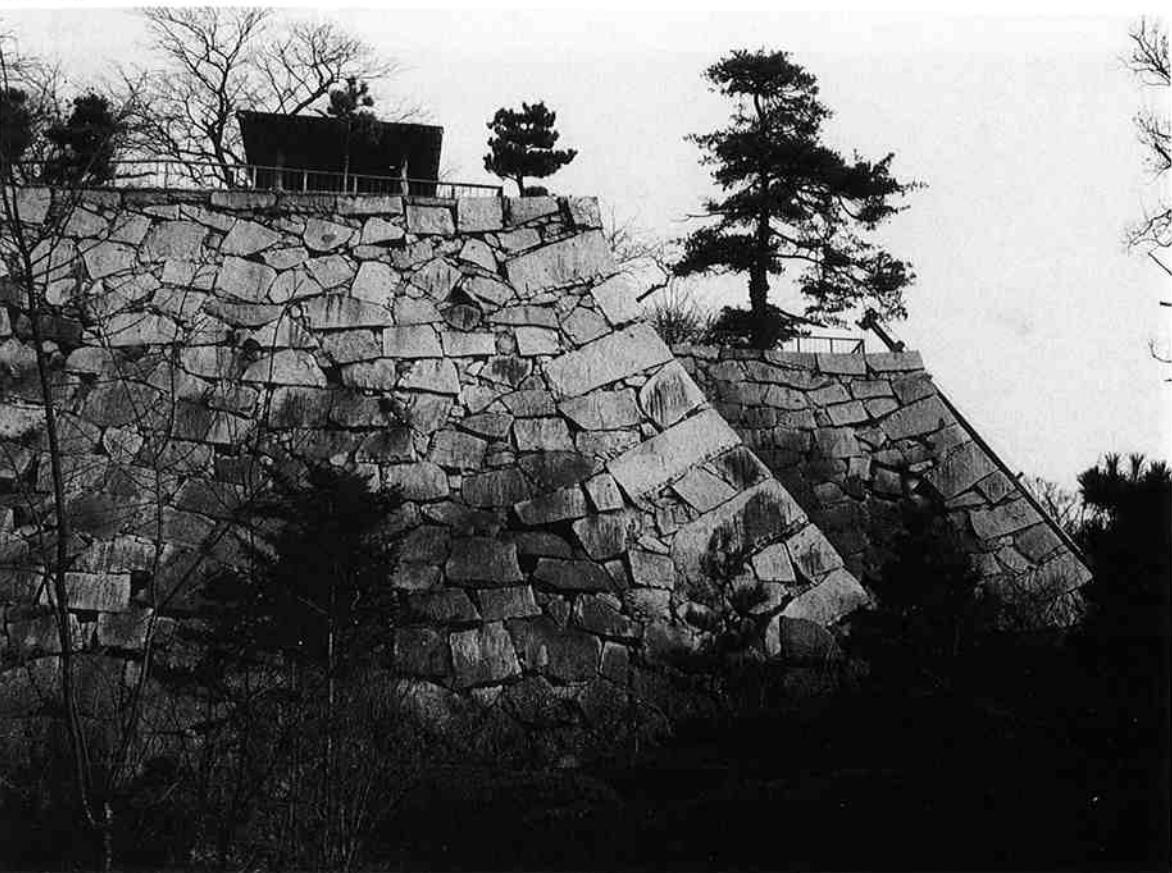
腰曲輪
二階橋石垣
(S→N)

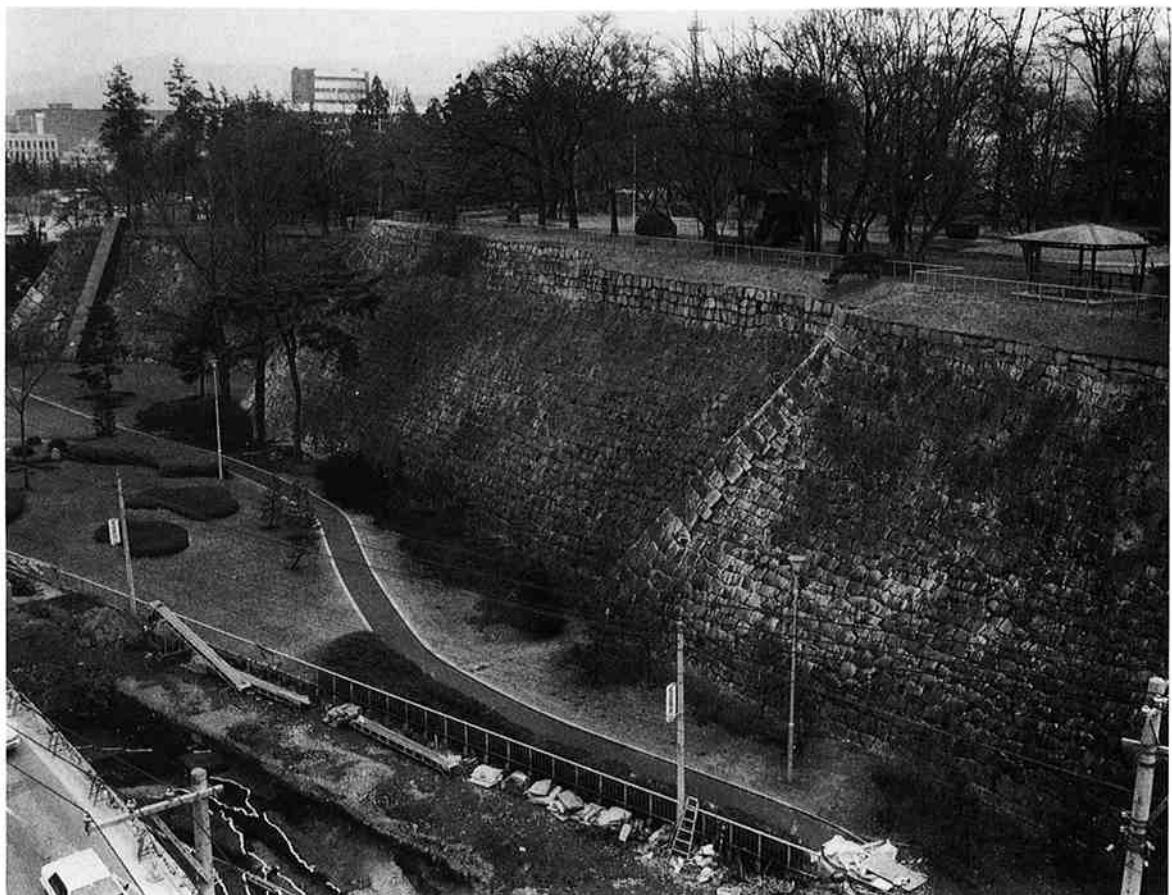
二ノ丸
三ノ丸石垣
(W→E)

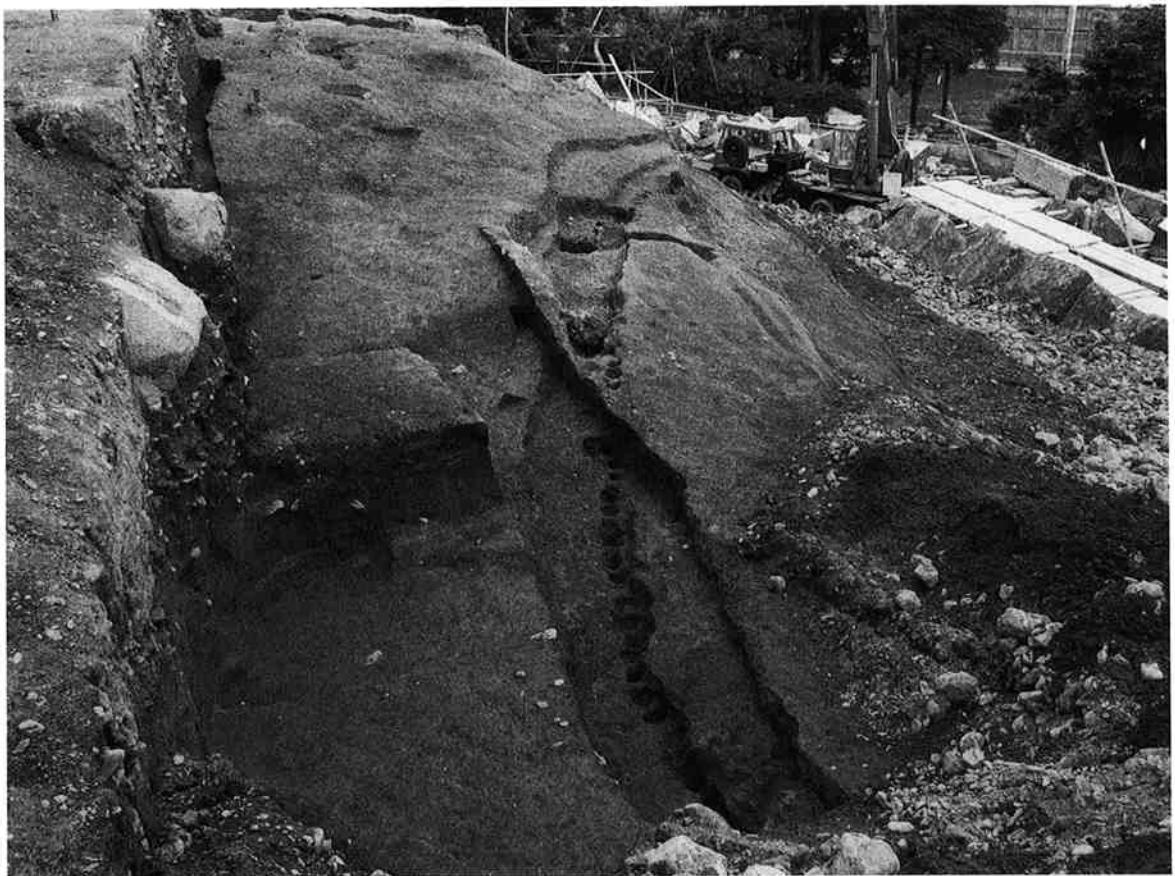
SA407
断面
(N→S)

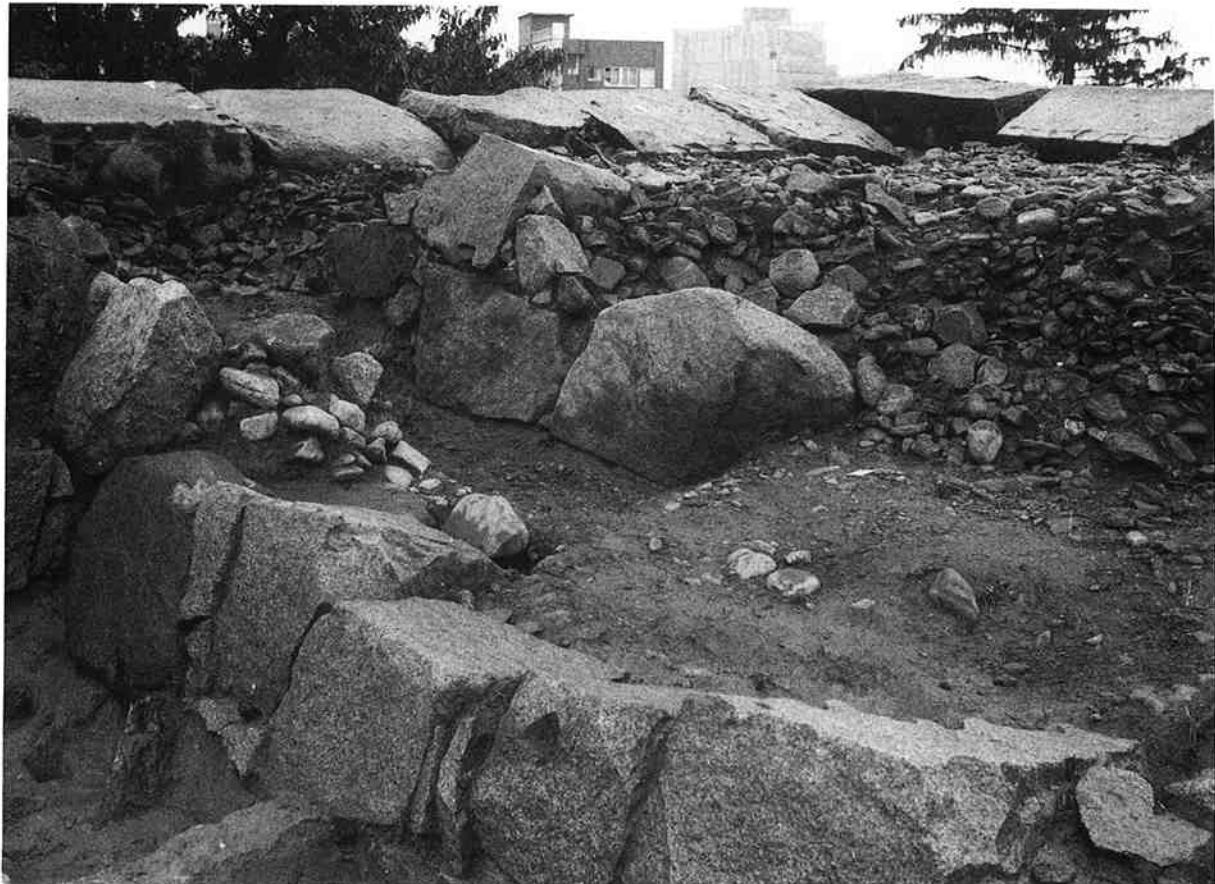
SB420二階櫓跡
北面の新旧の石垣

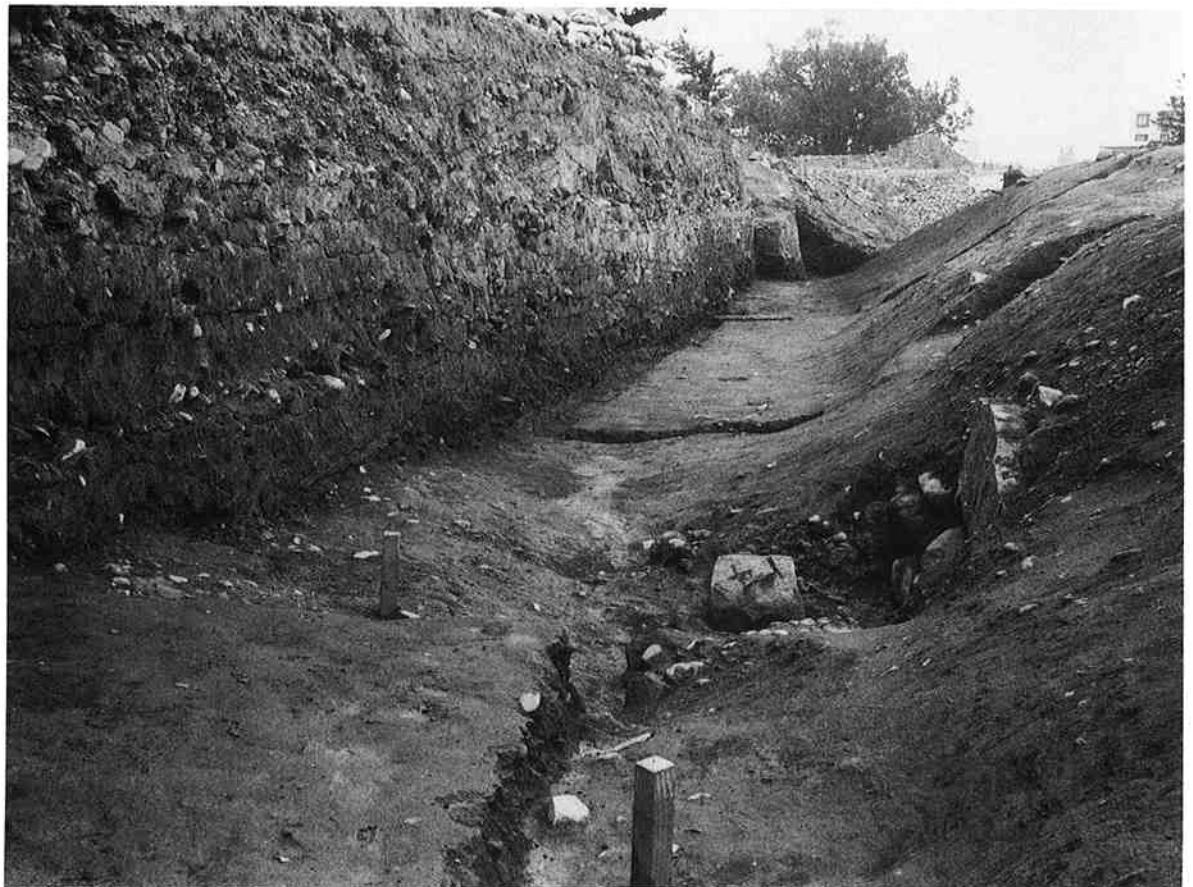
SJ406暗渠
全景
(W→E)
