Annual Report on the Research and Restoration Work of the
Western Prasat Top

Dismantling Process of the Southern Sanctuary

Nara National Research Institute for Cultural Properties
2015

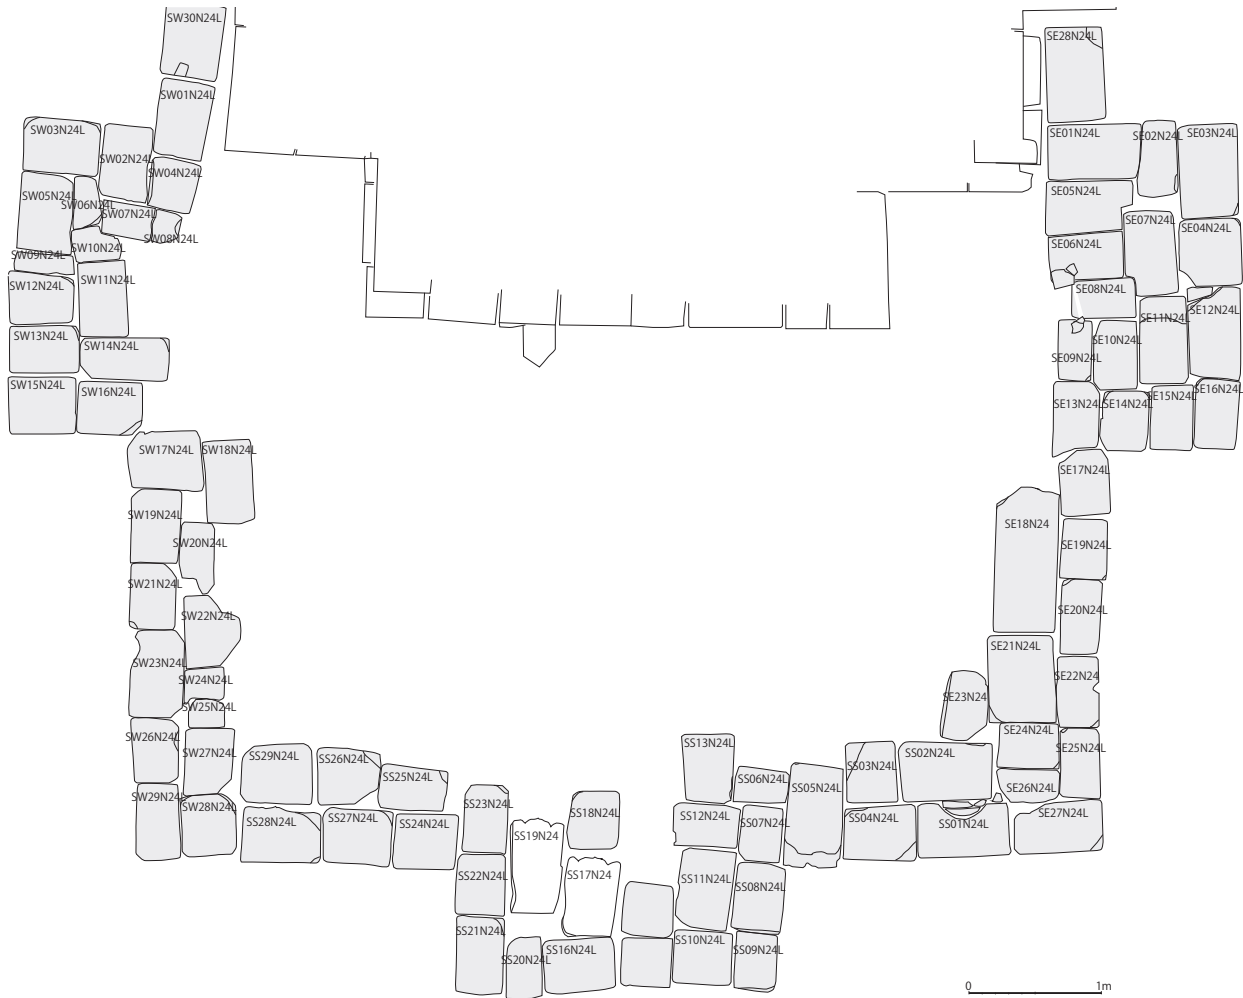
Fig. 28: N24 ground plan

Practically all blocks of N24 are made of laterite. Tiers above N24, down to N23, comprise the upper blocks of the foundation, so N24 and N25 are assumed to be laterite blocks that were installed as the base of the above sandstone blocks. The paving is rather disorderly, with the blocks of the east stairways paved most carefully and blocks of part of the west stairways missing altogether. The laterite blocks of the south stairways are also disorderly, but SS17 and SS19 on the inside are sandstone Sema stones. Heretofore, 12 Sema have been discovered from the upper foundation, as reported in the previously-published restoration report. The two recently-discovered Sema were also installed in the stairways, with their head in the direction of the foundation. Since they seem to have been arranged in this way with conscious awareness of their function as a Sema, it can be assumed that they had some ritualistic meaning(see Articles Chapter 3 p.56-64).

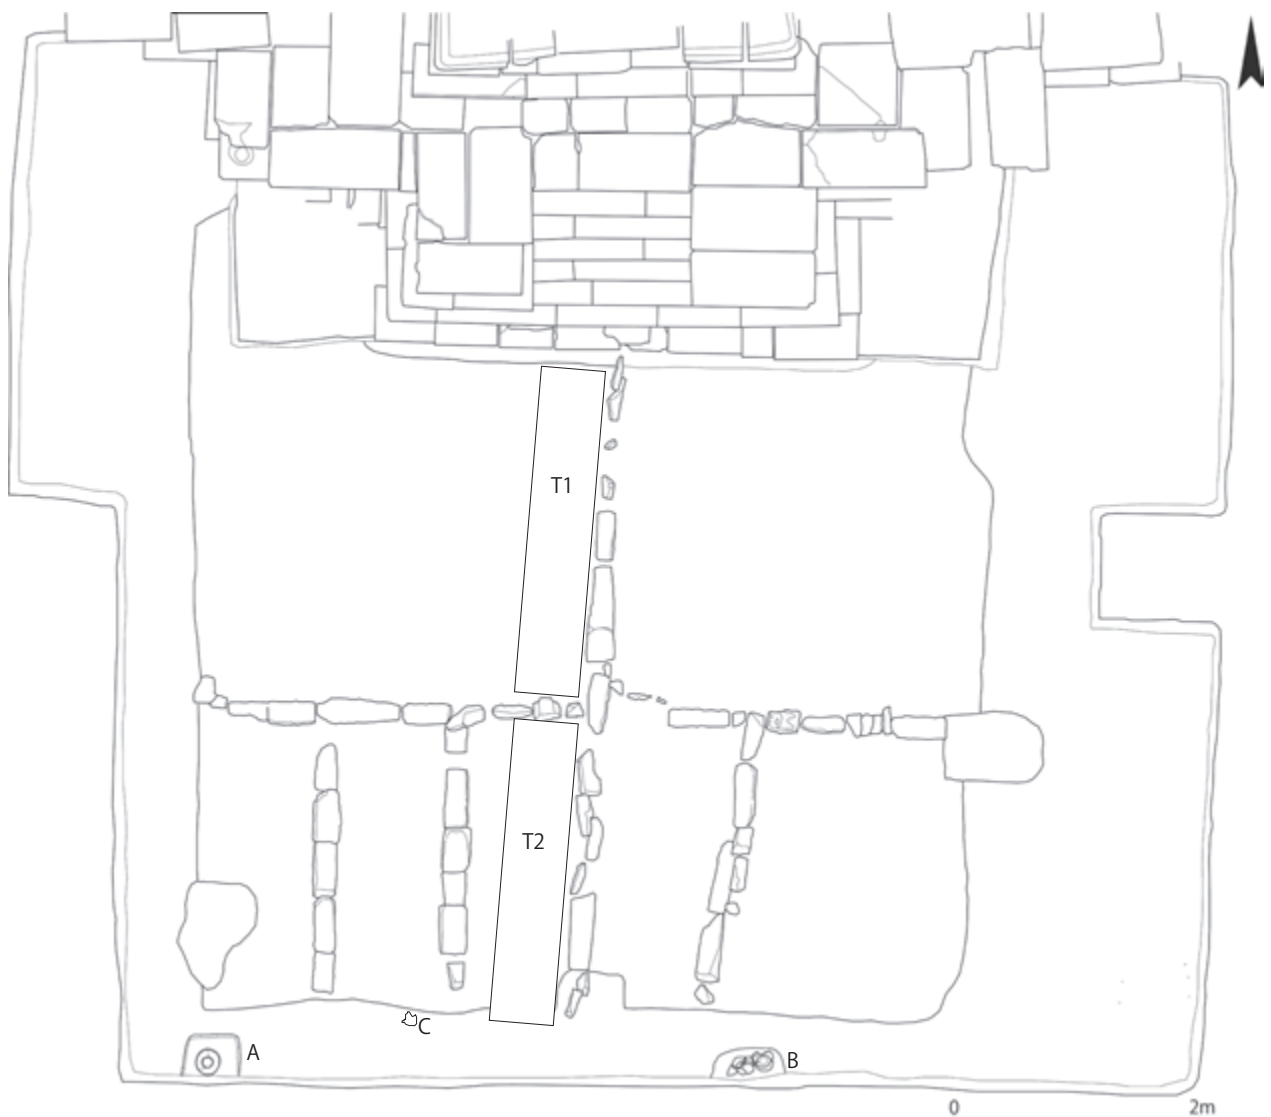
Stone lines were discovered in the foundation, as shown in Fig. 48, basically with a cruciform ground plan. The cruciform lines divide the platform digging ground into four compartments. Inside the southwest compartment are two stone lines in the north-south direction, and inside the southeast compartment is a stone line also in the north-south direction. The lines are a mixture of sandstone and laterite stones, and include blocks diverted from a statue of an old woman in the east-west line. The height of the stone lines measures approximately 1.45m from the top surface of the stones to the bottom surface of N18, and measures approximately 0.6m between the largest stone to the bottom of the foundation digging work. In other words, the lines are installed in the middle of the foundation ground. Their purpose thus poses a question. A number of possibilities can be conceived, including their use as retaining stones for the compacted soil in the digging work, or as a reference for marking north-south and east-west lines in the digging work. However, any conclusion shall be made after acquiring more similar examples.

Fig. 48: Stone lines in the foundation ground plan

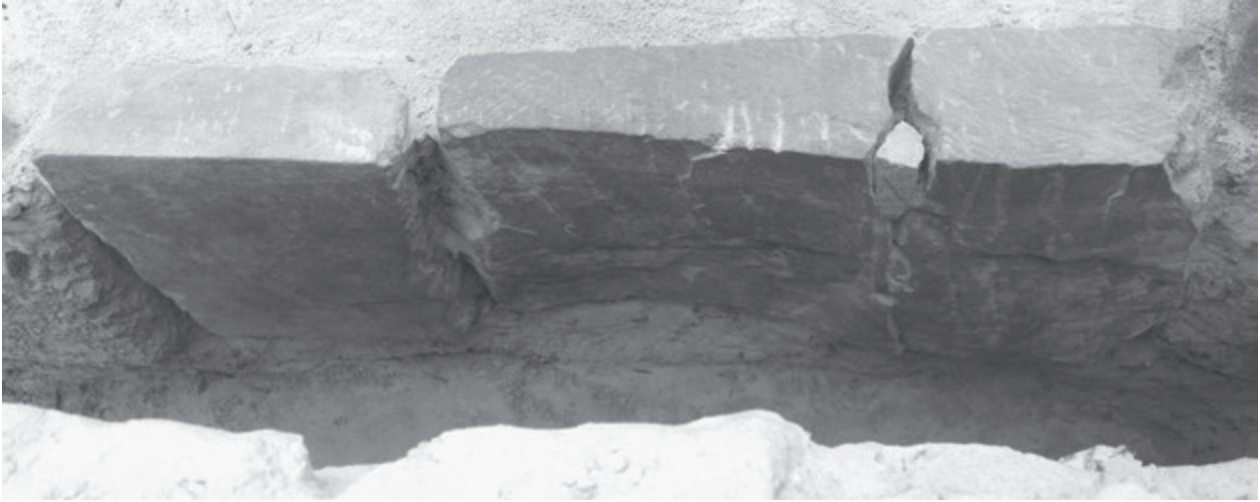
The five northern stones and one southern stone are relatively large, flat stones arranged vertically. The height of these six stones is practically aligned with each other. Other small stone blocks, however, vary in size and shape, and are uneven in height. As a result of this survey, the state of the digging line and the bottom of the basement digging ground was ascertained in part. The basement digging ground has been dug down diagonally, and the bottom is considerably uneven.

Fig. 49: Stone line in the foundation north cross-section (viewed from the west)

The stone lines in the foundation were decided to be excavated no further, but basically preserved as they are. For this reason, a detailed investigation of all stone lines was foregone, but a partial trench was opened on the west side of the north-south line of stones in the center to examine its cross section. The cross section is shown in the figure below.

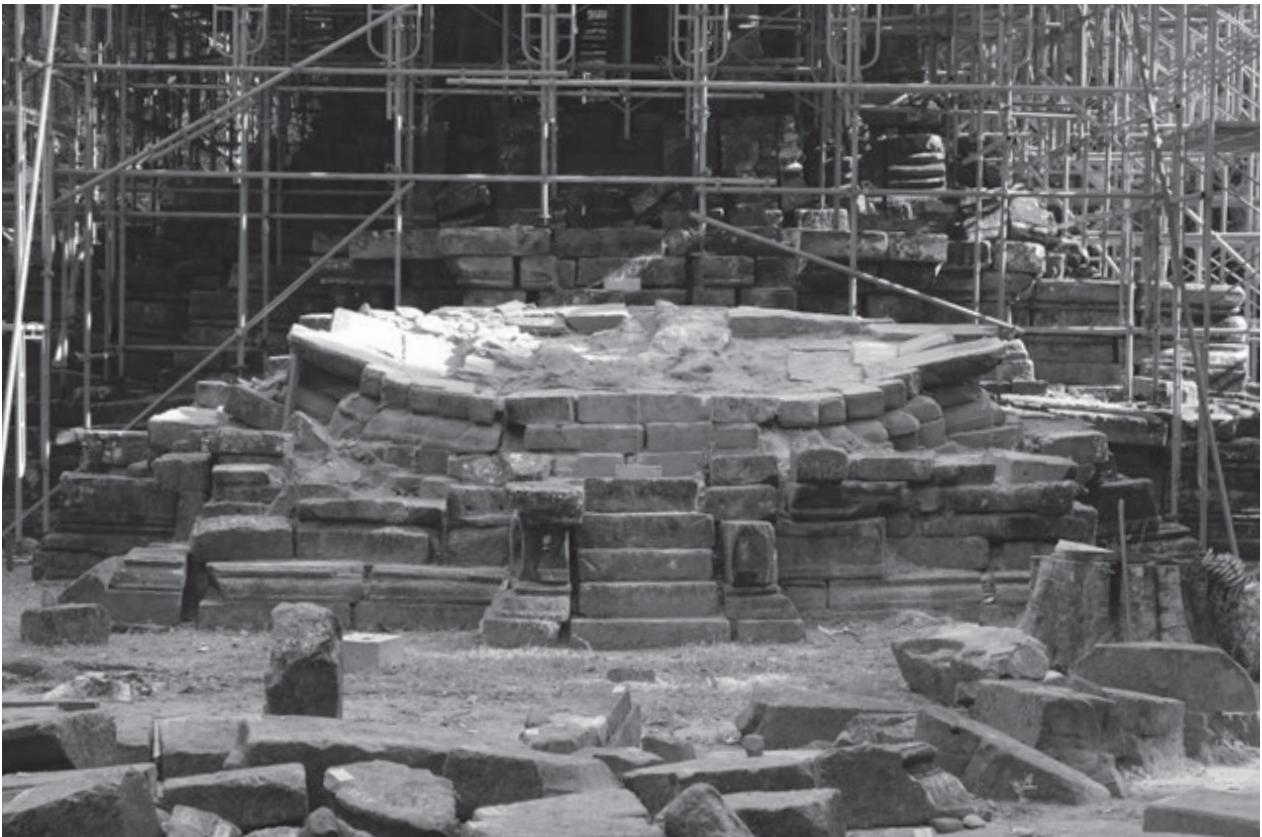
Photo 4: Subsidence of the top surface of the upper foundation

Photo 4 shows subsidence of the upper foundation, and Photo 5 shows subsidence of the central area of the sandstone pavement of the surface of the lower platform. Measured from the sandstone side walls on both sides, it is sunken approximately 56cm at the most. However, the subsidence is minimal on the north side, which connects with the Central Sanctuary. Since it has been found in an excavation survey that the south stairways of the Central

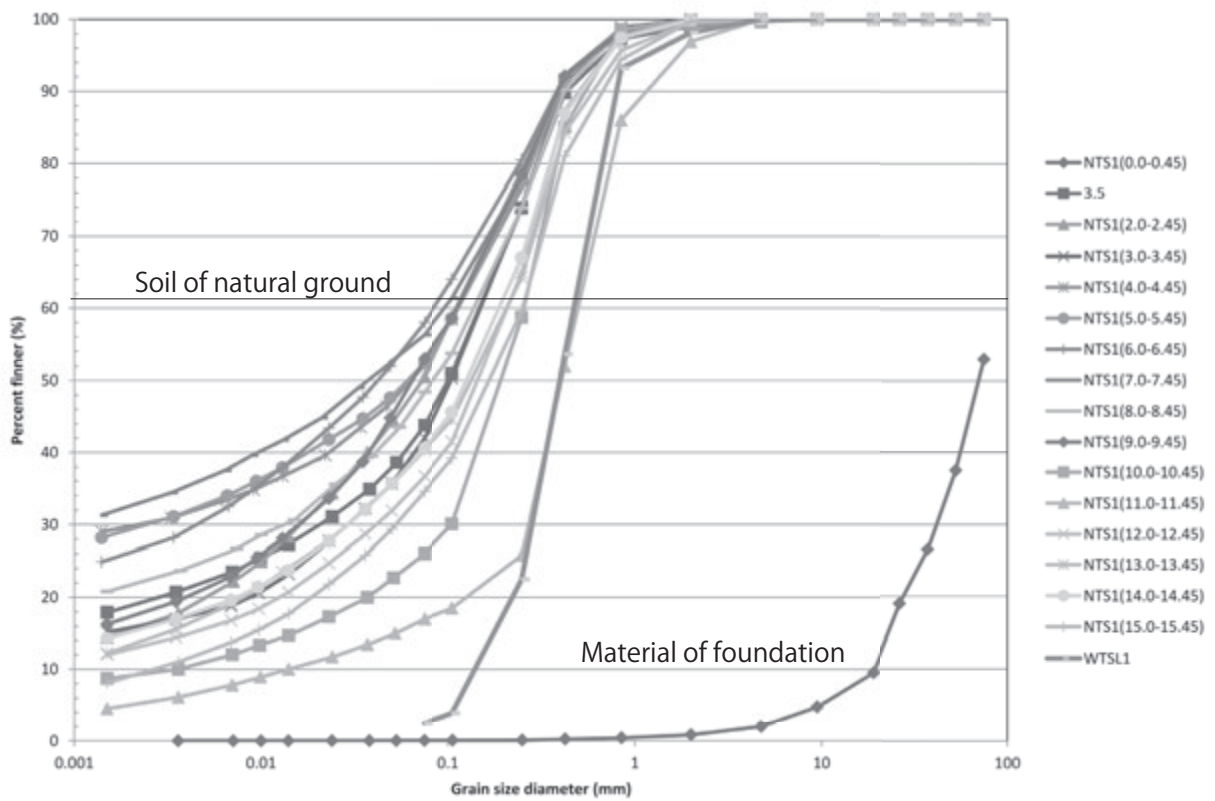
Fig. 4: Grain size distribution of the foundation material at the South Sanctuary

The foundation material is coarse sand with readily erodible properties. The solid line in Fig. 4 represents the grain size distribution of the foundation material. The dotted lines show the grain size distribution of sample soils collected from a natural ground boring survey conducted at Western Prasat Top. The foundation material is composed mostly of coarse grains that are more than 0.1mm in diameter. Contrarily, soils from the natural ground are composed mostly of fine grains. As the grain size characteristics are not readily apparent by the above graph alone, the grain size distribution curves shall be expressed in terms of a representative index, although details will be omitted. That is, in terms of representative diameter, a diameter index of 10-2mm or more expresses the property of sand, 10-3 to 10-2mm the property of silt, and 10-3mm or less the property of clay. Fig. 5 shows an overview of the representative diameter index. The representative diameter index of the natural ground, according to the figure, is $(1 \text{ to } 2) \times 10^{-2}\text{mm}$ in the surface layer and lower layers, which indicates sand layers, and ranges between $(3 \text{ to } 7) \times 10^{-3}\text{mm}$ in the intermediate layers, which indicate silt layers. Meanwhile, the representative diameter index of the foundation material is $1.1 \times 10^{-1}\text{mm}$, which represents sand, and indicates that the foundation material is made of coarser sand compared to the sand layers of the natural ground.

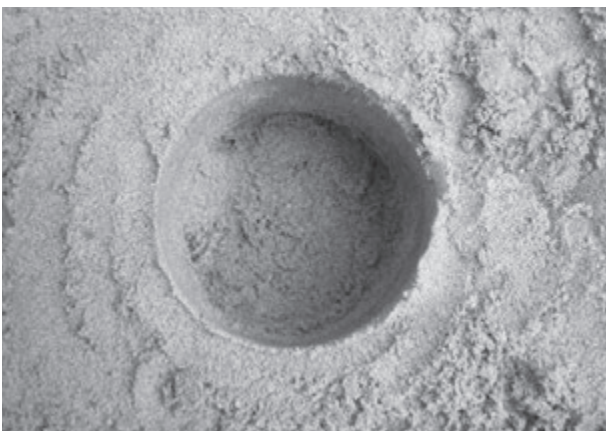
Photo 8: Erosion of the material of the lower platform

Photo 8 shows the bare hole of a permeability test performed on the lower platform. The hole maintained its shape in wet condition, but when water was quietly applied, the area around the hole eroded as though to melt, and the hole lost its shape.

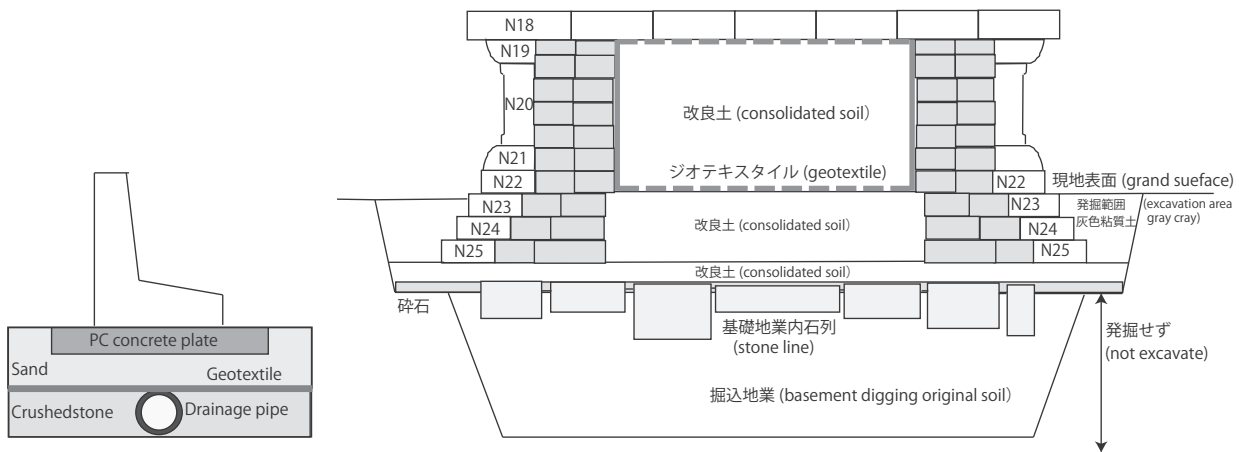
Fig. 16: Unwoven textile application example

Opening size is determined by the grain size of the soil that is to be prevented from flowing in or out, and could be roughly defined as $D_{85}/\text{Opening size of the textile} > 1$. D_{85} is the maximum diameter of 85% of the particles that pass through the textile in terms of the grain size distribution curve. With reference to Fig. 13, an opening diameter of roughly 0.2mm (200 μm) can be obtained. A plastic board drain is also used in some cases for improvement of clayey ground. In this case, the core material is covered with unwoven textile to prevent clay particles from getting into the core material. The average opening diameter of this unwoven textile would be 50 μm .
