## Chapter 3: Door Elements on the Central Sanctuary of Western Prasat Top Temple (Monument 486)

Sok Keo Sovannara

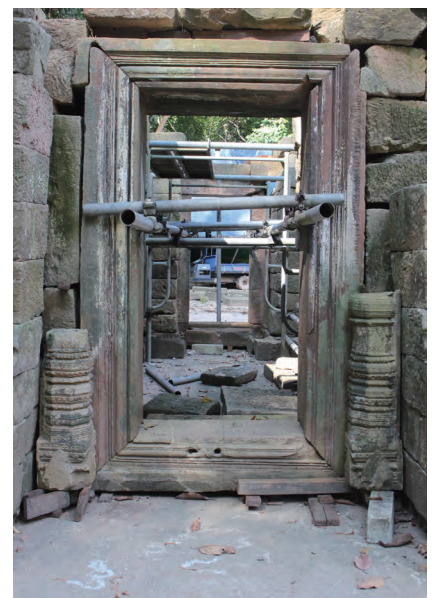
Fig.6 Eastern door frame (during reconstruction)

The eastern door frame blocks are completely made of red or pink sandstone. There are in total four blocks, such as the: lower frame; vertical right frame; vertical left frame; and, upper frame. Both vertical frames were almost the same height and thickness. The lower frame was short in length and thickness, but its width was bigger than the vertical and the upper frame. The inner side had two holes cut into it for the wooden door jambs and door. The upper frame is longer than the lower frame. Originally, the north-west edge of this frame was already broken before it was installed on the vertical frames. These four frames seem to have been produced and installed together in the original period of construction since, when we reinstalled them, the connection points were also almost fixed in shape.

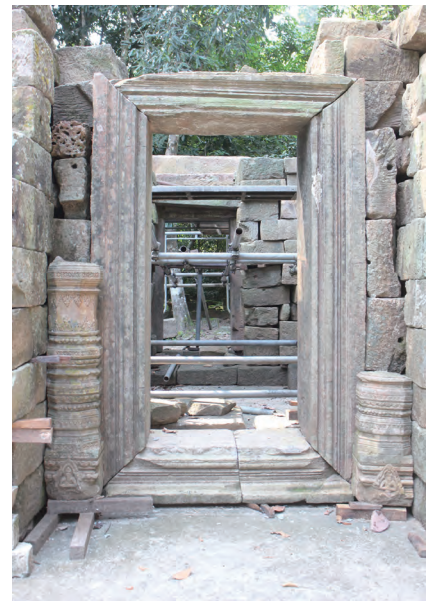
Fig.8 Northernn door frame (during reconstruction)

There are five blocks in this frame. The vertical frames are made from red sandstone of the same sizes. The lower frame is made of two blocks of pale-yellow sandstone. These two lower blocks seem to be remade or reused to connect with the vertical frames, because their tenons are not fixed to the mortises of the vertical frames. The problem is related to the size of the mortises, which are bigger than the tenons. So, the constructors had to add a block or keystone for fixing the space or gap of the tenons and mortises. Actually, we found a small block of laterite inside this space. Also, the western block of these lower frames had broken at the edge and was originally fixed by adding another piece. The upper frame was made of grey sandstone, similar to the lower frame of the southern door. This grey sandstone block is very poor and fragile. It broke into parts, but these parts can be repaired and used again.

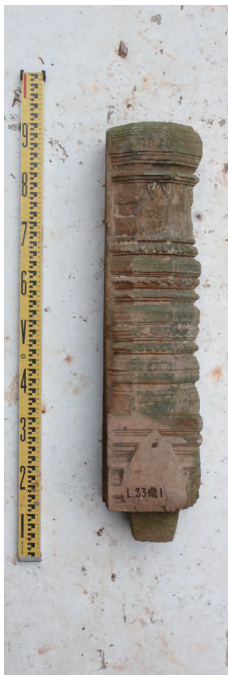
Fig.9 A part of the Colonnette from the eastern face

The two colonnettes of the eastern door are made from red sandstone, measuring about 1.7m high and 0.185m wide. The colonnettes are roughly rectangular in shape with the lower part carved with four corners while the body is carved into a heptagonal (7-sided) shape. The two long sides connect to the door frame and wall, while the other five are decorated with motifs. The southern colonnette is decorated on three sides only. The northern colonnette is decorated on five corners.

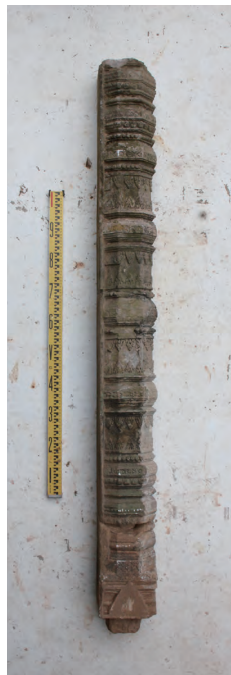
Fig.10 Colonnette from the western face

The two colonnettes of the western door are made from pale-yellow sandstone, measuring about 1.74m high and 0.185m wide. The colonnettes have broadly rectangular shapes, with the bottom part having square-shaped profile while the body is heptagonal. Two long sides are connected to the door frame and wall while the other five are decorated with motifs. These

two colonnettes are decorated on five sides. We have found that these two colonnettes were made or brought from the same place, but the southern colonnette was broken and cut at the lower part and finally added a new connection before installation.

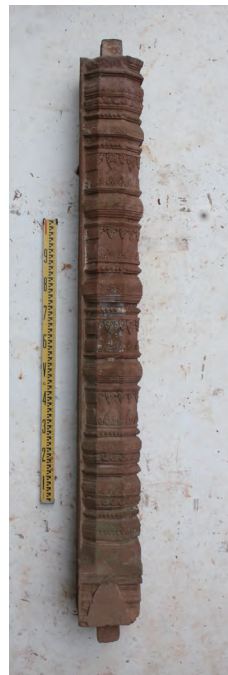
Fig.11 Colonnette from Southern face

The two colonnettes of the southern door are made from light-red sandstone, measuring about 1.86m high and 0.22m wide. The east-side colonnette is rectangular, with the lower part being four cornered while the body is heptagonal. The west-side colonnette is eight sided. Normally, two long sides are connected to the door frame and wall while the other five are decorated. These two colonnettes are decorated on five sides.

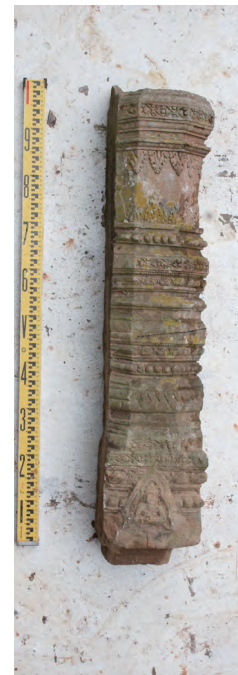
Fig.12 A part of the Colonnette from the northern face

The two colonnettes of the northern door are made from light-red sandstone, measuring about 1.81m high and 0.21m wide. The colonnettes are rectangular, the lower part being four cornered but with a heptagonal body. Two long sides are connected to the door frame and wall while the other five are decorated with motifs.

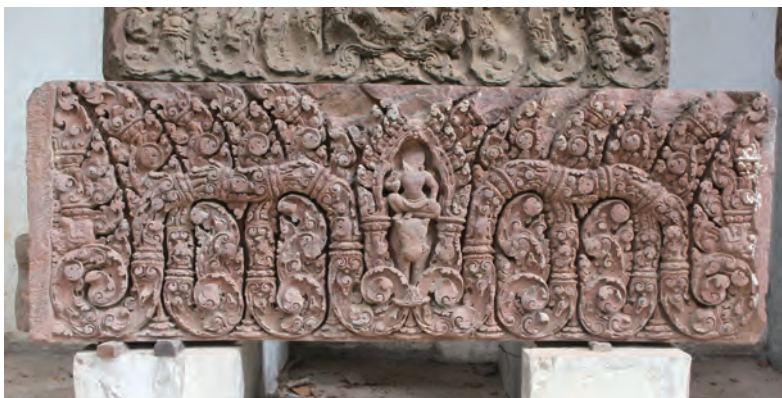
Fig.13 Eastern lintel

The eastern lintel is made of red sandstone measuring 1.47m long, 0.4m wide and 0.49m high. The northern side is straight while the southern side retains in its original edge measuring 0.07m long, 0.29m wide and 0.20m high. The north-west edge of the lintel originally broke and disappeared before dismantlement. The front face of the lintel is well designed with stylistic decorations between the Pre Rup to Banteay Srei styles. The middle part of the lintel shows an image of the god sitting on a horse. He is the god Kubera who controls the north direction.

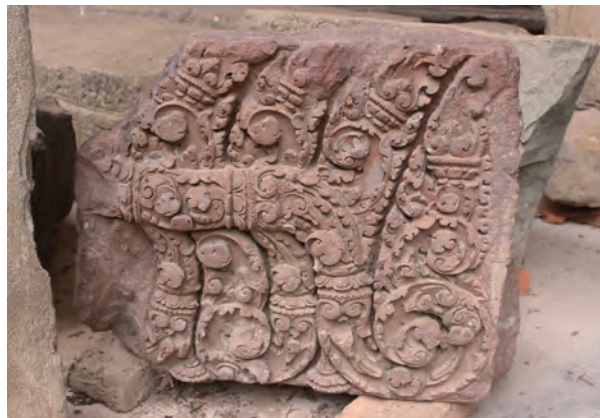
Fig.14 Western lintel

The western lintel is made of red sandstone. The original length of this lintel is not clear because it was cut into three. The middle part was stolen in 1994, and the other two parts (right and left) were collected and preserved in the Conservation d'Angkor. The sizes of these two blocks are about 0.50m long 0.41m wide and 0.42m high.

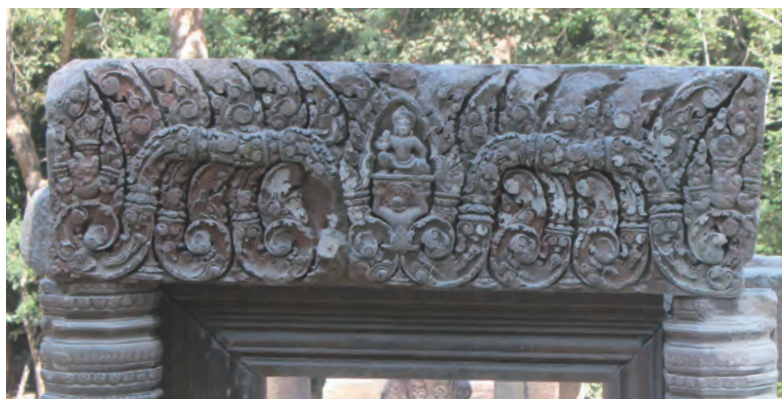
Fig.15 Southern lintel

This lintel remained in place before dismantling. It is made from red sandstone measuring 1.32m long, 0.465m wide and 0.425m high. The middle part is designed with an image of the god sitting on the lion, carrying a stick or sword in his right hand that could be Ketu.

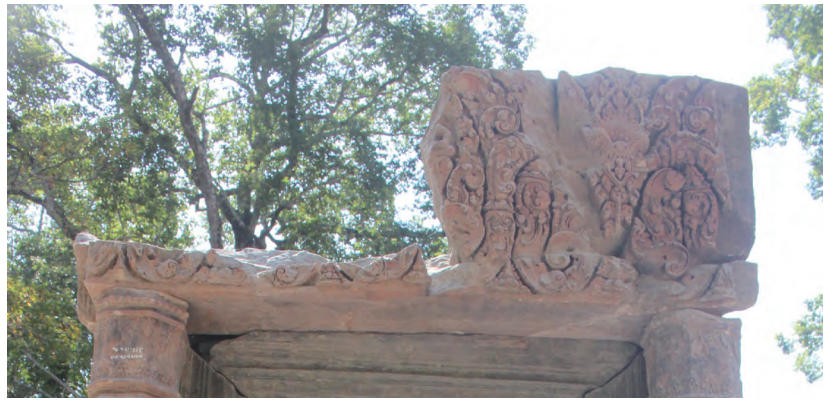
Fig.16 Northern lintel (under reconstruction)

According to an old photo by the EFEO, this lintel remained complete, but was probably destroyed and cut into pieces before 1994. The middle part was stolen. We have found and collected the broken pieces for repair. This lintel is made of pale-yellow or yellowish-grey sandstone measuring about 1.57m long, 0.39m wide and 0.52m high. It is bigger than the other three lintels of the central sanctuary. The remaining parts show an ear of the elephant. If we compare it to the old photo, we know that the middle design was an image of the god

sitting on an elephant. This god is Indra who controls the eastern direction.

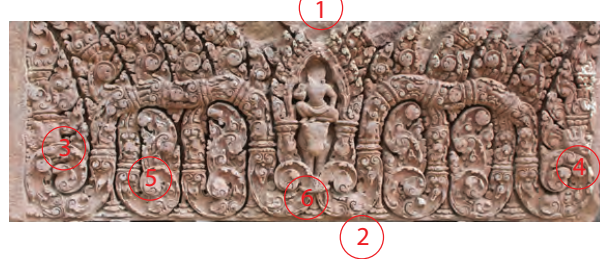
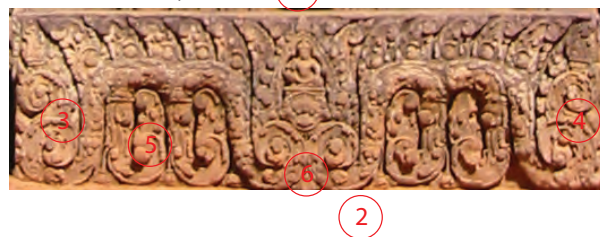
Fig.22 Comparison of lintels at Western Prasat Top and Banteay Srei

- Absent of the original upper edge (1)
- Absent of the original lower edge (2)
- Bow arcs appear from the central medallion outward, created as Hamsa (swan) tails (3)
- Presence of lion heads spitting out a

cluster of flowers (4)

-Garlands of flowers spiralling like snail shell (5)

-Tied ring as Makuta (crown) at the ends of bow arcs in the central point (6)

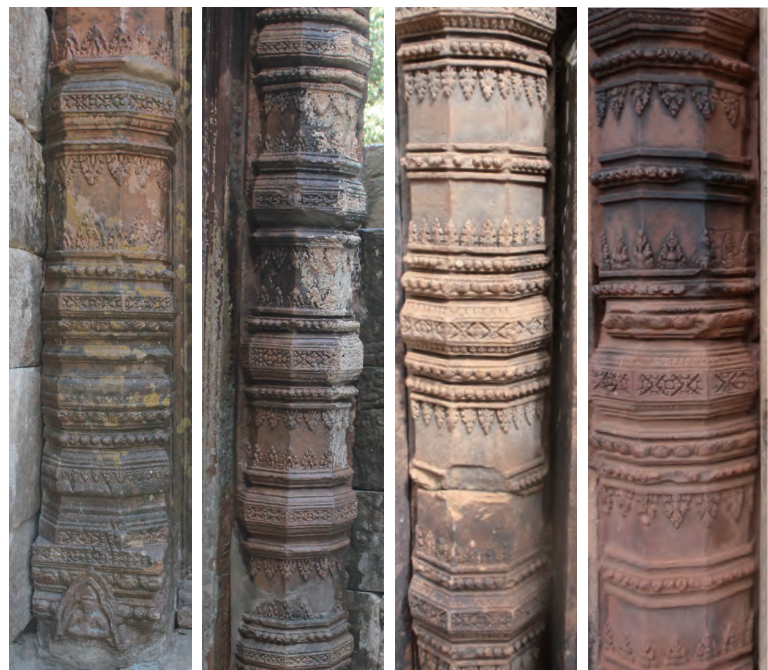
Fig.23 Comparison of colonnettes at Western Prasat Top and Banteay Srei

There are some similarities of the colonnettes at Western Prasat Top temple and Banteay Srei temple.

-Most colonnettes have seven sides or corners

-The Colonnets are divided into three parts: heads, bodies and bottoms.

-The Heads are designed with multiple rings decorated by lotus-petal and fish-egg motifs.

-The bodies are divided into three parts such as:  $\frac{1}{2}$  ring, and two  $\frac{1}{4}$  rings decorated with multiple motifs.

-The  $\frac{1}{2}$  rings are normally created by a rectangular motif of a flower associated with two lines of flower blooms, and two lines of fire-leaf (face down and face up) motifs.

-The heads and bottoms are decorated with the same motifs.

-The lower parts of the bottoms are square shaped and decorated with images of figures praying in Kudu designs.
