Chapter 4 Survey of the Foundation

Section 1 Survey of the Digging Work

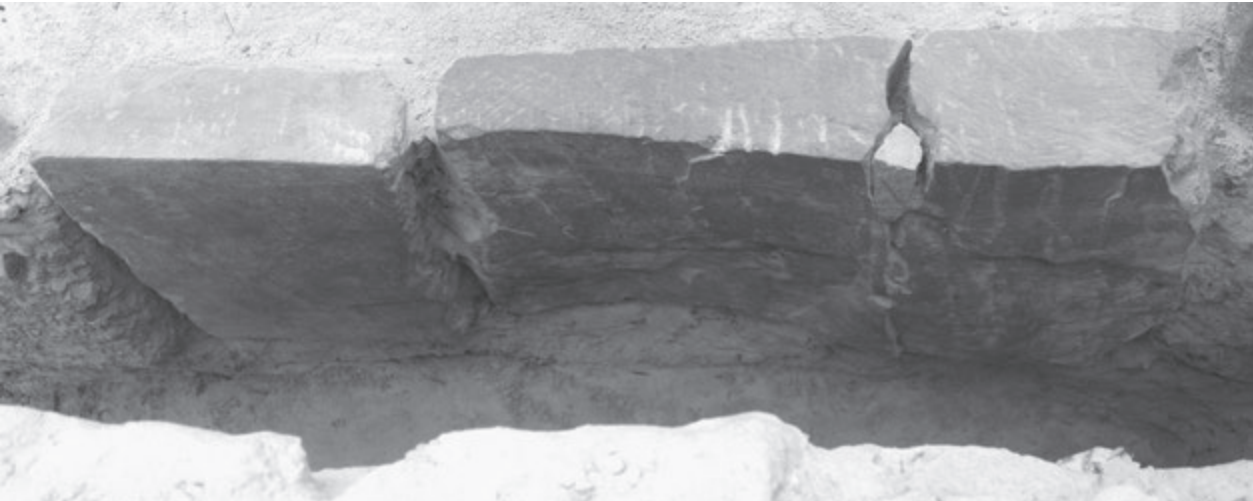
Fig. 49: Stone line in the foundation north cross-section (viewed from the west)

The stone lines in the foundation were decided to be excavated no further, but basically preserved as they are. For this reason, a detailed investigation of all stone lines was foregone, but a partial trench was opened on the west side of the north-south line of stones in the center to examine its cross section. The cross section is shown in the figure below.

The five northern stones and one southern stone are relatively large, flat stones arranged vertically. The height of these six stones is practically aligned with each other. Other small stone blocks, however, vary in size and shape, and are uneven in height. As a result of this survey, the state of the digging line and the bottom of the basement digging ground was ascertained in part. The basement digging ground has been dug down diagonally, and the bottom is considerably uneven.

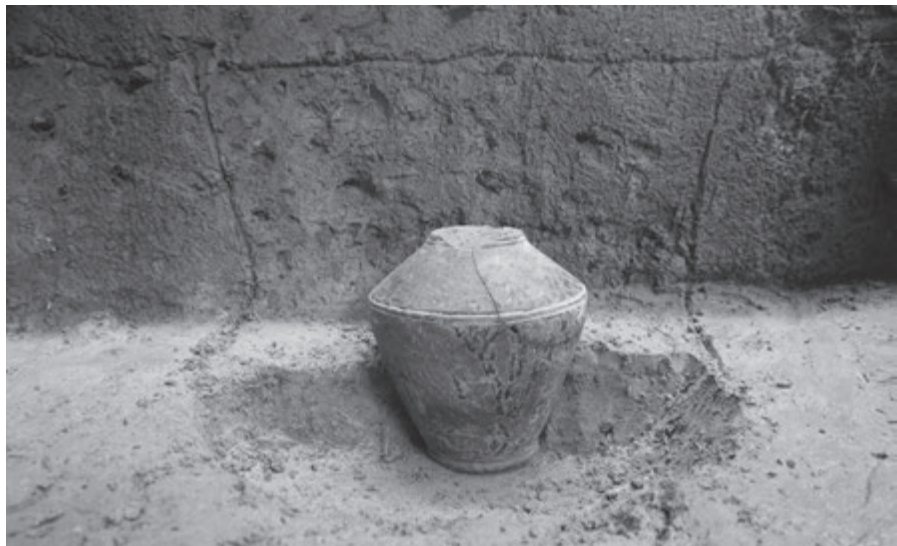
Fig. 59: Buried pottery A excavated state

Buried pottery A (Fig. 59) A black-glazed wide-mouthed Jar was excavated from outside the southwest corner of the digging work of the foundation. As shown in Fig. 63, it was installed upright in a recess created in a layer believed to have been the ground surface when the Southern Sanctuary was built. The mouth and neck portions are missing, and are thought to have been destroyed intentionally when burying the pottery. There is black glaze on the shoulder but not on the body, although there are apparent drips from the shoulder. Although no lid was discovered, it was thought to have a wooden lid. As the inside of the pottery was filled with soil, the soil was carefully removed, but all that the Jar contained were a few laterite and sandstone fragments that had probably fallen to the bottom of the Jar.

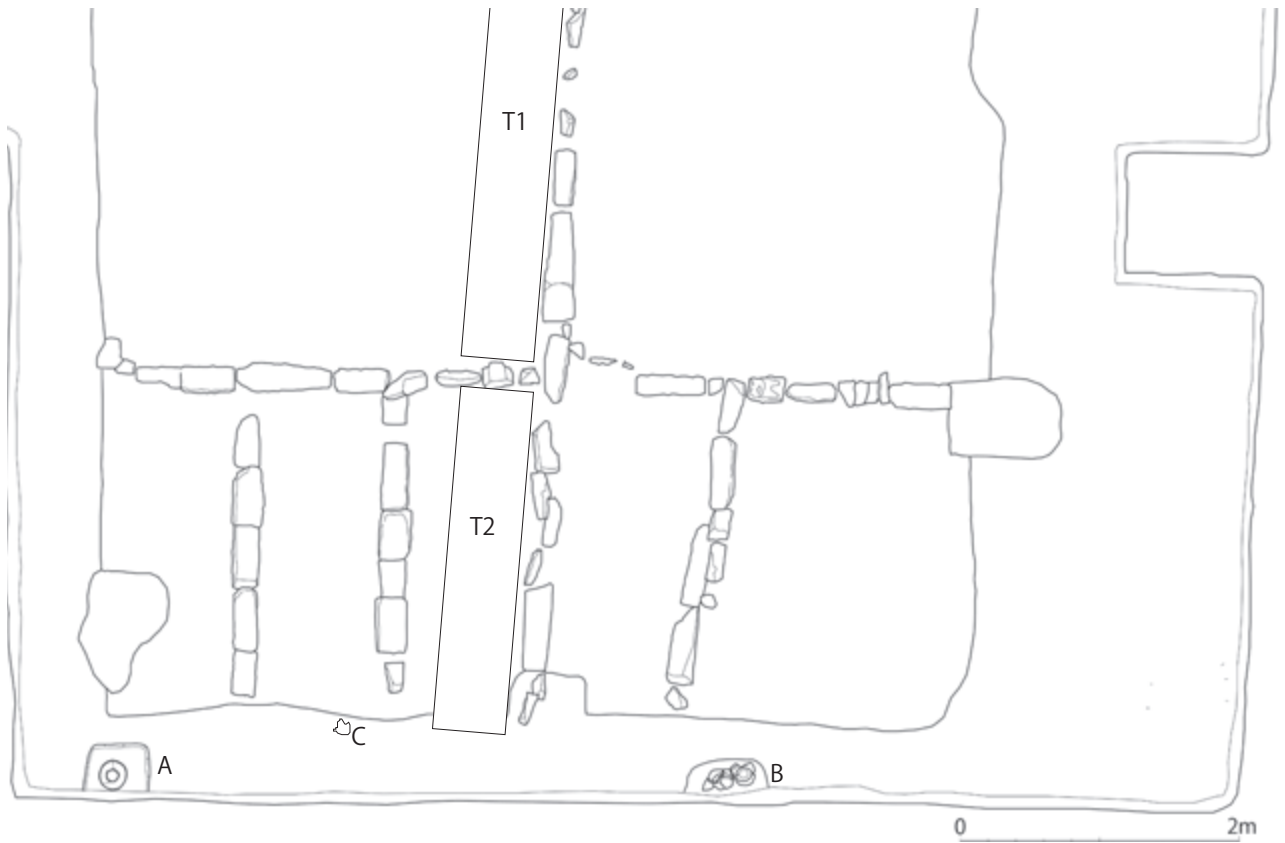
Fig. 60: Buried pottery locations

Four pottery pieces belonging to three pottery remains were discovered. The pottery remains are assumed to have been buried from the outside of the southern digging line of the digging work.

These buried pottery remains were all placed along the south side of the basement digging ground, and buried pottery A was found ensconced in a pit made in the same surface as the basement digging ground, so it is thus assumed that these pottery vessels were all buried at the time the basement digging ground was prepared. Such observation can be said to provide valuable reference for studying the dates of earthenware.

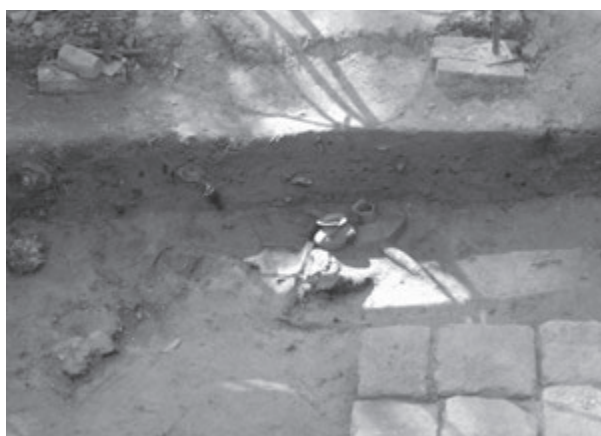
Fig. 64: Buried pottery B excavated state

Buried potteries B (Fig.68,B1,B2) A round-bottomed Jar made of reddish-brown clay resembling earthenware was found in its complete form from the south side of the basement digging ground of the foundation, along with the top half portion of a long-necked vase also made of Haji-type reddish-brown clay.

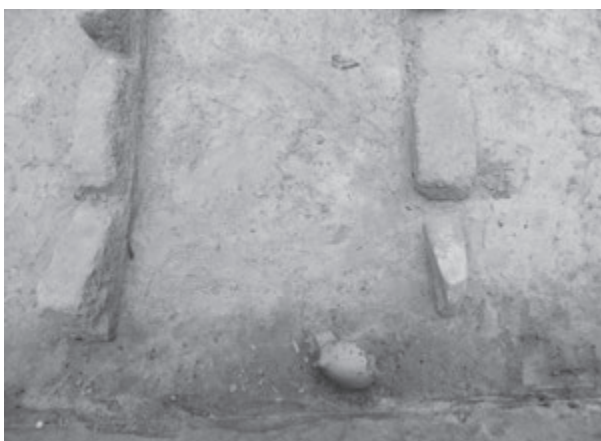
Fig. 66: Buried pottery C excavated state

Buried pottery C (Fig.68,C) The kendi is 10.8cm in diameter around the neck and 24.0cm in diameter at the widest part of the body. A spout approximately 4cm in length is attached to the shoulder. There are two deep lines in the horizontal direction around the attachment of the spout. The entire vessel was first shaped, and then a hole was made where the spout is to be attached using a circular rod. Clay was wound around this rod to shape the spout. The clay of this pottery is more refined than that of the above two vessels.

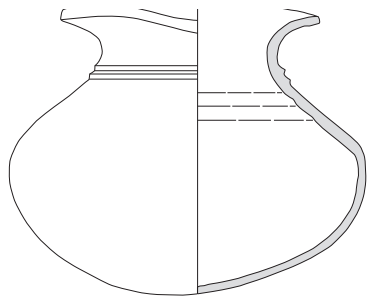
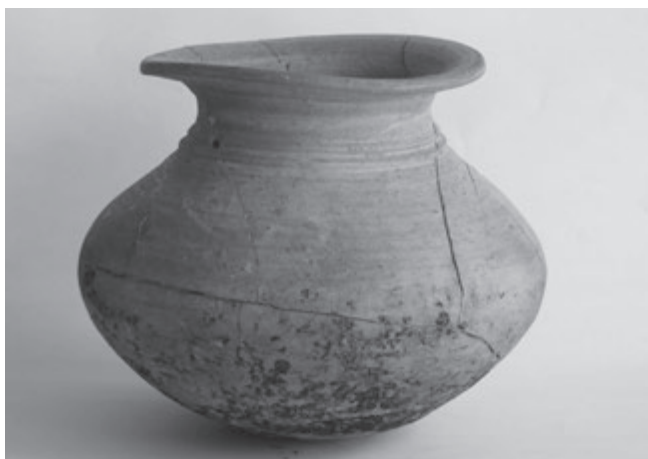
Buried pottery B1 is a round-bottomed Jar. It is 13.6cm in diameter at its mouth, 15.4cm high, and 18.7cm in diameter at the widest part of its body. Unlike regular round-bottomed pots, it rises in a somewhat convex manner above its maximum diameter, and has a shallow, round bottom. There are two grooves around the neck. The rim shows a slight undulation. The clay and firing are both good.

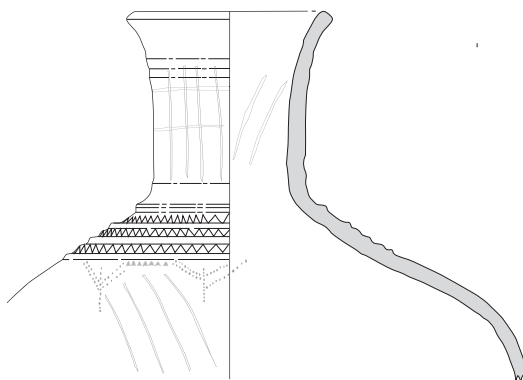
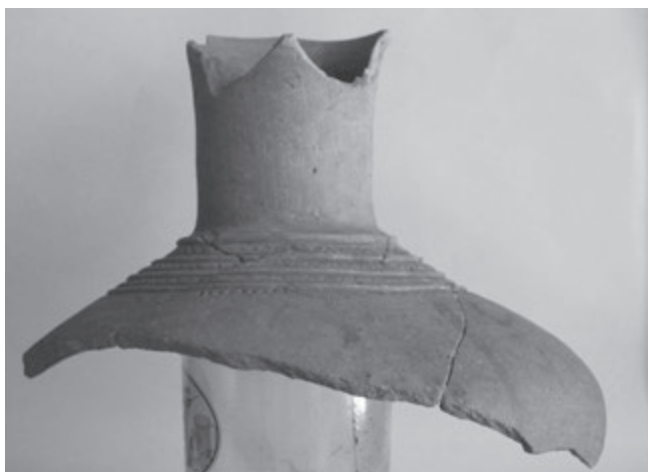
Buried pottery B2 is a long-necked Jar. It has a mouth that is 10.8cm in diameter and a neck that is 9.8cm long. The part below the neck extends widely outward. Roughly one-third of the vase has been found. There are four grooves around the shoulder, with sawtooth patterns carved between the grooves. The part below the grooves is decorated with a zigzag pattern made with long strokes, and between each two zigzag patterns are triangular impressions made with a triangular tool. The outer surface of the body other than the parts with zigzag patterns displays rough linear rubbing marks. The inside of the neck displays marks made when shaping the neck by squeezing. The clay and firing are both good.

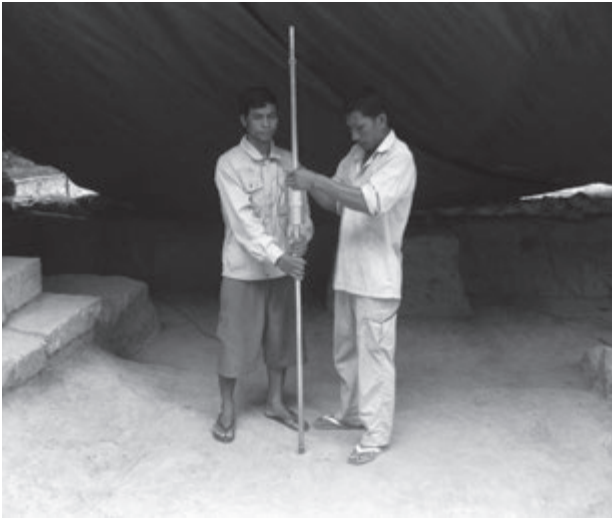
Fig. 69 (top left): Simple penetration test

Prior to reassembly the foundation soil, a ground survey was conducted around the stone lines in the foundation. On June 10 and 11, 2014, a simple penetration test, permeability test and a boring test using a hand auger were performed in two locations at the stone lines. Results of the tests are provided in a separate ground survey report.
