Chapter 5 Progress of Restoration Work

Section 1 Progress of Trial Assembly

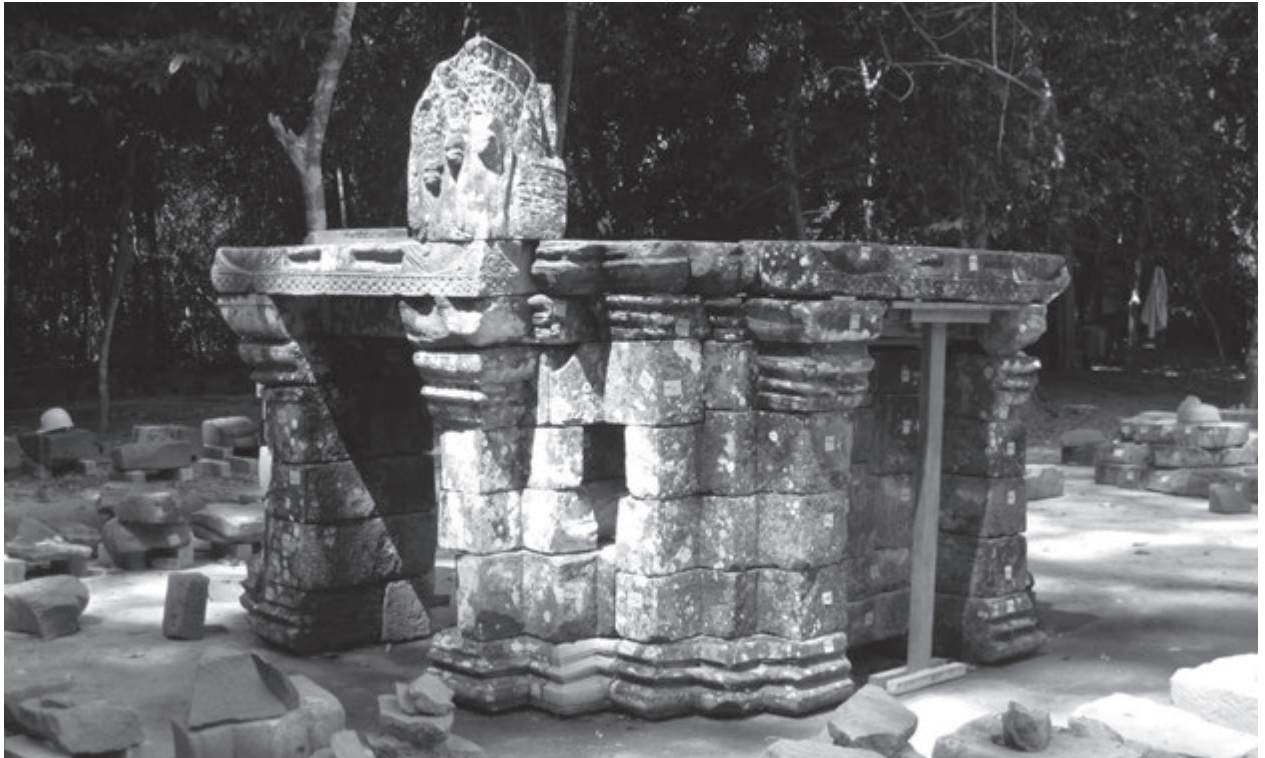
Fig. 73: Trial assembly of the framework (viewed from the northeast)

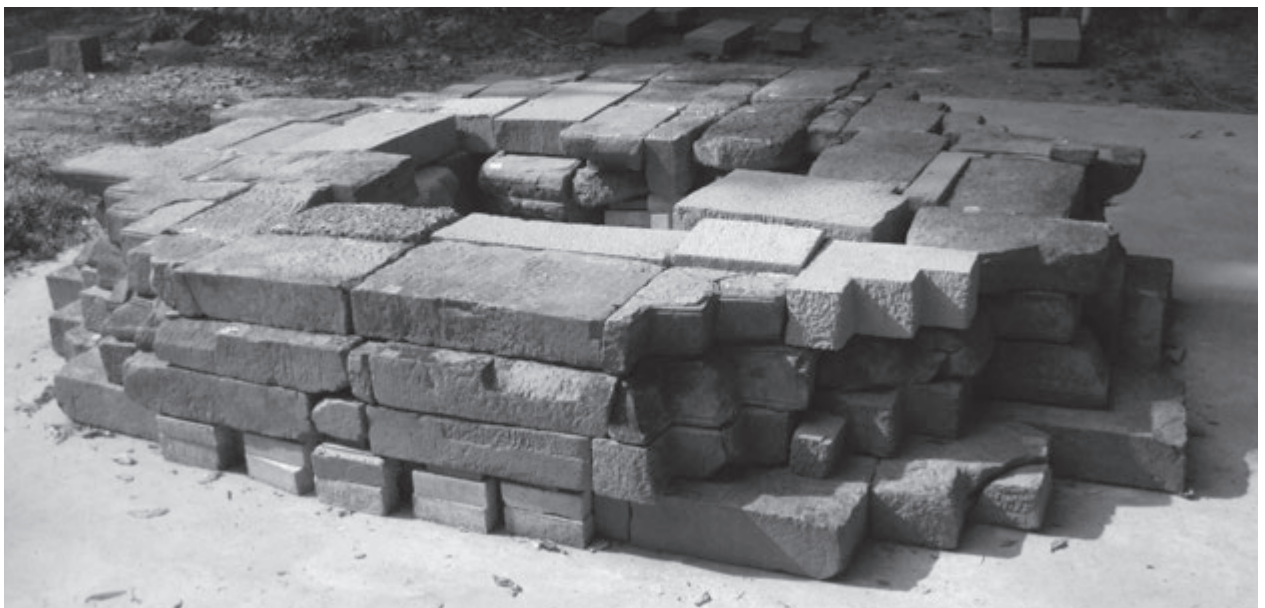
Fig. 74: Trial assembly of the upper foundation (viewed from the northwest)

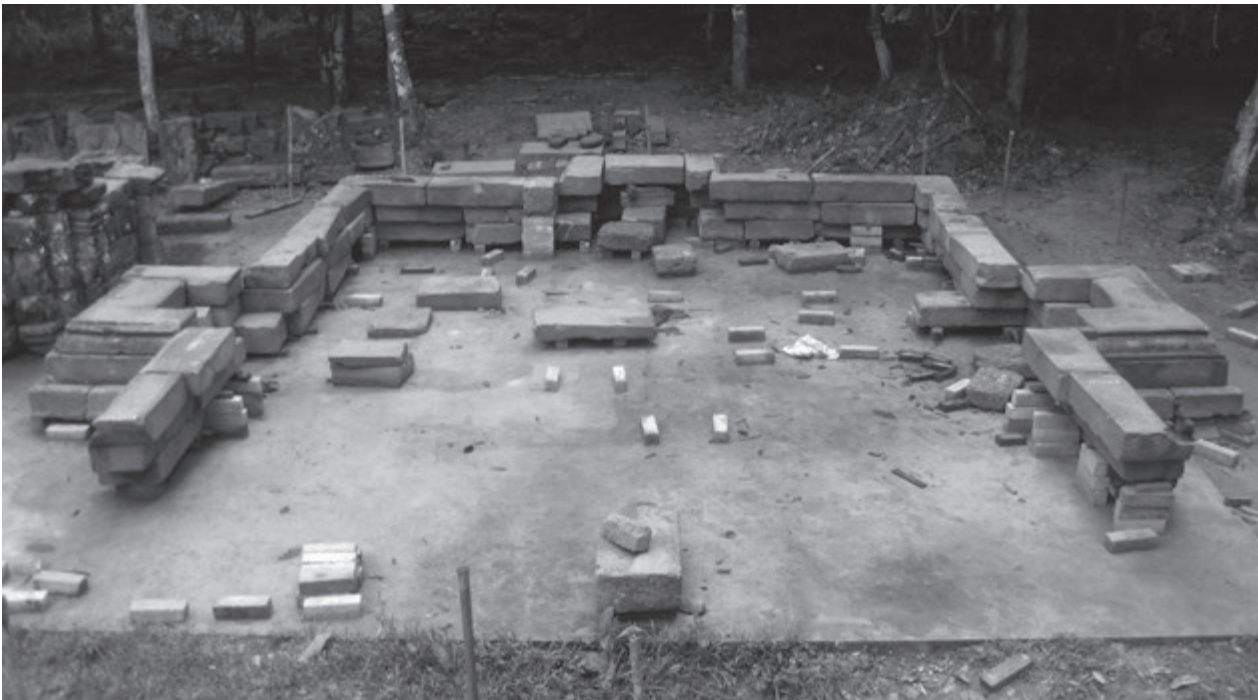
Fig. 75: Trial assembly of the lower platform (viewed from the west; June 10, 2014)

Trial assembly of the lower platform was commenced in the beginning of FY2014, and is currently ongoing.
