### Chapter 1 Examination of Restoration Methods for the South Sanctuary of Western Prasat Top

Taisei Geotech Mituharu FUKUDA

#### Section 1 .Structure and Foundation of the South Sanctuary of West Prasat Top

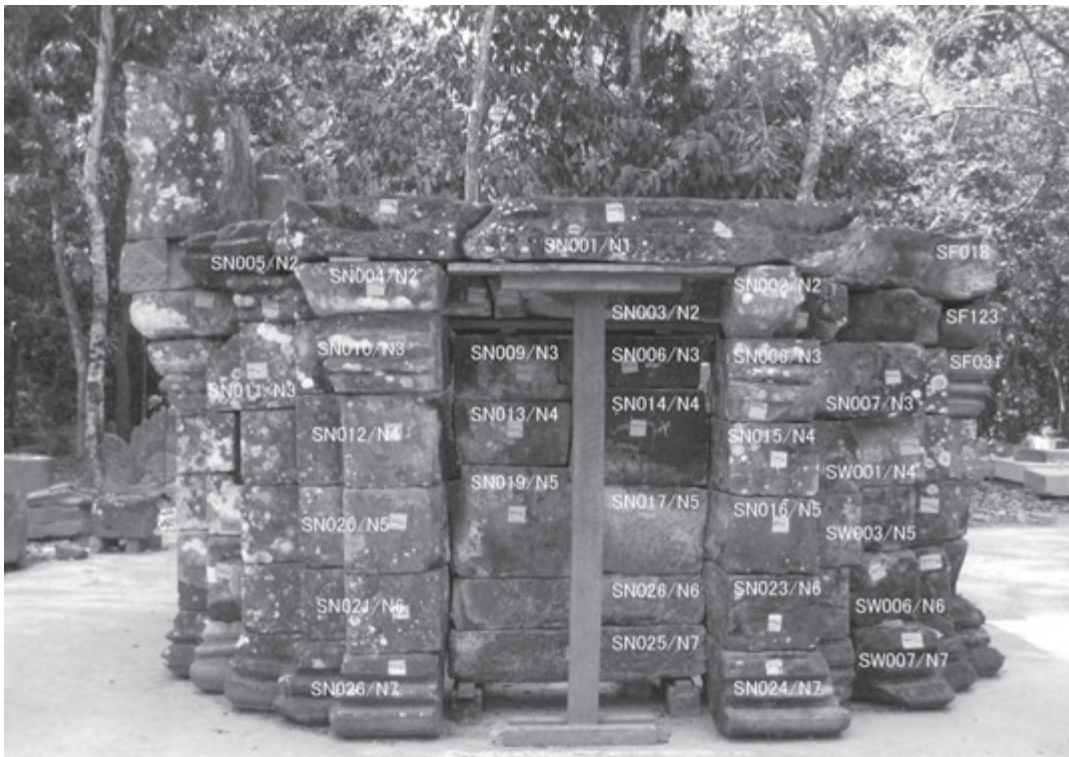
Photo 1: Temporary assembly of the main structure of the South Sanctuary

Among the West Prasat Top remains, the South Sanctuary shall be restored first. The South Sanctuary is composed of an upper foundation and lower platform as shown in Fig. 2, and a main sandstone structure on the upper foundation as shown in Photo 1. The original soil below the lower platform digs into the natural ground at depths below N22, and is composed of three-tiered sandstone side walls and stone lines below the walls, which further dig into the ground to a depth of approximately 80cm. The sandstone side walls of the lower platform stops immediately above the stone lines, below which is a bare hole with no sandstone walls.

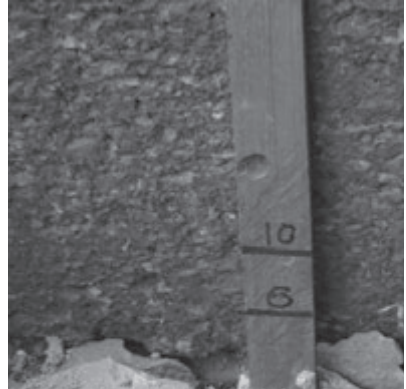
Photo 15: Soil spreading thickness and compacted thickness

Using a rammer, the test soils were compacted from a spreading depth of 10cm to a compacted depth of 6cm. Then, after compacting the areas that come into contact with laterite, a Yamanaka hardness meter was used to control the degree of compaction. After confirming that the control conditions are satisfied, the soils were applied and compacted in sequence. Once the prescribed thickness was obtained, a simple penetration test, loading test, permeability test and density test were conducted to inspect the quality of the test foundation.
