第100図 鹿兒島紡績所の推定位置

第2節 薩英戦争時の薩摩藩の砲台について

This time, an excavation survey was conducted at Kagoshima Spinning Mill Site, which was a major factory of the Shuseikan Project. A similar survey was also conducted at Gionnosu Battery Site and Tenpozan Battery Site, where the British Navy and Kagoshima fought during the Anglo-Satsuma War, and vital elements in stories describing Japan's modernization by the Satsuma Clan. This document tries to clarify the findings.

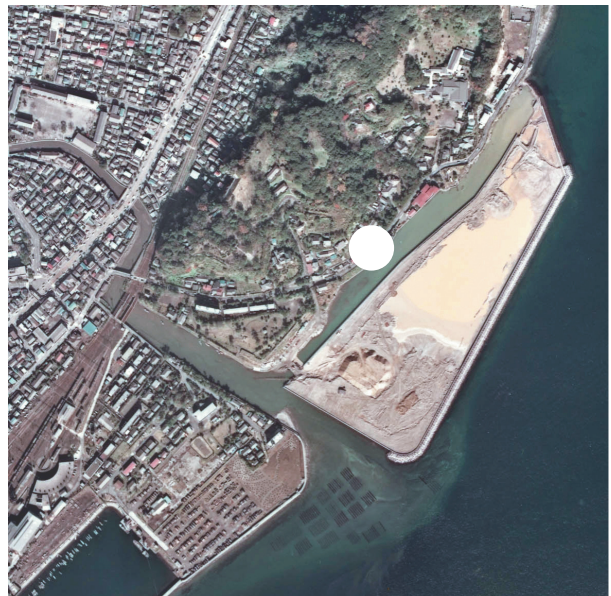
第101図 祇園之洲砲台跡の荷揚場推定位置
図中の白丸が荷揚場推定位置

祇園之洲砲台からは検出されなかったが、第29, 30, 33図を見ると海へ突き出した格子目のスロープ状のものが描かれており、これが祇園之洲砲台跡の荷揚場であると考えられる。この位置については、既に破壊されているのではなく、第4章で述べたように砲台の北側は現在祇園之洲砲台跡が公園として利用されている範囲よりも本来は広く、砲台の北側で護岸の石垣が近年つくられた護岸の内側に残存している可能性が高いことから荷揚場もここに残存している可能性が高い。

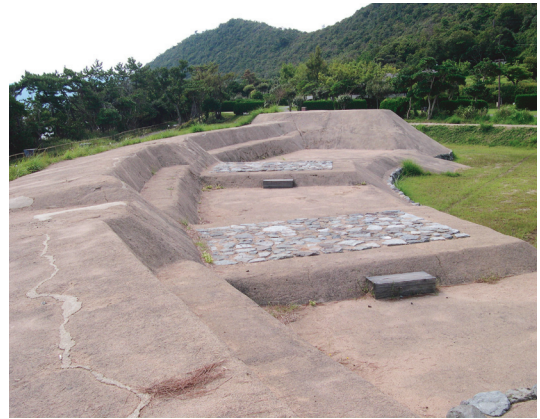
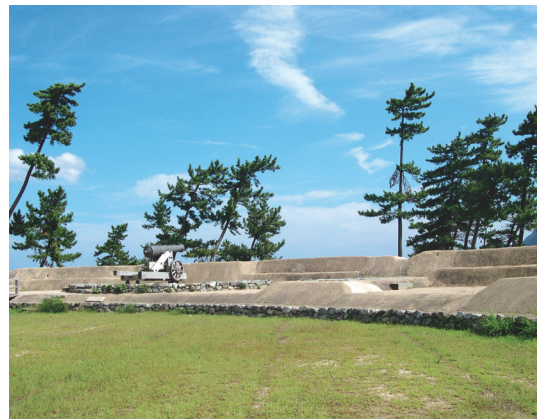
「小松藩 松ヶ瀬・鋸崎台場発掘調査報告書」大飯町教育委員会2000年3月より転載

附遍において、弁天波止砲台の薩英戦争時の姿について考察がなされ、方形の砲座（砲床）について述べられている。このことについて、祇園之洲砲台跡と天保山砲台跡の調査成果からは改修時期の特定ができず、考古学的に積極的に裏付けることはできないと考える。しかし薩摩藩から遠く離れた小松藩の砲台ではあるが、福井県おおい町松ヶ瀬台場2号台場跡の検出遺構をみると、半円形の土を積み上げたのみの胸牆と胸牆端に構築された火薬庫、砲座、背牆が検出されている。胸牆は、砲台内側では階段状をなしている。砲座には、胸牆に沿い中央に胸牆の円弧とは逆を向き、砲台内部から胸牆に向かって開く半円形の軌条を持つ砲床1箇所とこの砲床の両脇に方形の砲床が2箇所ずつ、計5箇所の砲床が検出されている。この5つの砲床のうち、半円形の軌条を持つ砲床の箇所では胸牆の砲台内側が階段状とはならず、天端は内側へ突き出た平坦面を持つ構造である。おそらくここにはキスト砲架の大砲が配備され、この平坦面は弾薬を前から詰めるための施設と考えられる。その他の4つの方形の砲床の箇所では、胸牆に砲眼が開けられており、ここに配備された大砲は、回転式でない砲架のものと考えられる。この状況を附遍、4・5・6章で述べた砲座・砲床についてあてはめてみると合致するようである。また、松ヶ瀬台場跡の周囲にある鋸崎台場跡でも良好な方形の砲床と胸牆の砲眼の組み合わせが検出されている。

This topographic map illustrates the archaeological site of Tell el-Fel, showing the layout of the site, including the main enclosure, internal structures, and surrounding terrain. The map includes a north arrow, a scale bar (0 to 10m), and numerous elevation points and contour lines. Key features include a large central enclosure, a smaller enclosure to the north, and various internal structures and walls. The map is labeled with various numbers indicating elevations and distances.

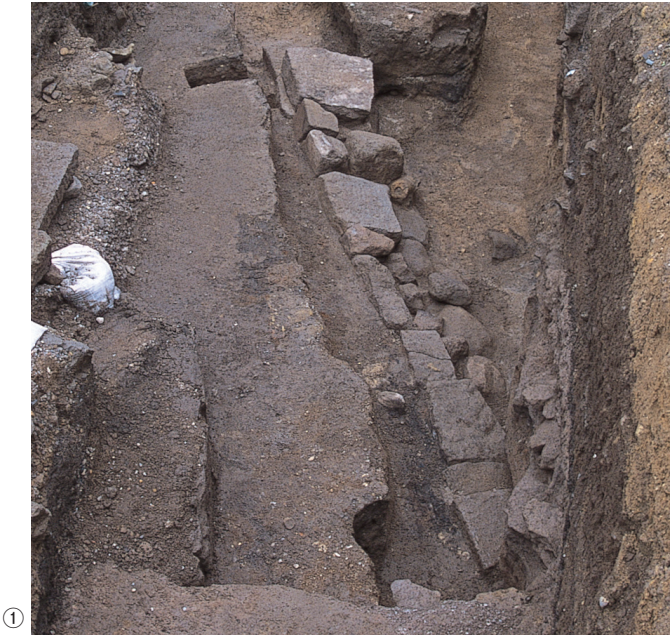
① 石垣検出状況
③ 石垣深掘
⑤ 坪地業

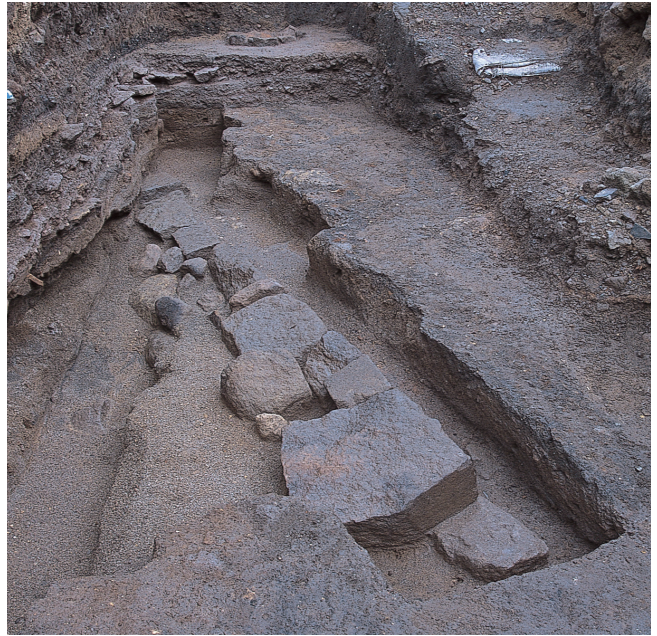
② 石垣検出状況
④ 石垣深掘
⑥ 緑青のある三和土

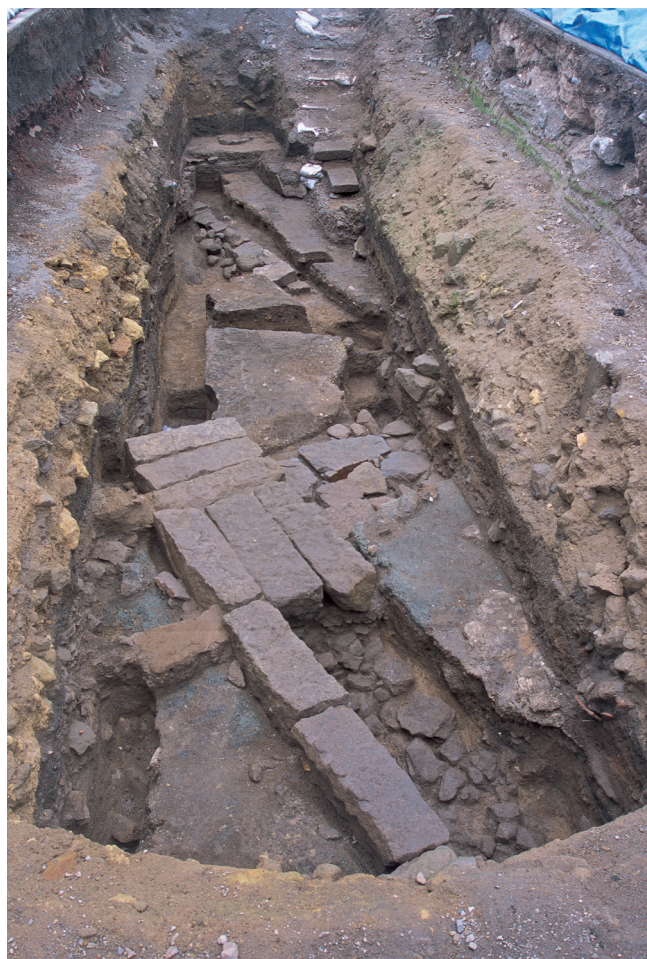
① 1トレンチ検出遺構
③ 布基礎検出状況
⑤ 布基礎検出状況

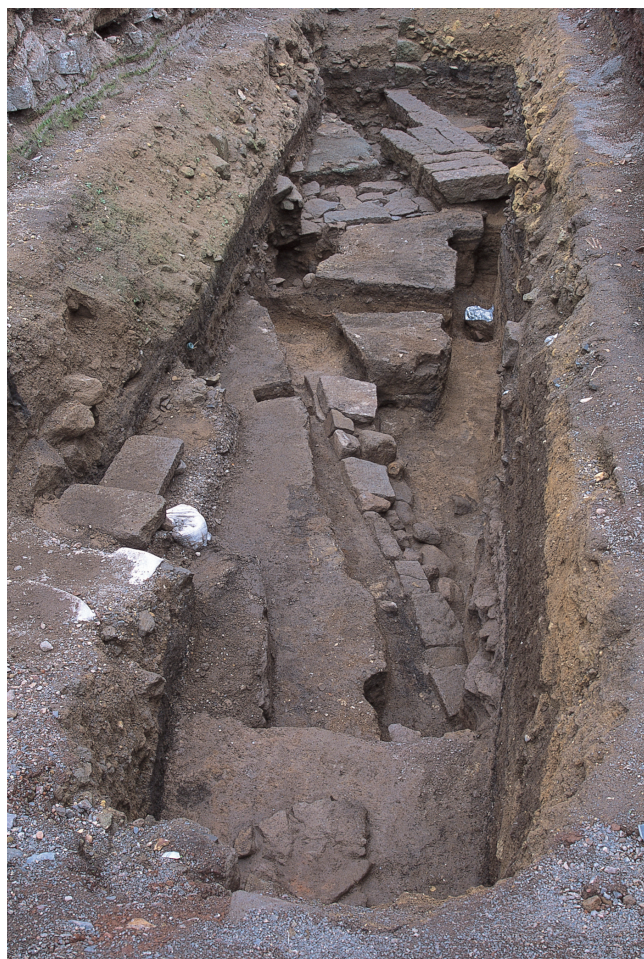
② 1トレンチ検出遺構（反対から）
④ 布基礎検出状況
⑥ 布基礎検出状況

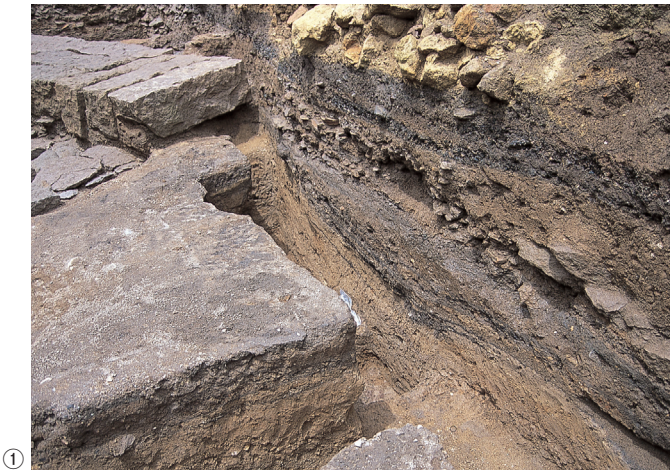
- ① 1 トレンチ土層断面
- ③ 2 トレンチ硬化面検出状況
- ⑤ 2 トレンチ布基礎検出状況
- ⑦ 2 トレンチ布基礎中のレンガ (No160)

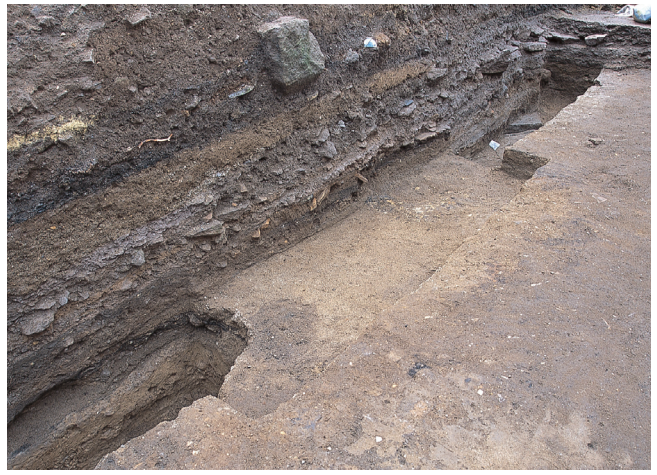
- ② 1 トレンチ土層断面
- ④ 2 トレンチ硬化面検出状況
- ⑥ 2 トレンチ布基礎検出状況
- ⑧ 2 トレンチ遺物出土状況

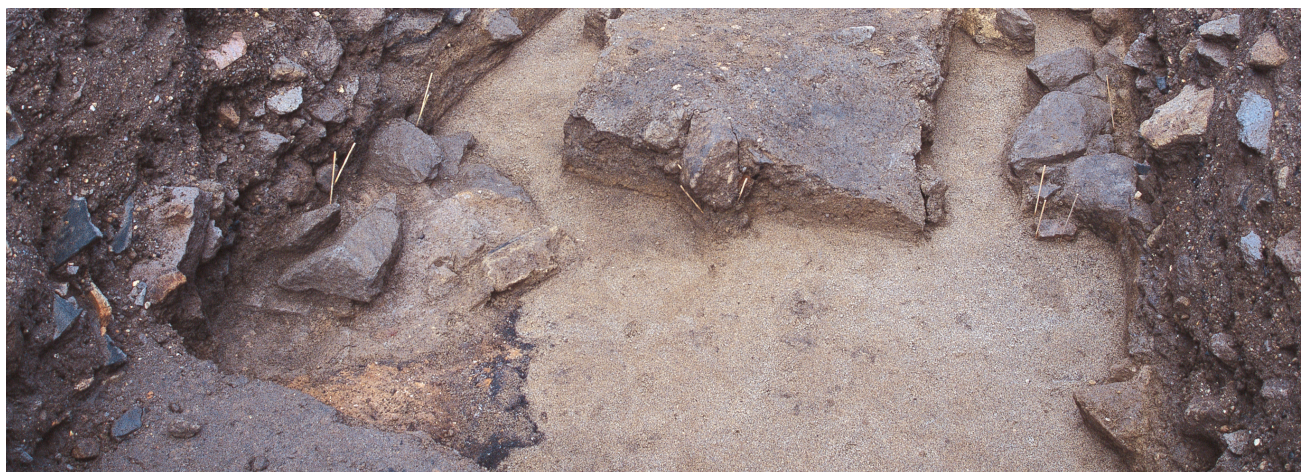
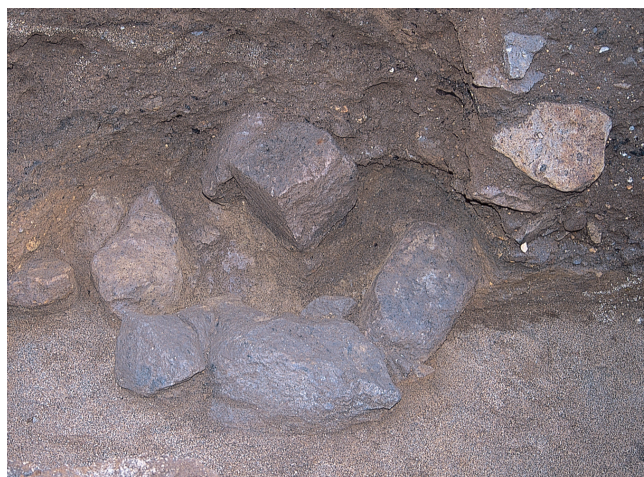
- ① 坪地業検出状況
- ③ 坪地業検出状況
- ⑤ 布基礎検出状況 2
- ⑦ 布基礎検出状況 4

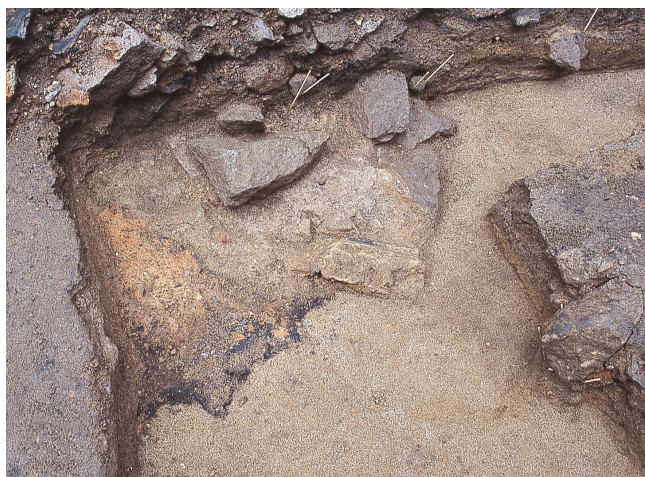
- ② 坪地業検出状況
- ④ 布基礎検出状況 1
- ⑥ 布基礎検出状況 3
