# 鎌倉の埋藏文化財22

Buried Cultural Properties in Kamakura 22

平成29年度発掘調査の概要

鎌倉市教育委員会

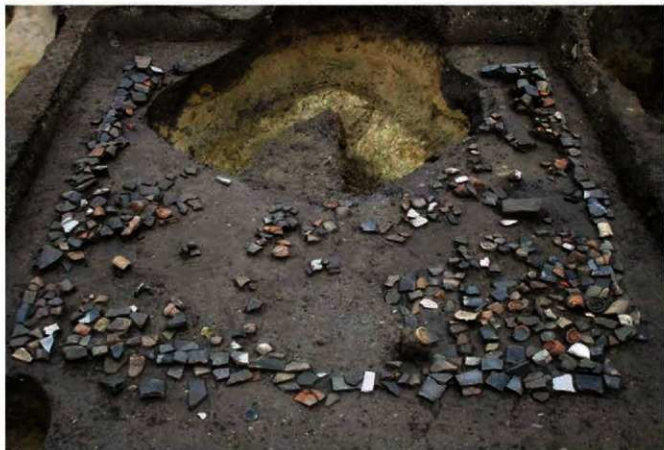
写真2 瓦片を基礎に使った建物跡

(photo2) Remains of building using pieces of tile on its base

調査地点は、鎌倉駅から東に約200m、若宮大路二の鳥居の南東に位置します。若宮大路東側のこの調査地点周辺では、これまでの発掘調査で中世の半地下式の建物跡が発見されることが多く、商業で賑わう区域であったことが想定されています。今回の調査では、13世紀前半から14世紀中頃に機能していた東西方向の区画溝と、その周りに沢山の遺構が発見されました。特筆すべきは13世紀後半頃の建物跡で、瓦を敷き詰めて基礎にしている珍しい事例です。当時、瓦の使用は寺院や有力者の屋敷などに限られていたため、それらの場所で使用された瓦を集め、基礎として再利用したようです。建物の北東部では銅銭と、かわらが瓦と混在して見つかっており、地鎮<sup>ツクリ</sup>が行われた跡の可能性もあります。このほか井戸の跡なども発見され、木製鋤<sup>ツクリ</sup>2本と漆器などが出土しました。その後、14世紀後半から16世紀後半には南北方向に走る溝や塀で区画された土地に、建物跡や井戸が造られますが、13世紀前半から14世紀中頃ほど土地利用は活発ではなかったようです。

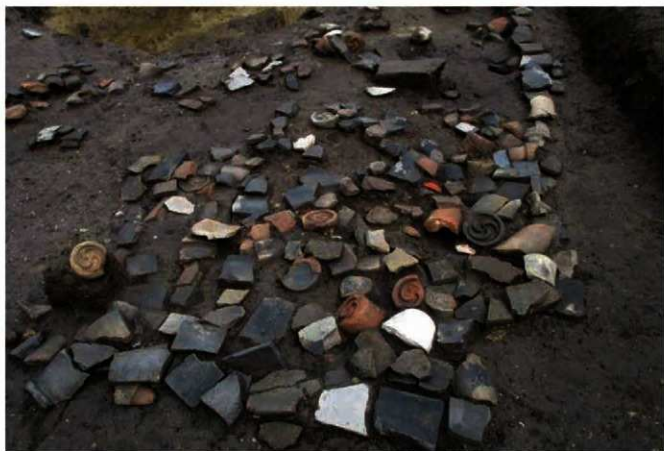
写真3 建物の南東隅に敷き詰められた瓦 (写真2の拡大)

(photo3) Tiles used to pave southeast corner of the base (Photo2.magnified)

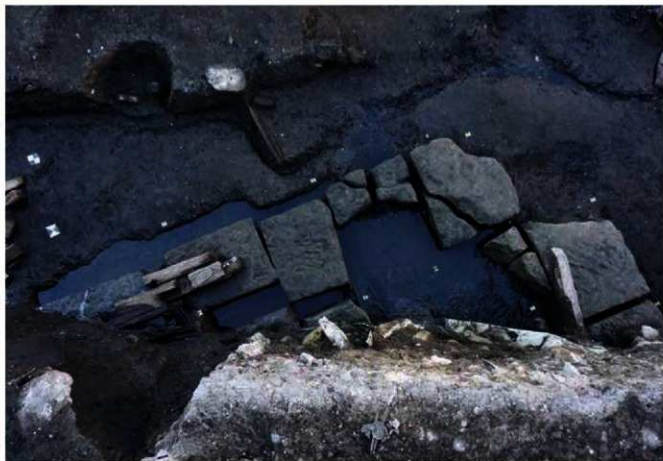
写真9 建物土台の石材検出状況（南から）

(photo9) State of excavated stone material forming bases of building

調査地点は、鎌倉駅の南西約200mの場所に位置します。ここでは、13世紀から14世紀頃の建物跡や井戸の他、地震の跡も発見されました。当時は敷地の東側と西側で地形が異なっており、東側が低くなっていることもわかりました。その地形の境で土地を区画するような溝も確認されています。東側の低い部分は建物跡が少なく、そのかわり、用途不明の穴が複数確認されました。遺物も、ゴミとして捨てたような木材片が多く、人々が暮らす生活空間から外れた場所であった可能性があります。それに対して、西側では半地下式の建物跡が数多く確認されました。建物の土台や壁板が残っているものもあり、釘を使わず壁板と柱を組み合わせて建てている様子も確認できました。過去の調査結果と合わせると、これらの建物群が今回の調査地点の南西側にも広がっていたこともわかります。

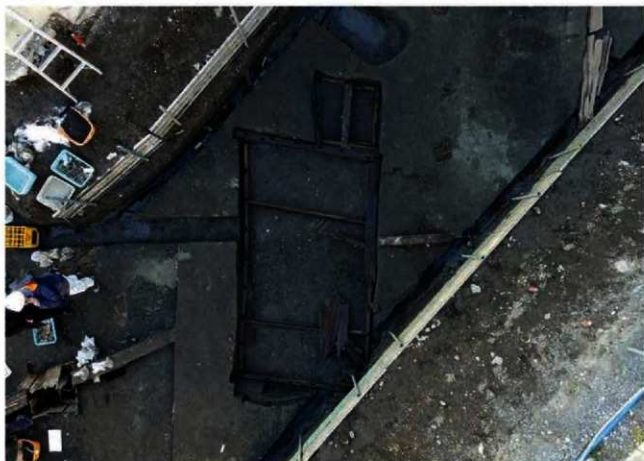
写真 10 地震によってゆがんだ建物跡（写真上が西）  
 (photo10) Building remains bent by force of earthquake

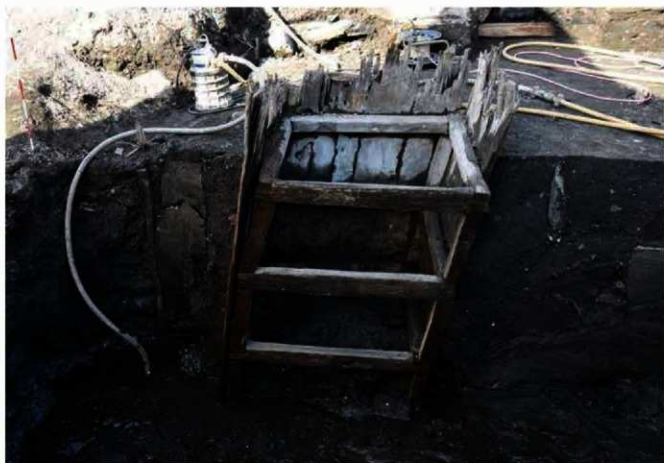
写真 11 傾いた井戸  
 (photo11) Slanting well

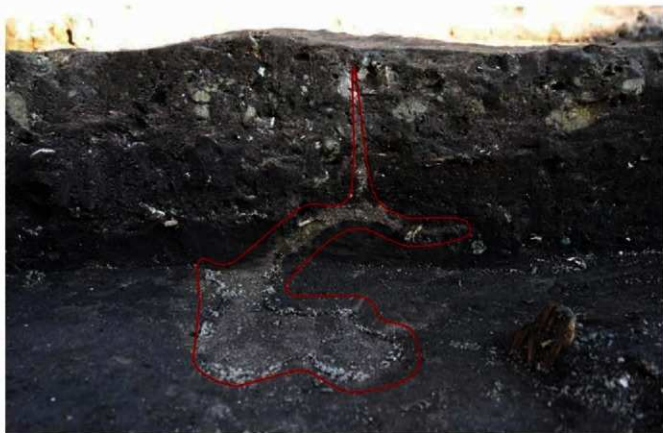
今回の調査では、主に地震による液状化を起こした地盤で起きる、噴砂現象の痕跡が見付かりました。

写真 12 噴砂  
(photo12) Sand boil

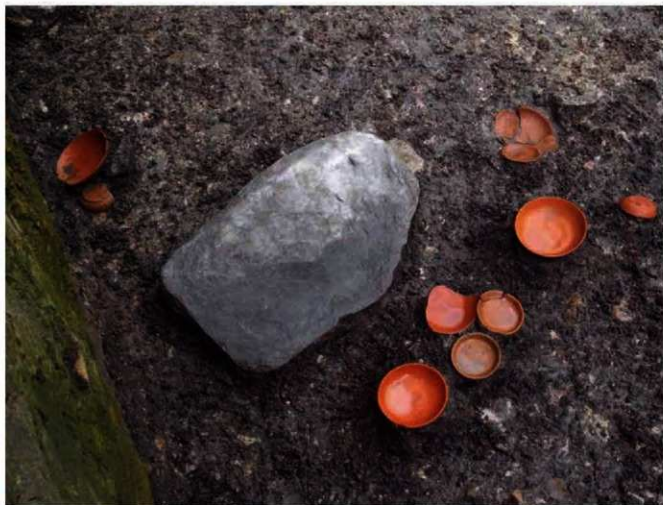
写真 13 礎石の周囲に置かれたかわらけ (14 世紀前半頃)  
(photo13) Earthenware placed around foundations (early 14th century)

今回の発掘調査では、中世に属する 8 時期の生活面が発見されました。12 世紀末から 15 世紀前半にかけて盛土造成を繰り返しながら土地利用を続けていた様子が確認できたほか、各層から出土する遺物の時代ごとの変化もたどることができました。14 世紀前半頃の生活面では、小規模な礎石建物跡が見つかりました。さらにさかのぼる 13 世紀中頃の生活面上では、南北方向の道路や塀の柱穴などの遺構が発見され、道路には排水のための側溝も造られていました。最も古い時代の生活面の下からは、東側に落ち込む谷の痕跡を確認しました。この谷の埋没土からは、鎌倉時代でもごく早い時期(12 世紀末から 13 世紀初頭)の遺物が出土しており、鎌倉時代の初めに、人々が谷を埋め立てて平坦な土地を広げ、生活していたことがわかりました。

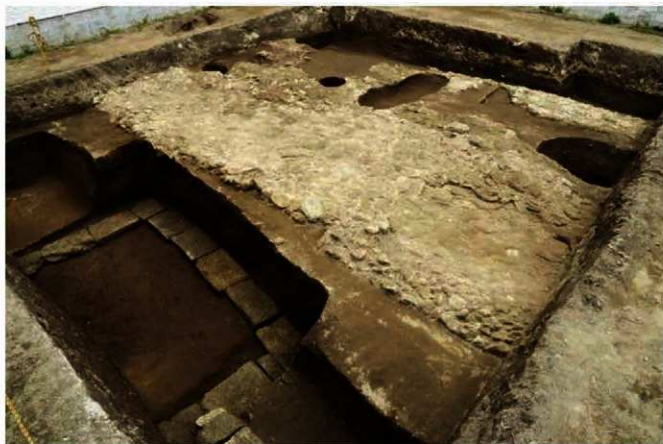
写真 14 道路跡と建物跡 (南西から)  
(photo14) Remains of roads and buildings

調査地点は、鎌倉駅から南西に約500mの場所に位置します。ここでは、13世紀から14世紀の建物跡や道路跡などが発見されました。見つかった道路は南北方向に延び、幅は3～4mです。一番古い時期の道路は砂質土を固くたたき締めて造られていましたが、時間が経つにつれて砕いた泥岩や凝灰岩等を用いた舗装や拡張が幾度となく行われ、幅が7mとなる時期もあることがわかりました。また、7棟発見された14世紀前半の建物跡のうちの2棟は、これらの道路を壊して造られていました。
