## Chapter 2: Outline of the Survey and Restoration Project of the Central Sanctuary

### Section 1: Progress of the reassembly of the central sanctuary

## Section 2: Return of decorative stone materials from Conservation d'Angkor

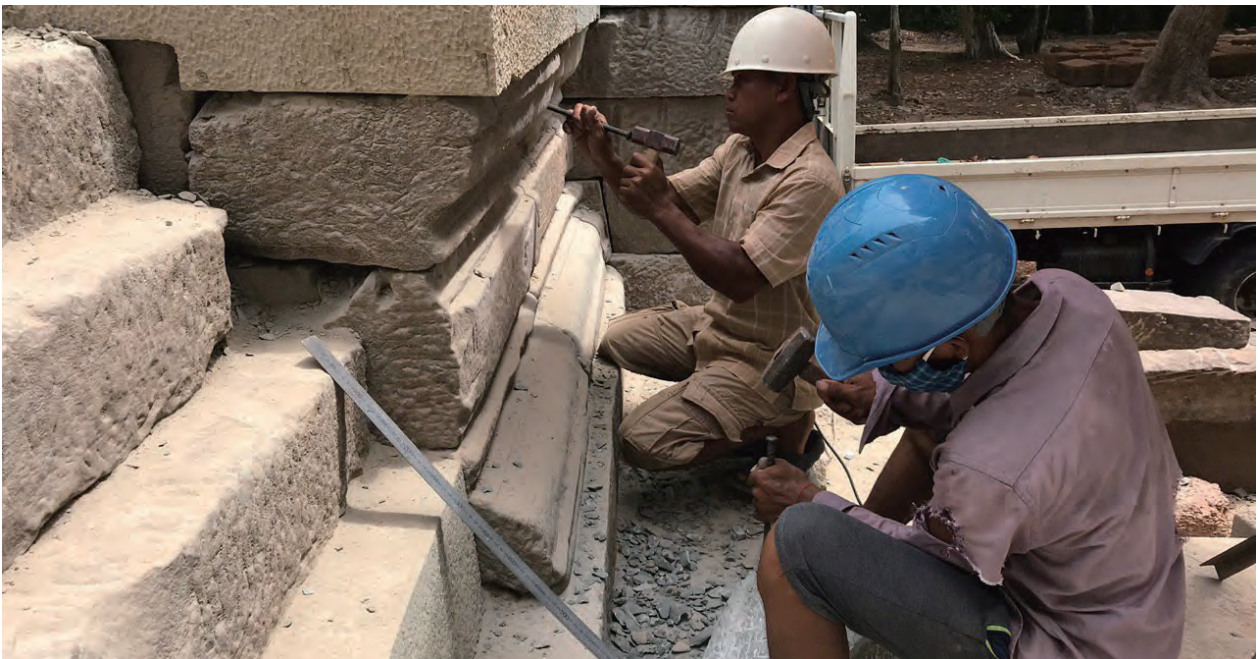
Fig. 24 Curving the new stone blocks for the central sanctuary

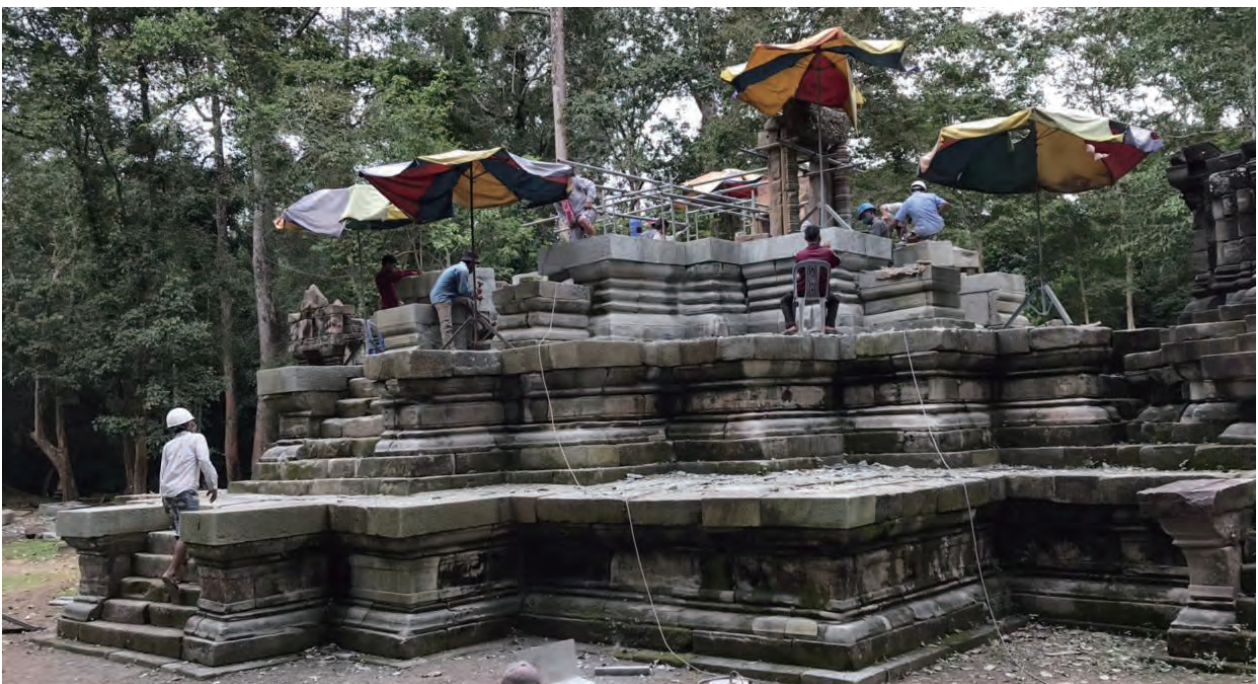
Fig. 25 View of the reassembly work of the central sanctuary

Regarding the reassembly of the building frame, the work was carried out after a trial reassembly. From September to December 2020, the doors of the four cardinal openings were temporarily assembled and reassembled. In November, the walls between the east and south openings were reconstructed.

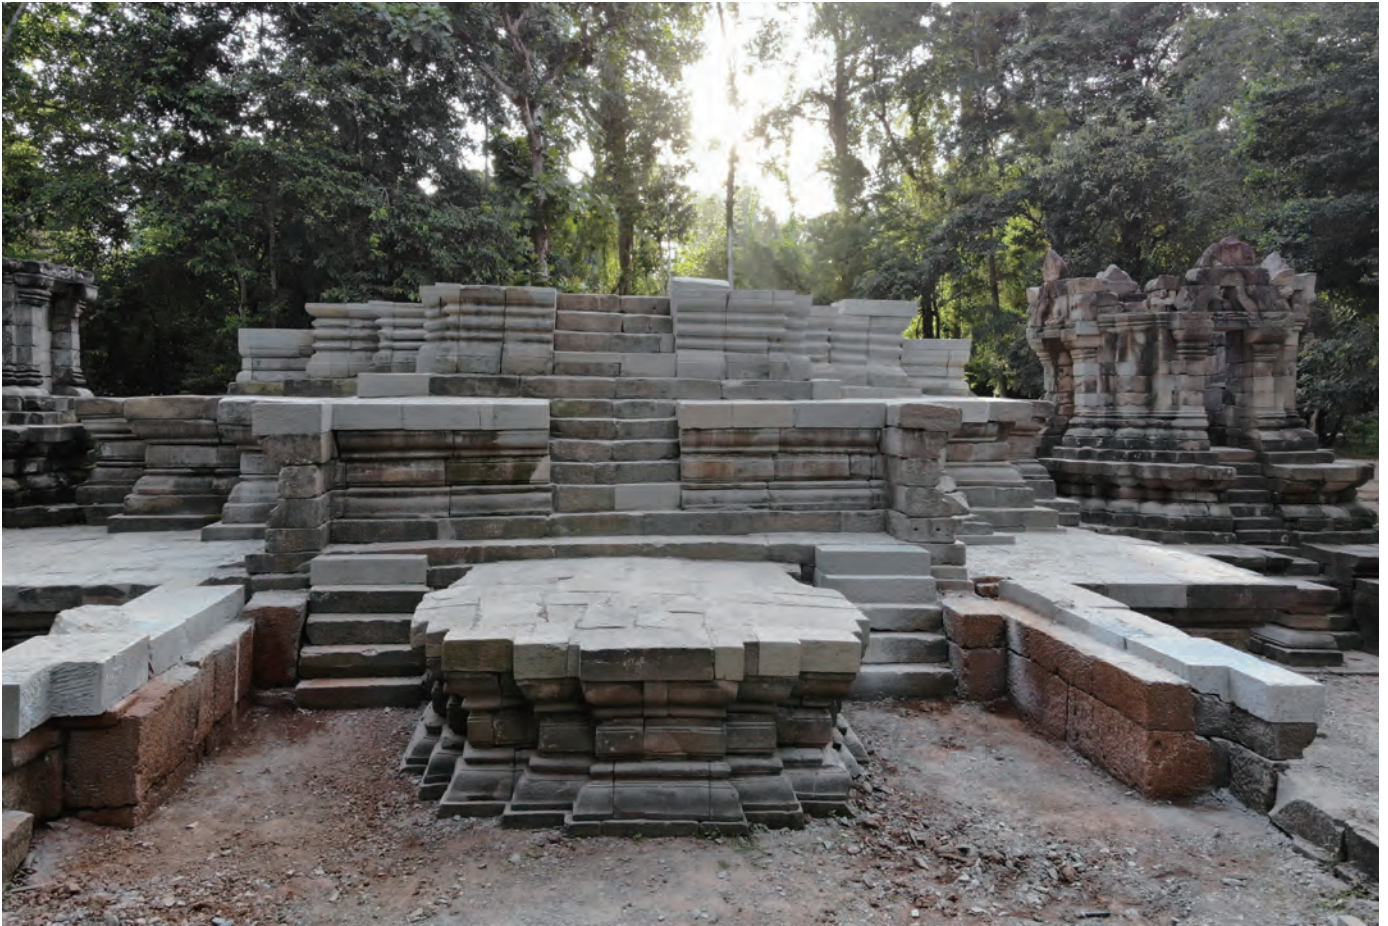
Fig. 26 View of the reassembled platform of the central sanctuary (view from the east)

As of December 2019, the reassembly of the lower part of the central sanctuary was completed, and the reassembly work of the middle platform was almost complete, except for the northeast part. We completed the reassembly of the middle platform in January to February 2020 and continued to reassemble the middle and upper platform from March to July. In August, we reconstructed the platform of the central sanctuary and the Buddhist pedestal located in the east.

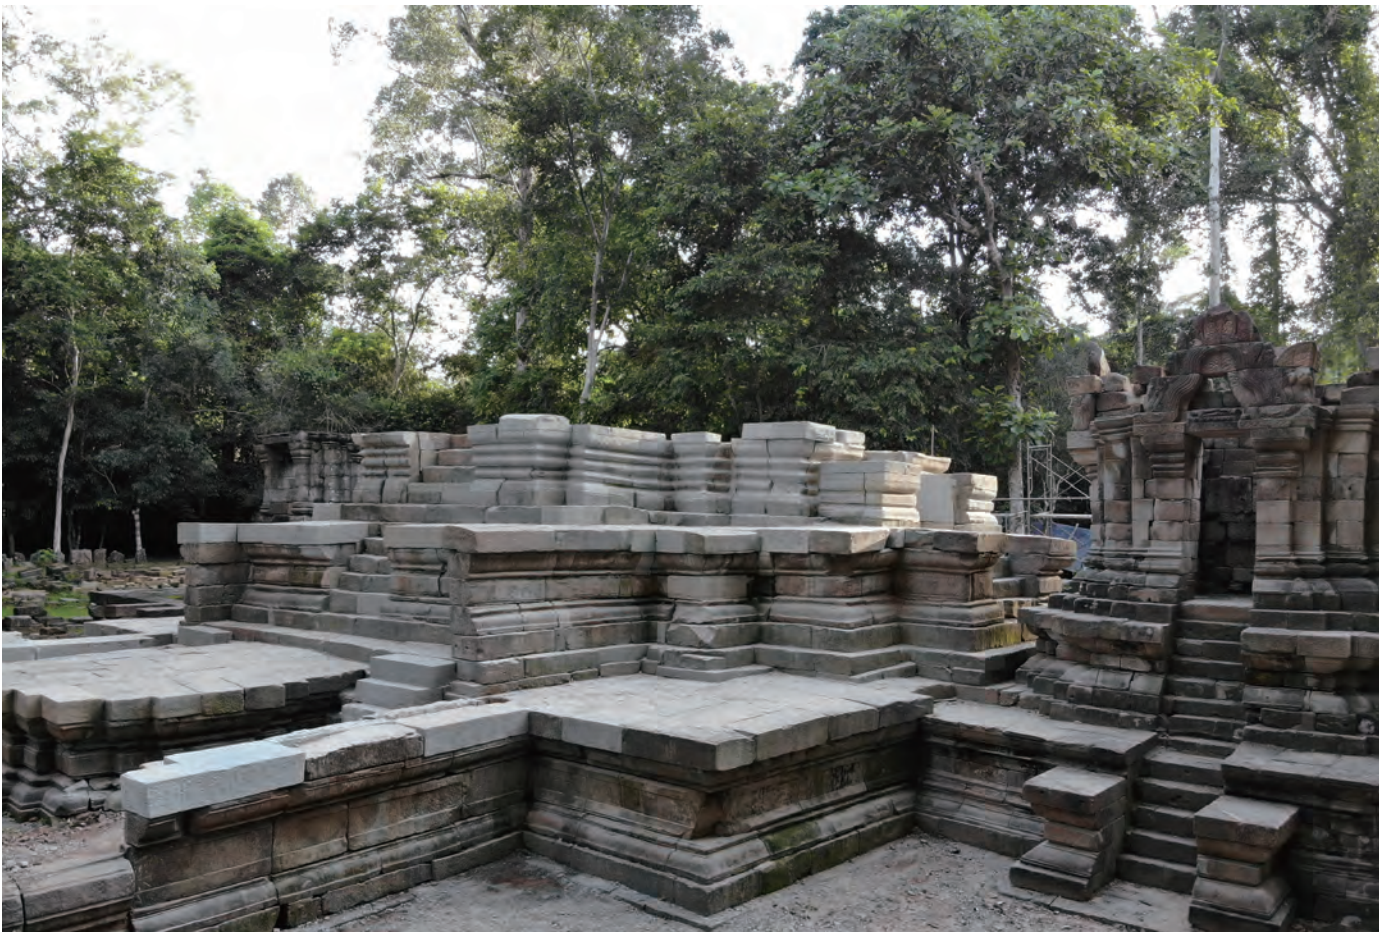
Fig. 27 View of the reassembled platform of the central sanctuary (view from the northeast)

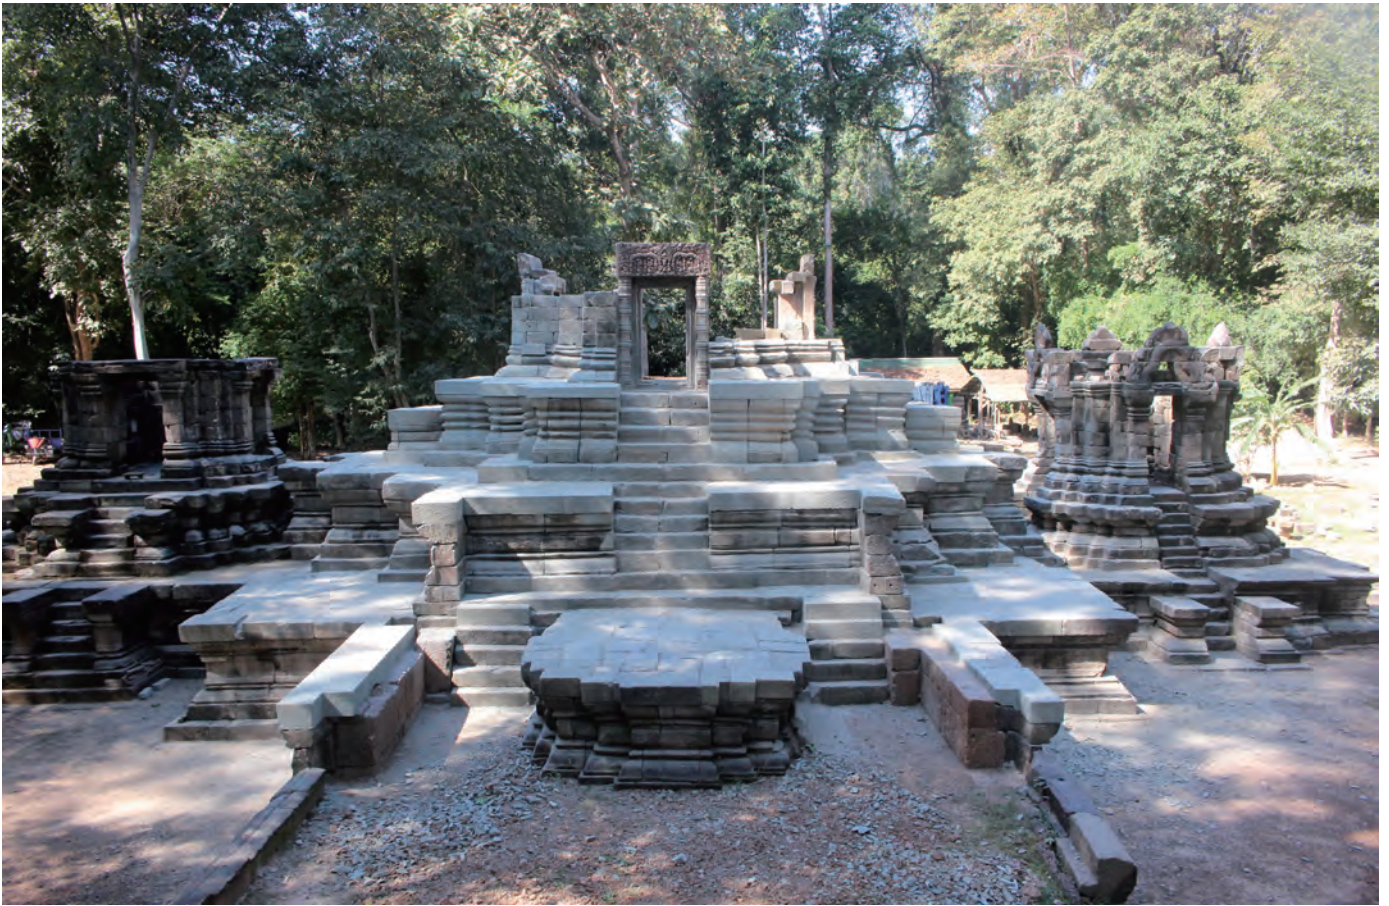
Fig. 28 View of the reassembled platform and façade of the central sanctuary (view from the east)

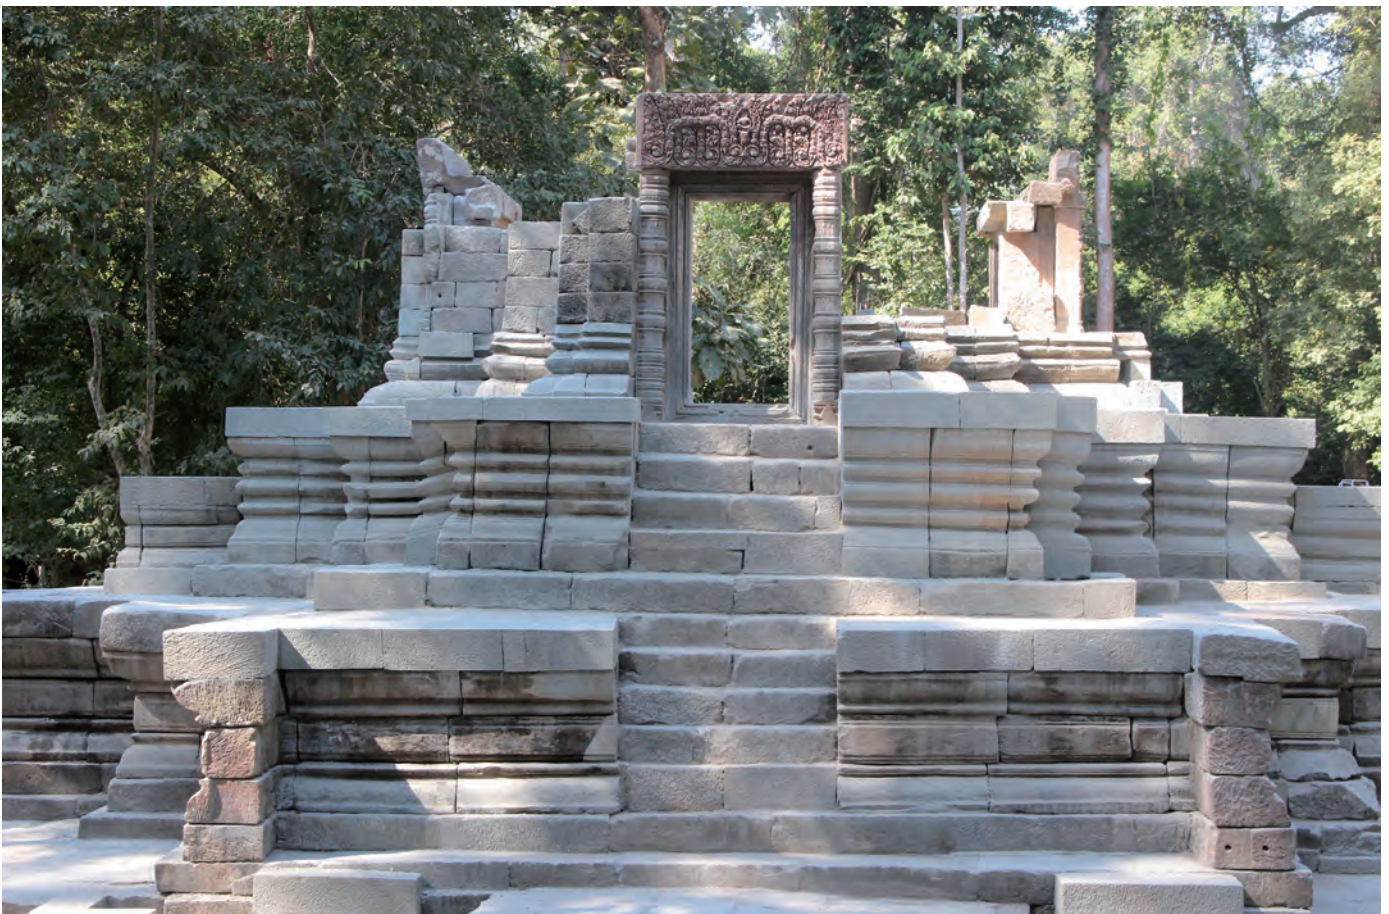
Fig. 29 View of the reassembled middle and upper platform and façade of the central sanctuary (view from the east)

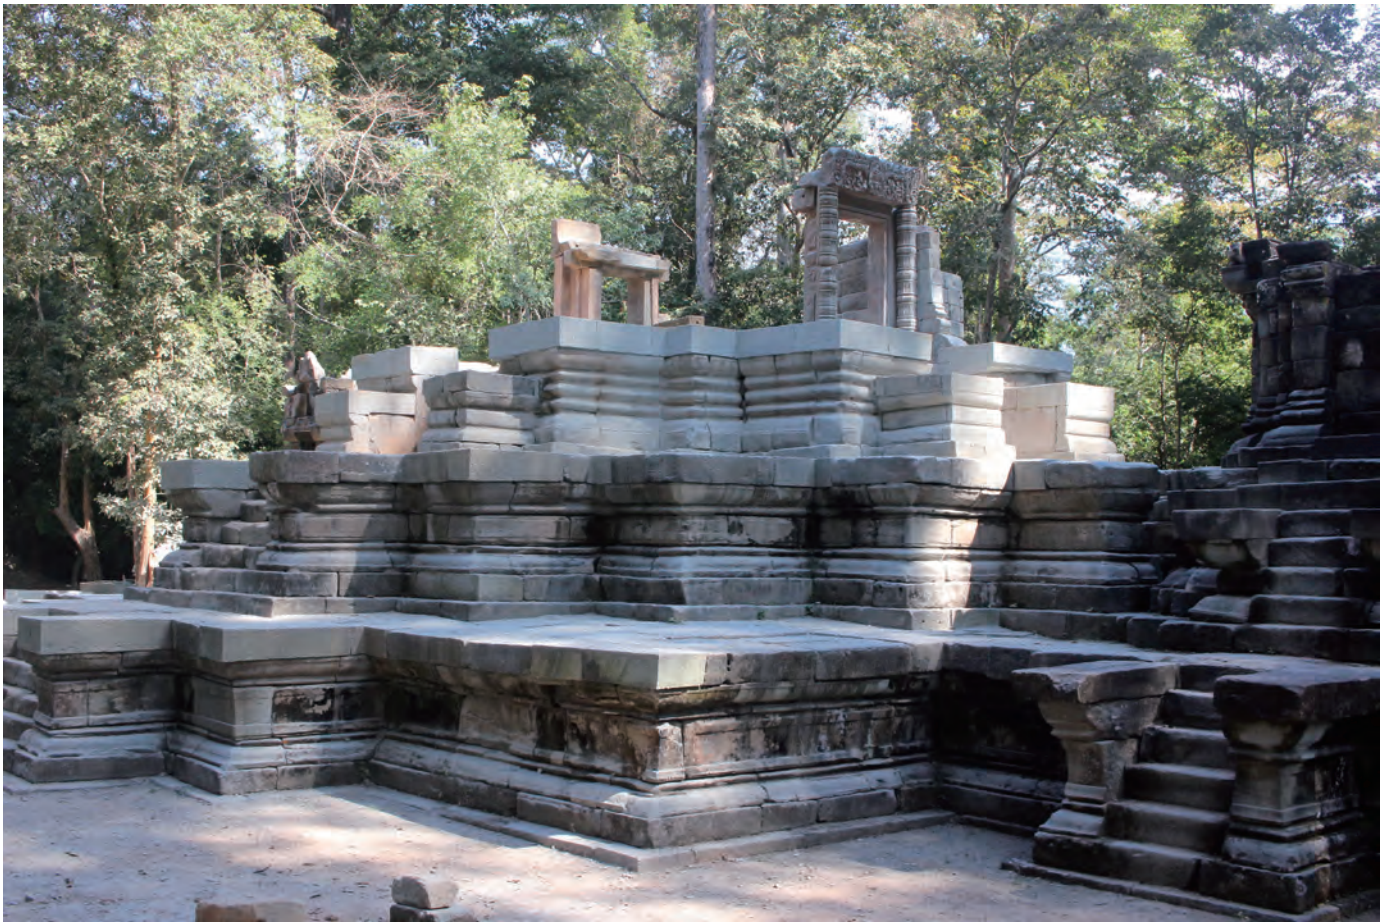
Fig. 30 View of the reassembled platform and façade of the central sanctuary (view from the southeast)

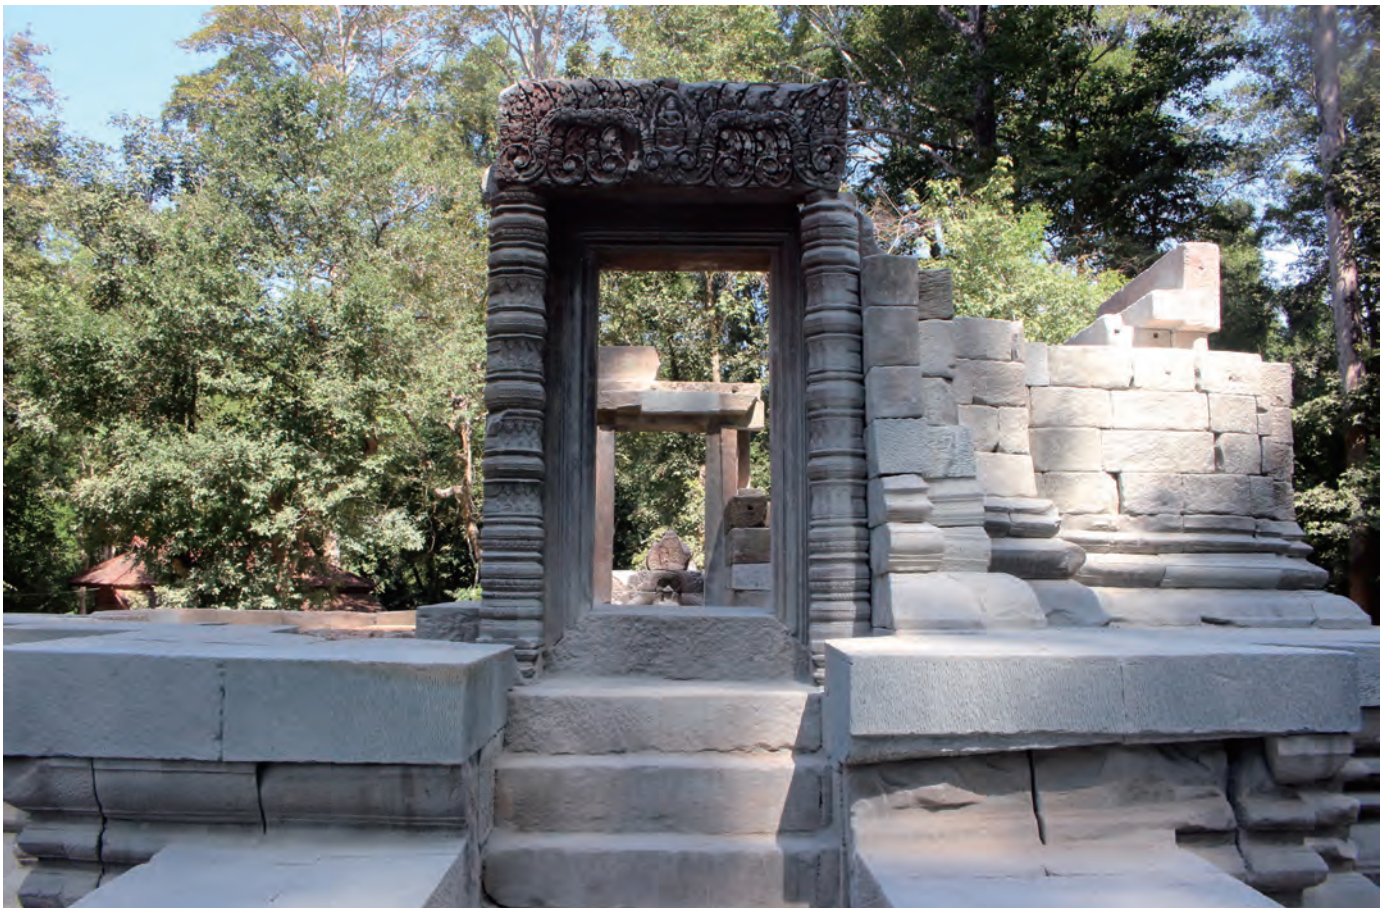
Fig. 31 View of the reassembled south façade of the central sanctuary (view from the south)

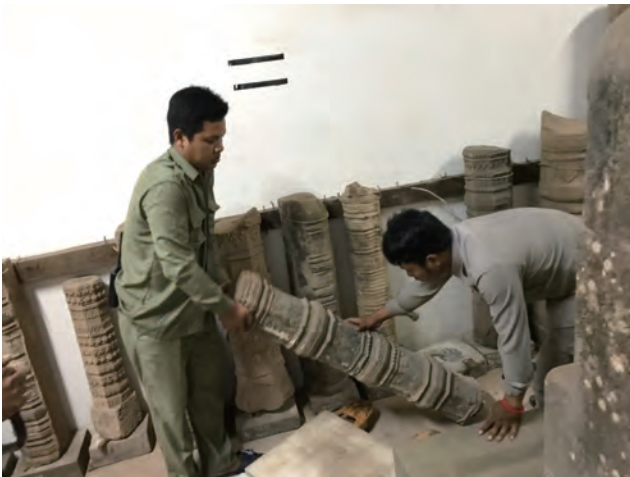
Fig. 32 Transporting the colonnette from the storage room of Conservation d'Angkor

Accordingly, the decorative stones belonging to the central sanctuary were transferred from the Conservation d'Angkor to the Western Prasat Top Site in October 2020. Officers from the Conservation d'Angkor and heritage police accompanied the transfer work, and the stones were safely transported to the Western Prasat Top site. After that, we started to repair those parts of the lintel and colonnette which needed to be joined and repaired. On the other hand, the pediment blocks were reconstructed with other parts placed at the Western Prasat Top site, and the reassembly of the iconography is in progress. The restored pieces will be reassembled in their proper position in the central sanctuary.

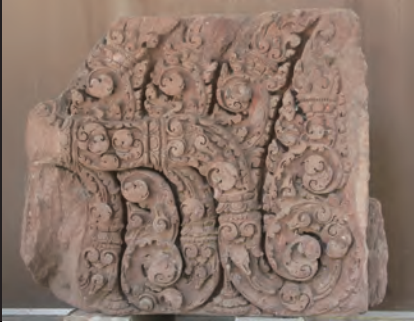
N423	140	48	40	Lintel	Eastern façade of central sanctuary Yama + Nandin

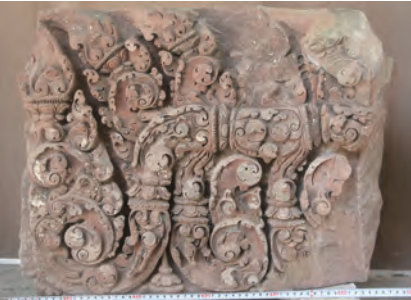
N425	75	47	36	Lintel	Western façade of central sanctuary

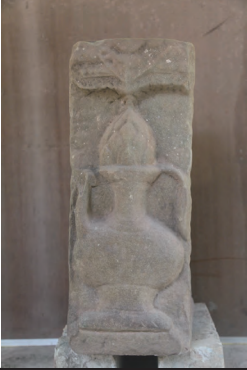
N435	18	46.5	36	Pediment	Kendi Lotus bud Bird-shaped spout

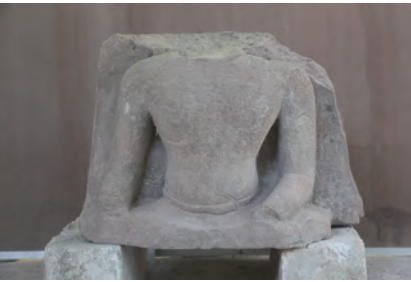
N437	34	25	16	Pediment	Seated Buddha with bhūmisparśa mudrā

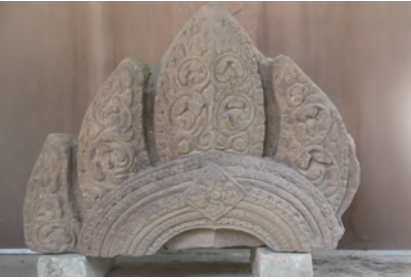
N445	64	50	23	Pediment

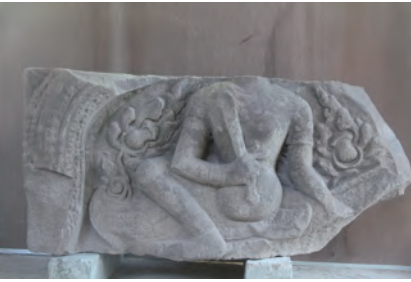
N446	90	40	19	Pediment	Yama with stick
