## Chapter 2 Dismantling of the Lower Platform

### Section 1 Dismantling of the Upper Tiers (N19- N22)

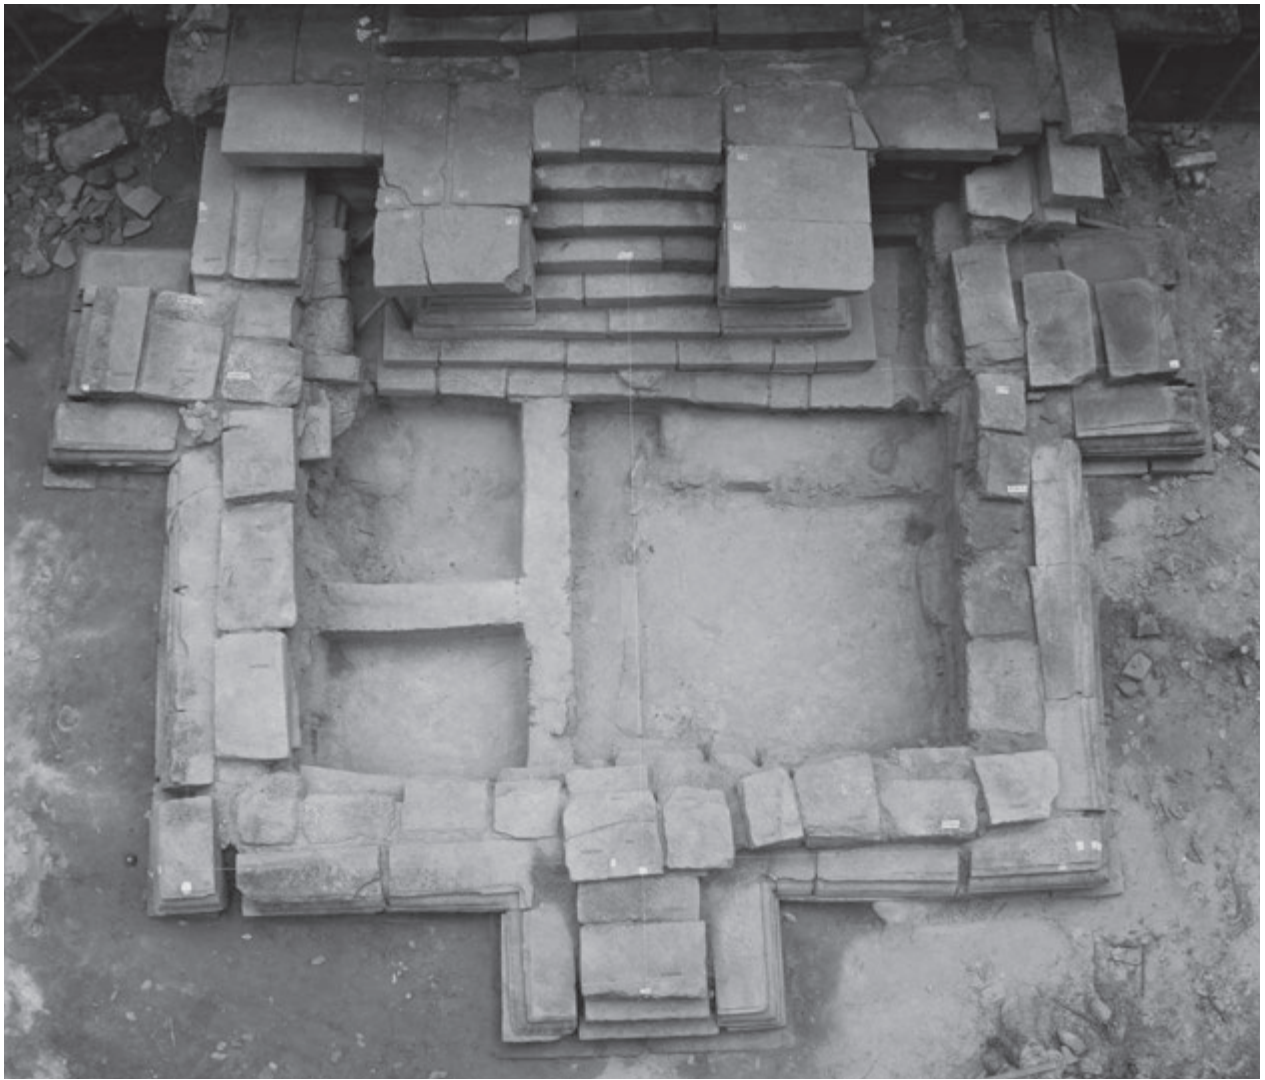
Fig. 6: Photo of N19 (viewed from the south; taken on July 11, 2013)

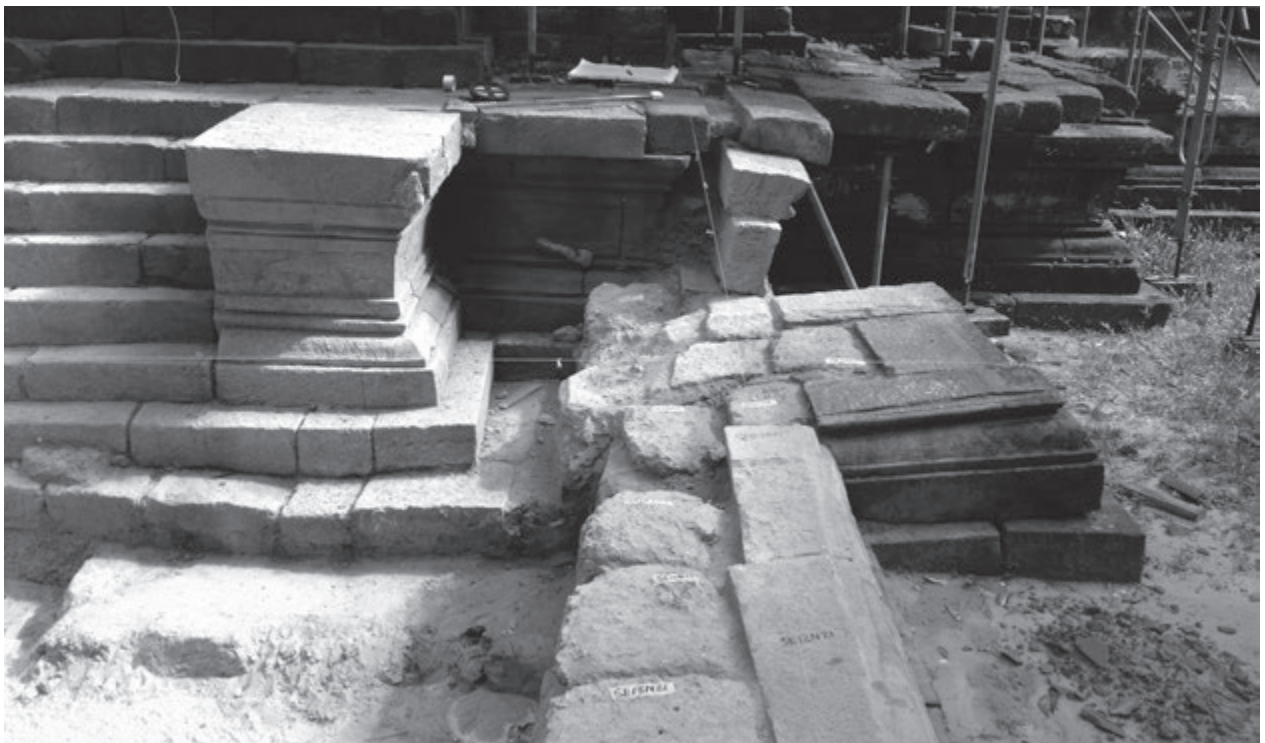
Fig. 7: Northeast corner of the lower platform

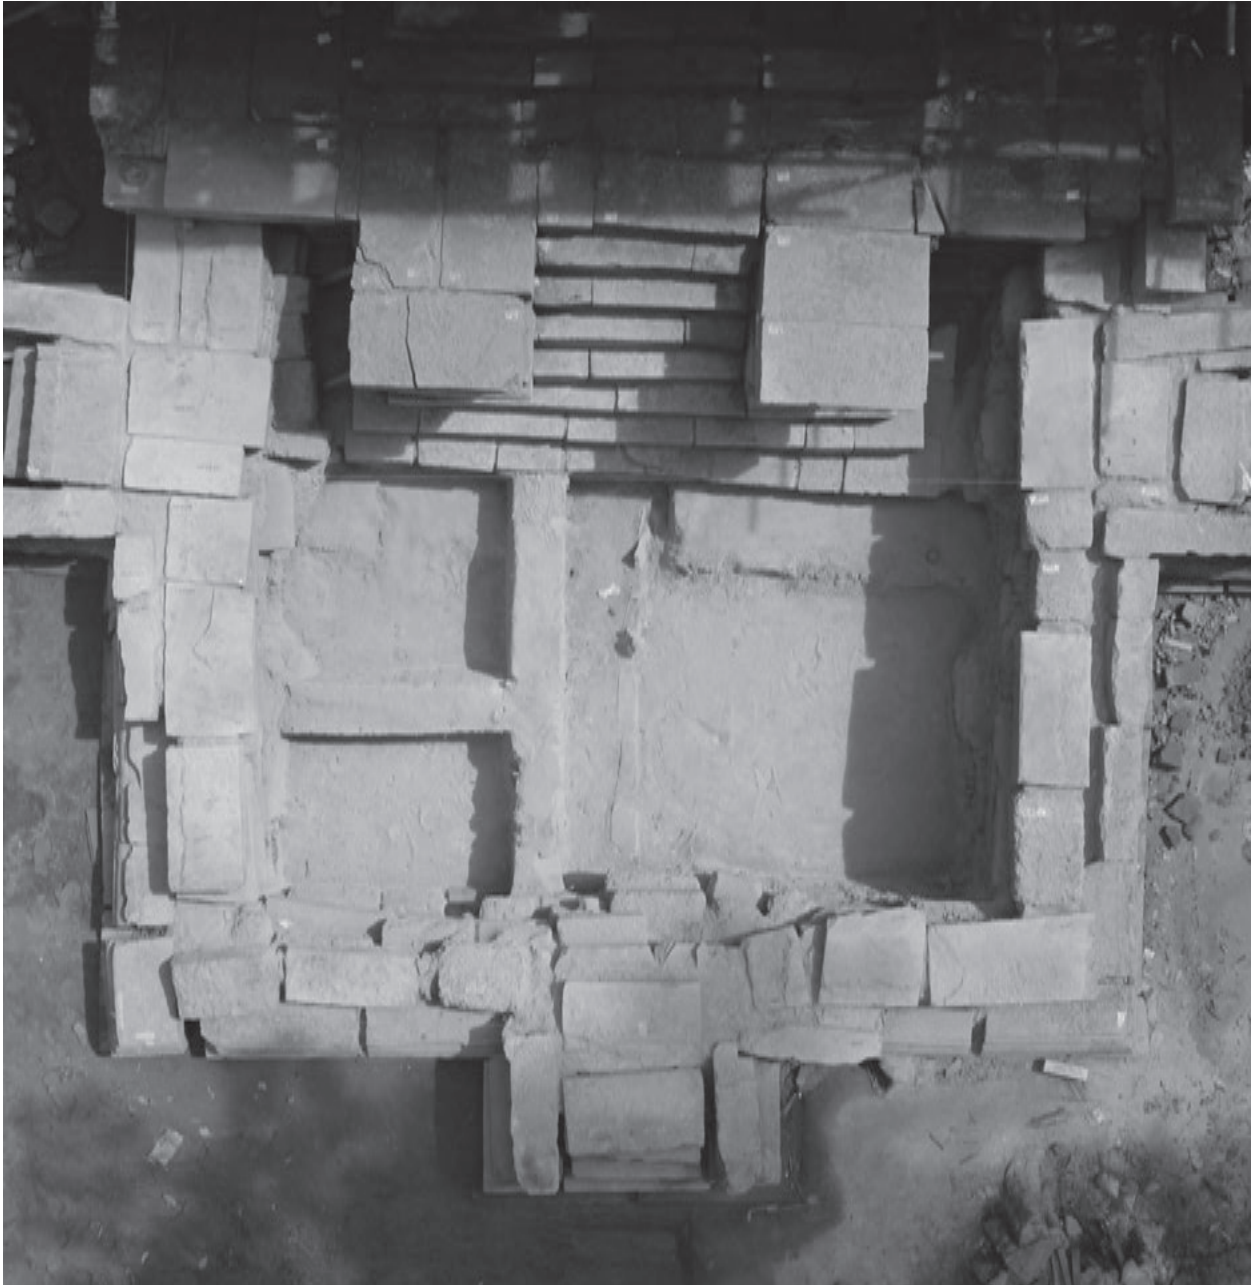
Fig. 9: N20 overhead photo

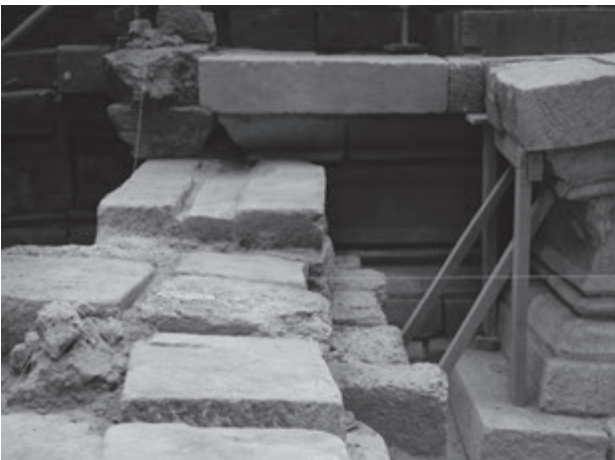
Fig. 10: Connecting area with the Central Sanctuary  
(view of west side)

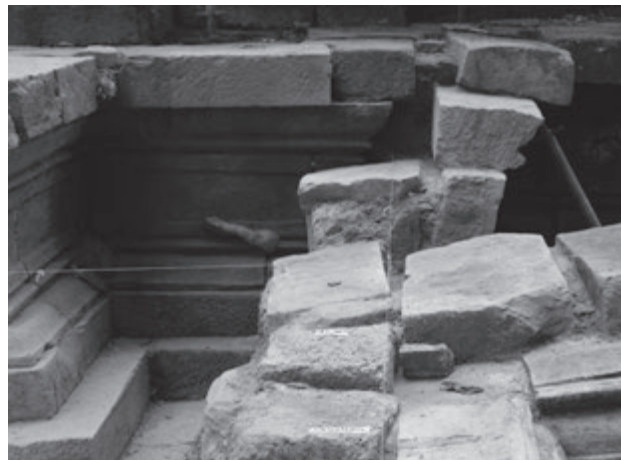
Fig. 11: Connecting area with the Central Sanctuary  
(view of east side)

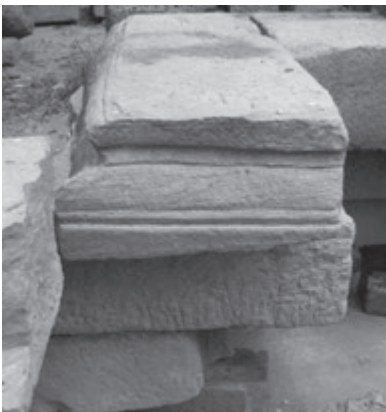
Fig. 13: Moldings on the rear face of SW07N21

N21 are stone blocks that correspond to base stones of the upper block of the foundation. The bottom half displays moldings that project outward in an arc. As they serve as base stones, most are long and narrow blocks on the whole, and because they have moldings, they include few diverted stones. Blocks SW07 of the west stairways and SS05 of the south stairways, however, are clearly diverted blocks, as they have different moldings on the side that adjoins the inner face of the foundation. Block SS03 on the south side has scraping marks along the top surface of its width. In the current dismantling work, a sling for hoisting the block has been applied to coincide with the marks. The marks might perhaps have been made as a result of a similar application in ancient times.

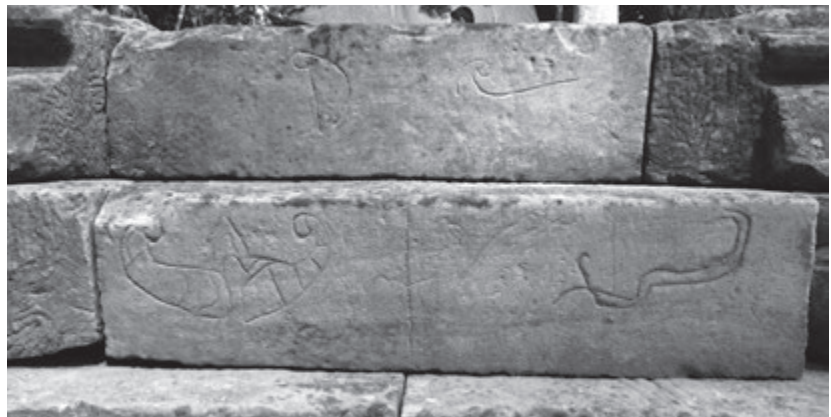
Fig. 14: Line engravings on SE03N21 and SE09N22

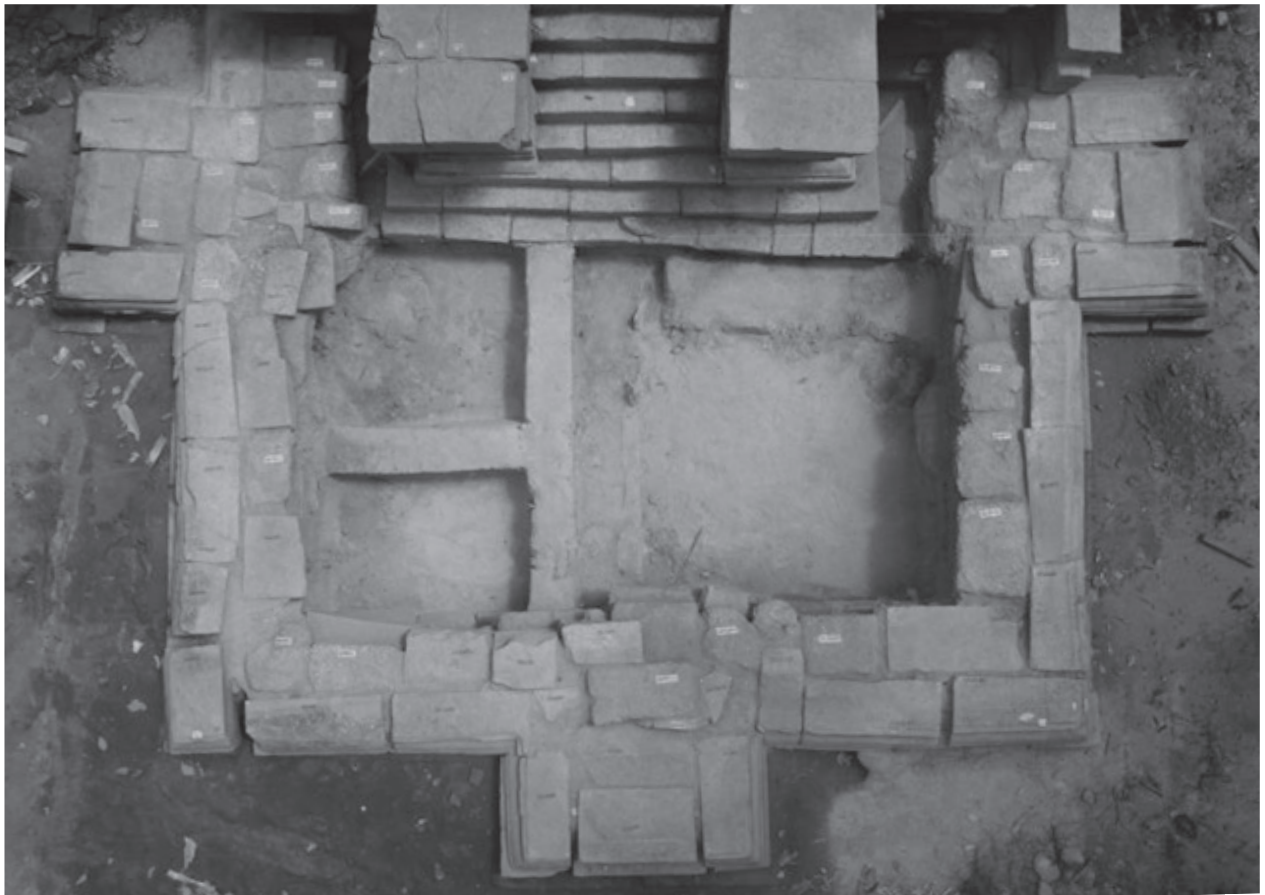
Fig. 15: N21 overhead photo

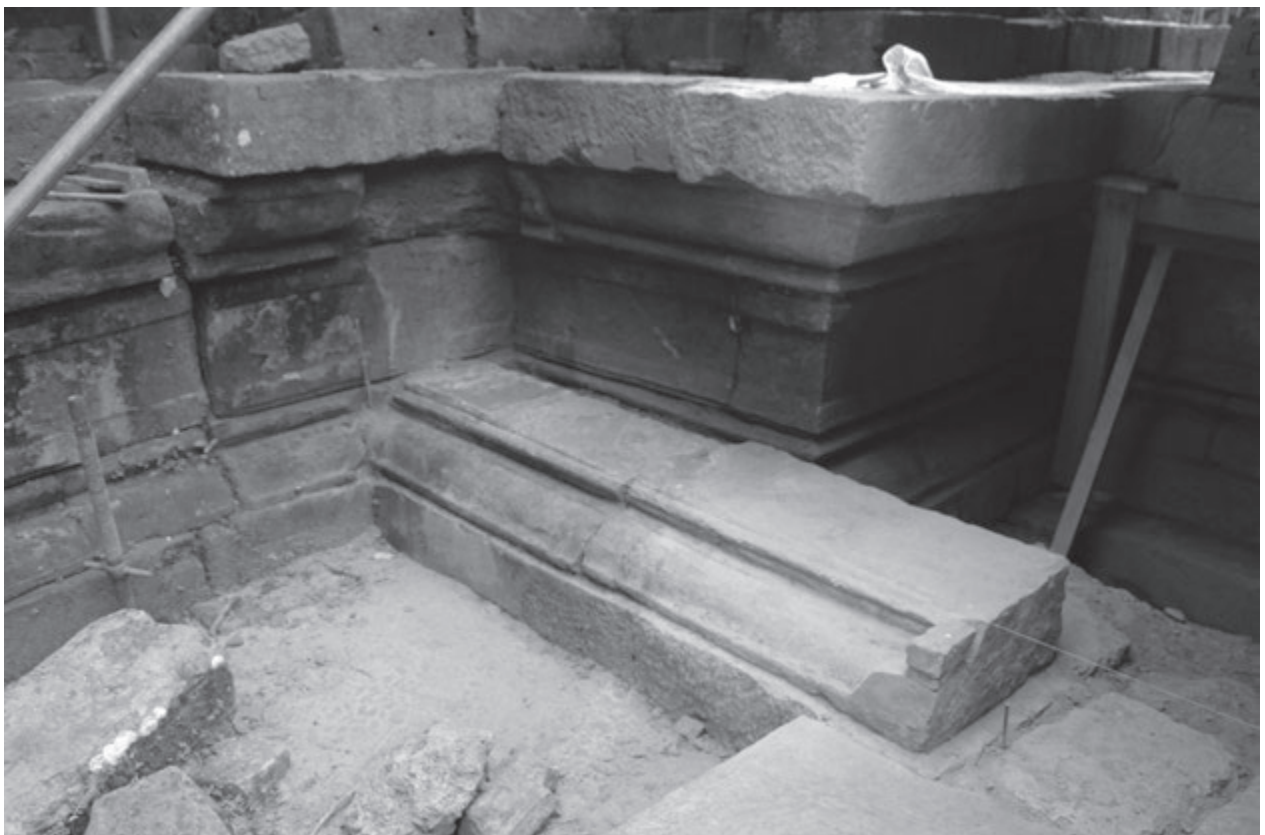
Fig. 16: Relationship between N21 and the southwest corner of the Central Sanctuary (viewed from the southwest)

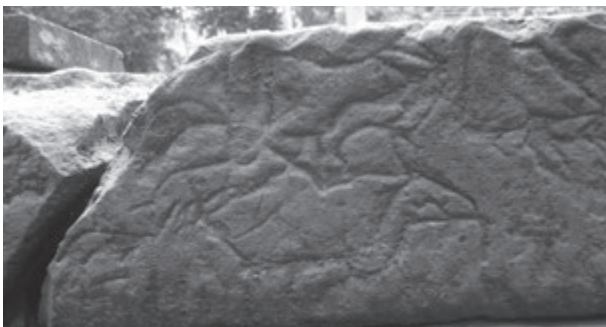
Fig. 18: Line engravings on SE03N22

N22 corresponds to the first tier of paving stones below the base stones. As they are paving stones, they are cuboid block with no moldings. For this reason, the ratio of diverted blocks is high compared to N21. Three blocks were found with hoisting holes, which are hardly seen in other stone blocks at Western Prasat Top, and many other blocks of N22 are characterized by line engravings that might have been markings made when diverting the blocks.

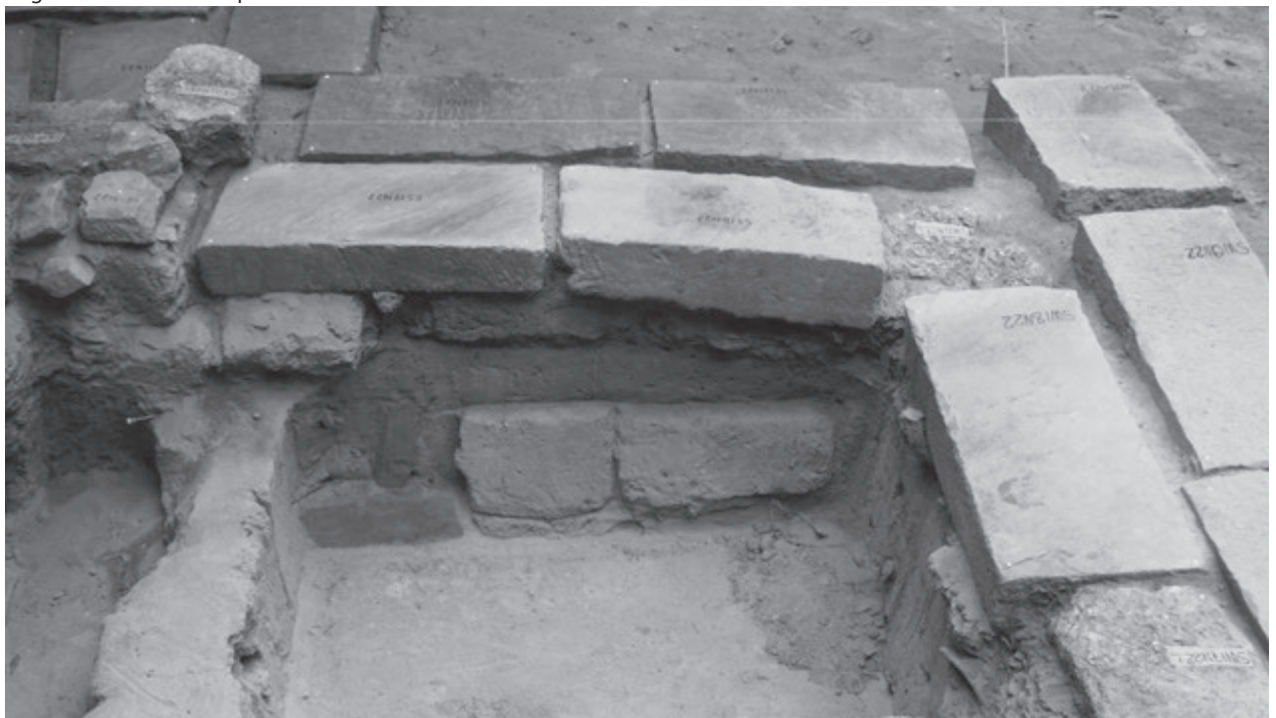
Fig. 21: Relationship between the stone blocks on the south side of N22, stone blocks of N23-N25 and the east-west stone line in the foundation

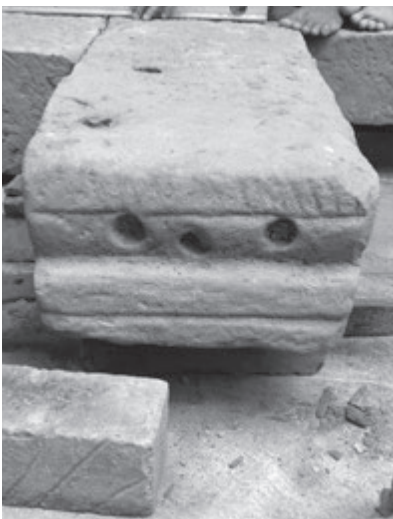
Fig. 23: Moldings on the rear face of SW12N23

Tiers N23 to N25 constitute the lower part and basement of the lower platform, and are part of the base that lies buried in soil at present. Many diverted blocks are included, and blocks with crude surface processing were found, as shown in Fig.25. SW12 has moldings on its rear face, as well as holes for hoisting, and is thus clearly a diverted block (Fig. 22). Furthermore, as shown in Fig. 23, some other blocks mainly around the stairways display line engravings that mark the position of N22 blocks that come on top.

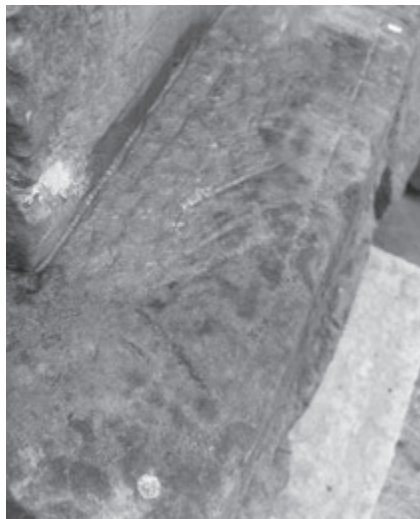
Fig. 24: Line engravings on SE03N23

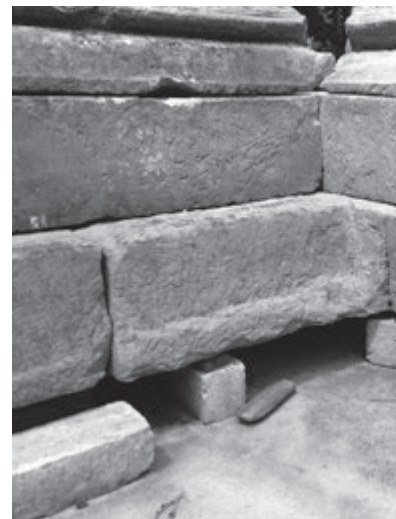
Fig. 25: SE02,03N23

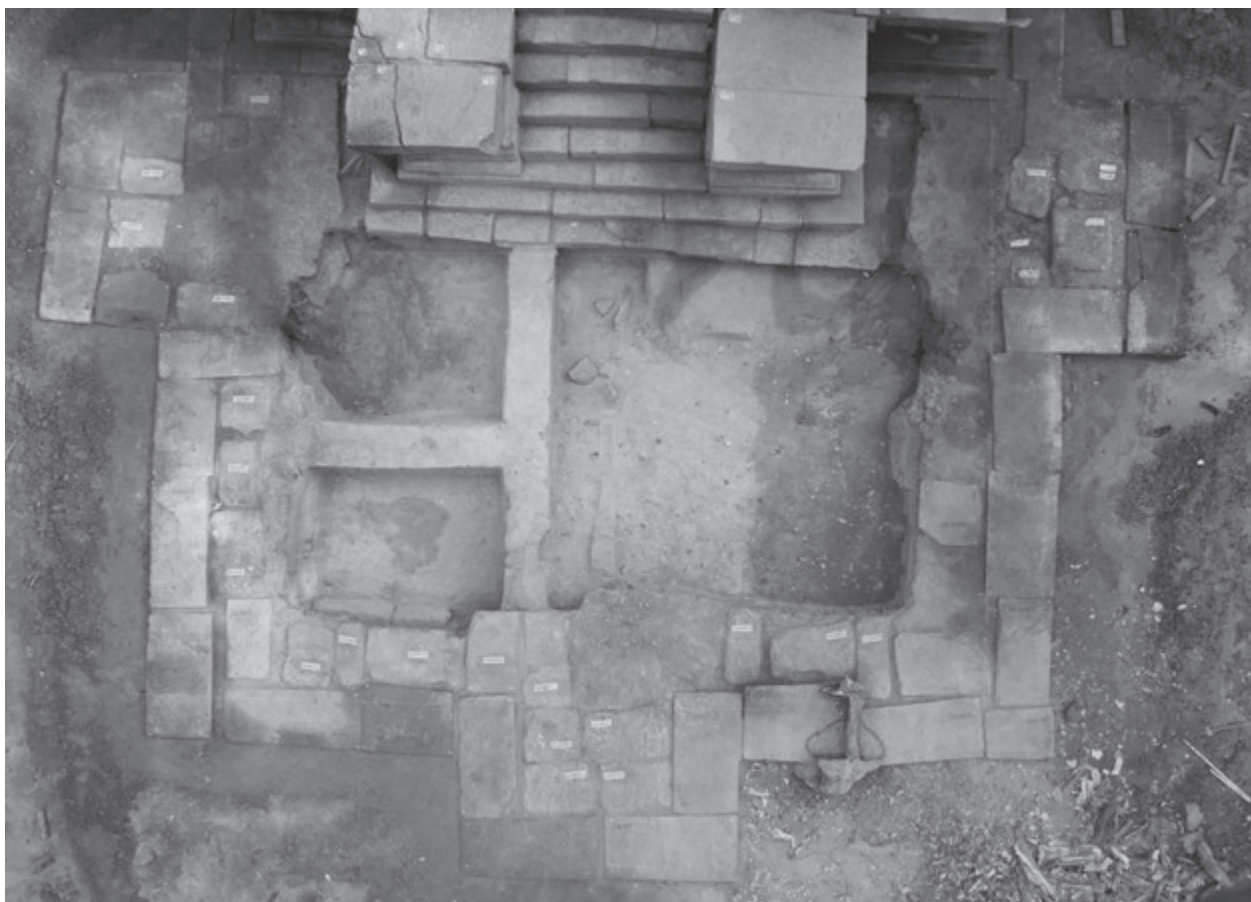
Fig. 26: N23 overhead photo

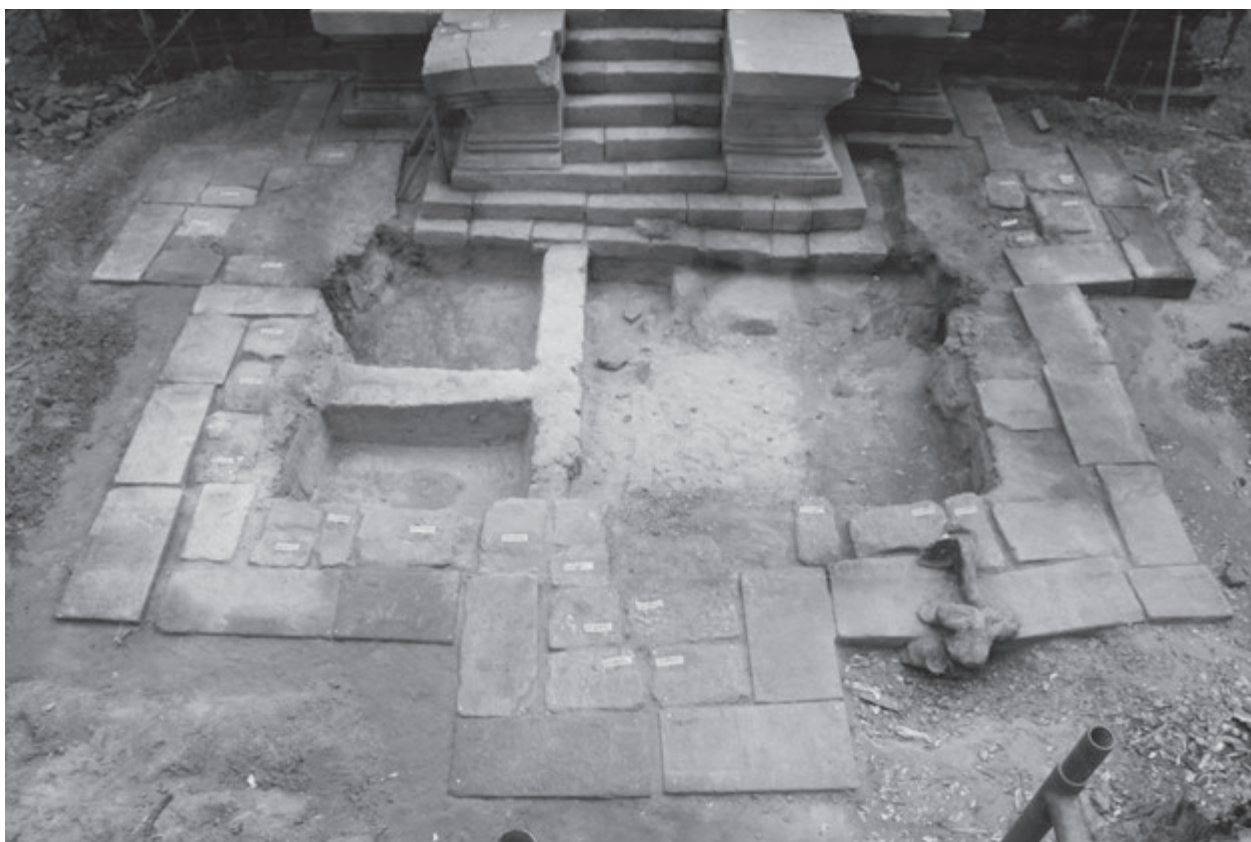
Fig. 27: N23 and the south stairways of the Central Sanctuary

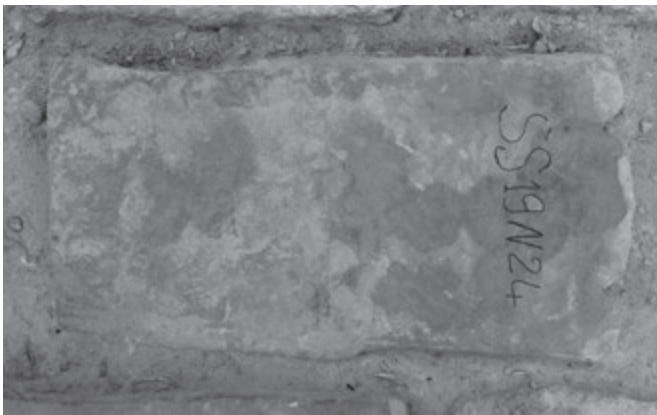
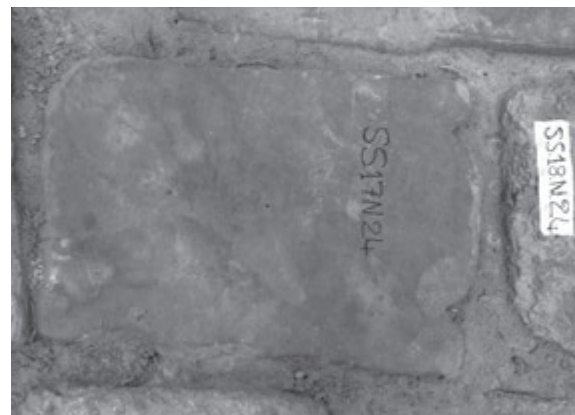
Fig. 29: N24 Sema stones; left: SS19, right: SS17

Practically all blocks of N24 are made of laterite. Tiers above N24, down to N23, comprise the upper blocks of the foundation, so N24 and N25 are assumed to be laterite blocks that were installed as the base of the above sandstone blocks. The paving is rather disorderly, with the blocks of the east stairways paved most carefully and blocks of part of the west stairways missing altogether. The laterite blocks of the south stairways are also disorderly, but SS17 and SS19 on the inside are sandstone Sema stones. Heretofore, 12 Sema have been discovered from the upper foundation, as reported in the previously-published restoration report. The two recently-discovered Sema were also installed in the stairways, with their head in the direction of the foundation. Since they seem to have been arranged in this way with conscious awareness of their function as a Sema, it can be assumed that they had some ritualistic meaning (see Articles Chapter 3 p.56-64).

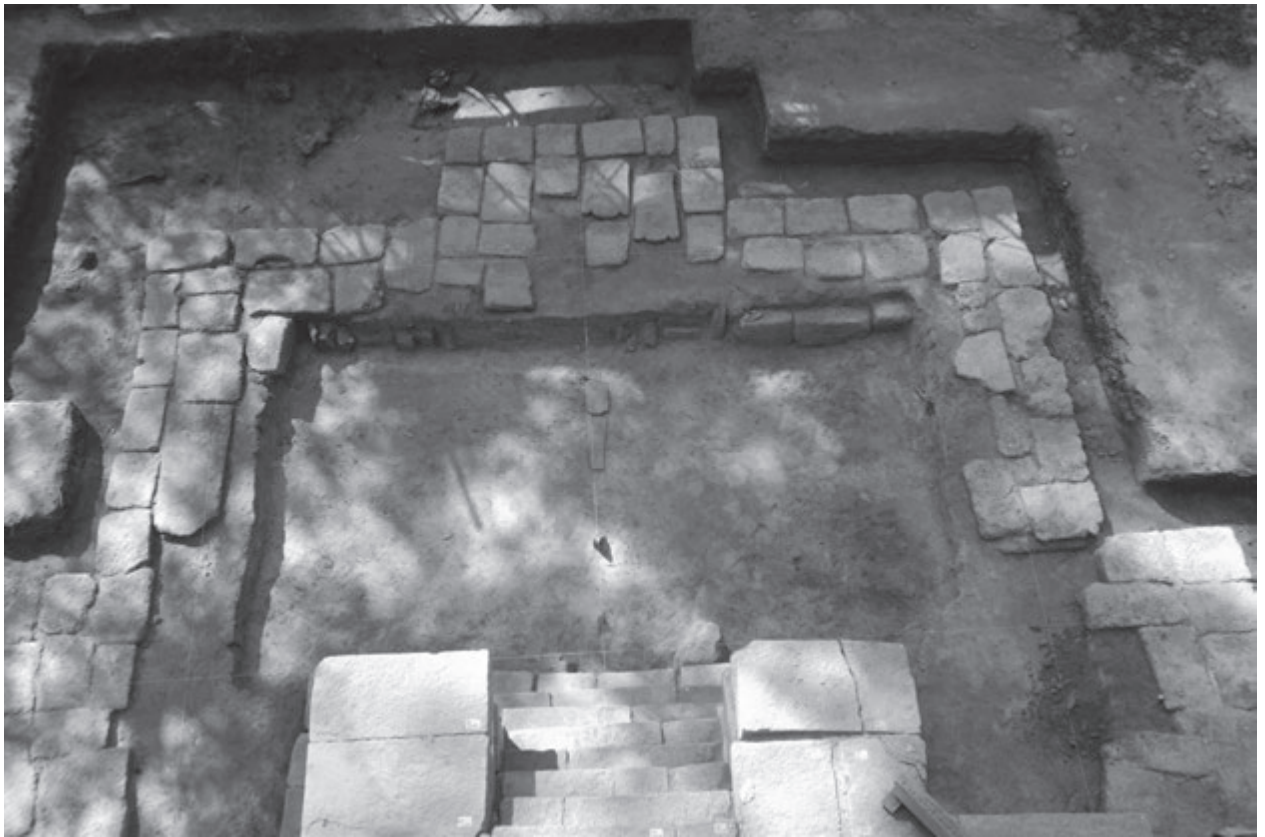
Fig. 30: N24 viewed from the north

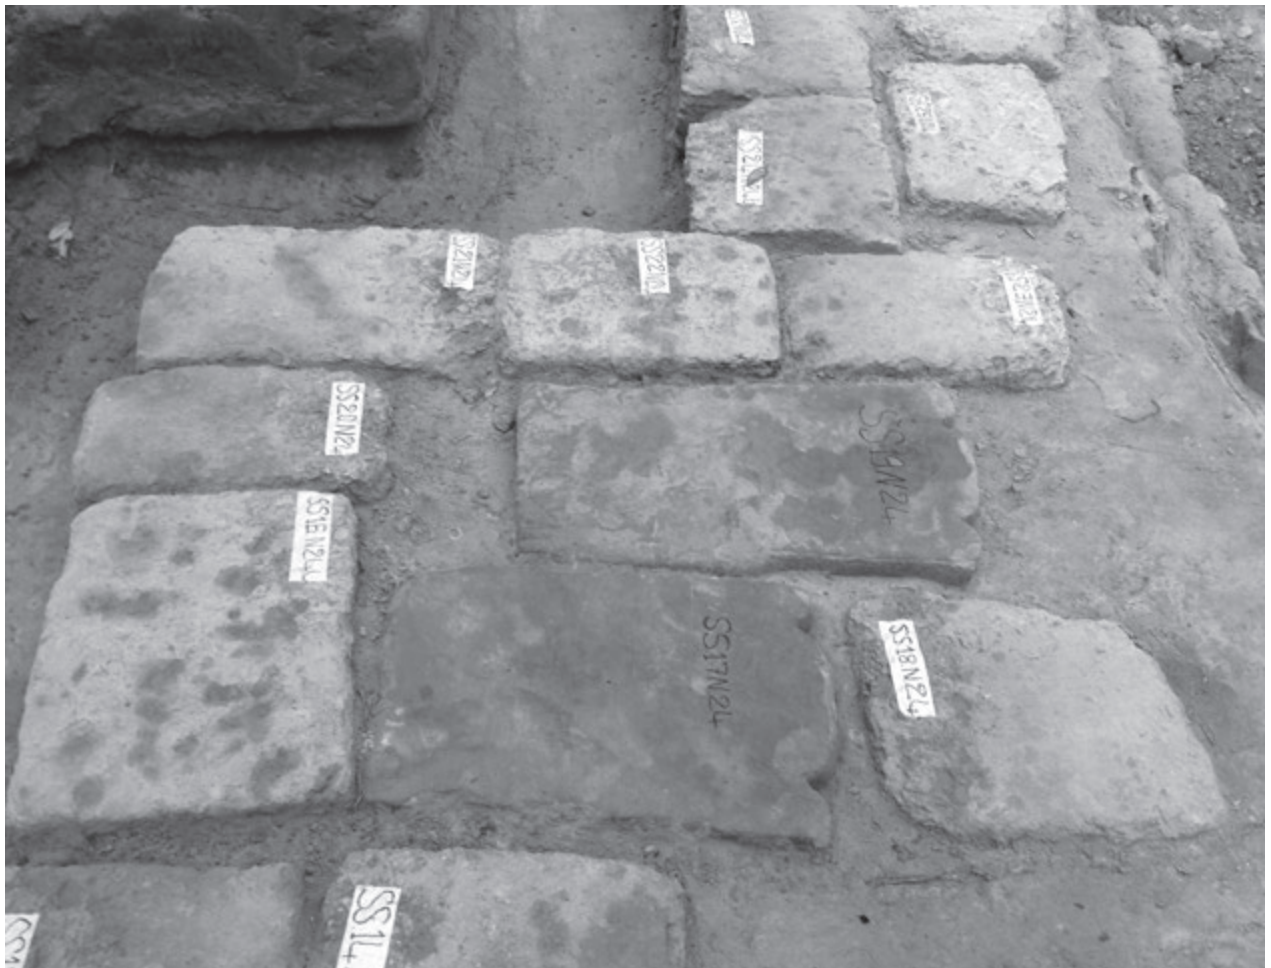
Fig. 31: Sema stones diverted for use in N24 (viewed from the east)

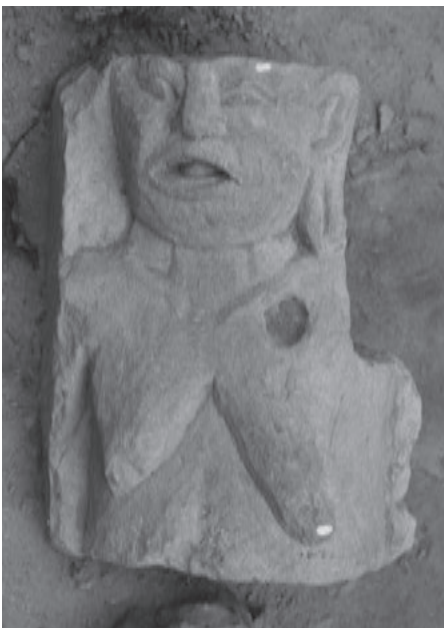
Fig. 33: Sculpture diverted for use in the stone line in the foundation

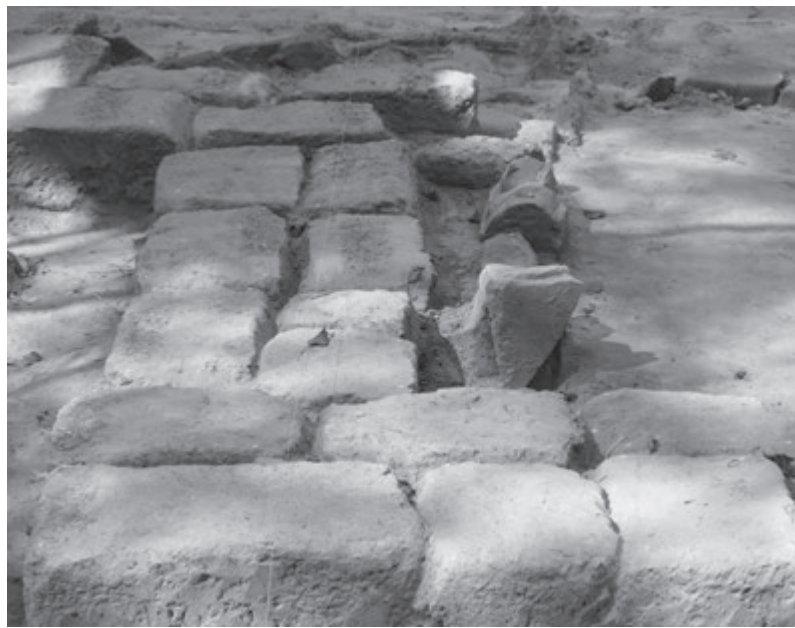
Fig. 34: Relationship between N25 and the stone lines in the foundation

N25 is a stone line in the bottommost tier of the lower platform. It is comprised entirely of laterite, although some parts in the northwest and southwest areas are empty. As it is an intermittent line of stones, it is regarded as part of the base work along with N24, rather than foundation stones. In this sense, as shown in Fig. 21, the top surface of the stone lines in the foundation is practically aligned with N25, and could also be regarded as part of the foundation work accompanying the installation of N25.

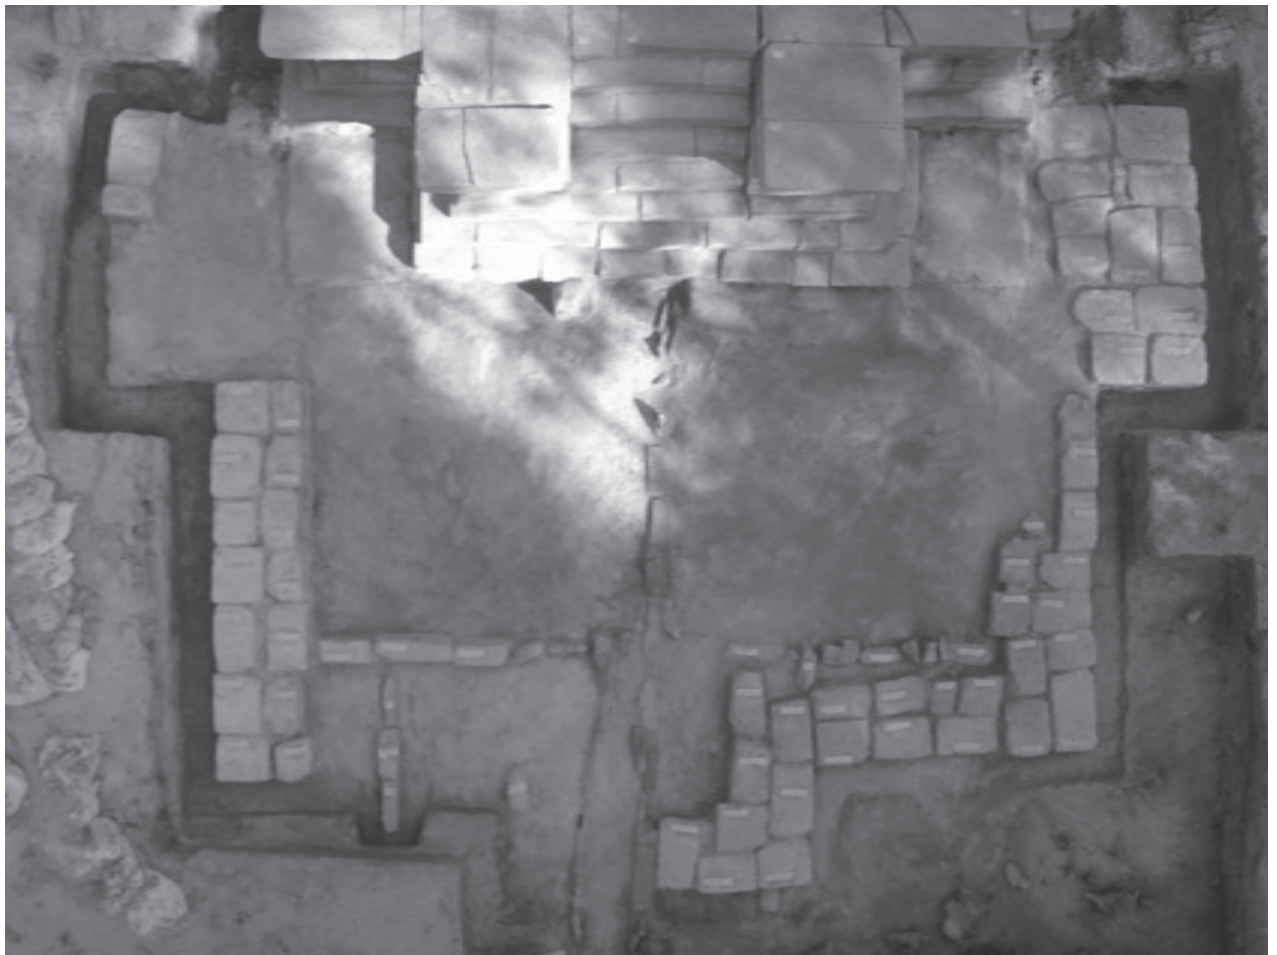
Fig. 35: N25 overhead photo (taken on Jan. 24, 2014)

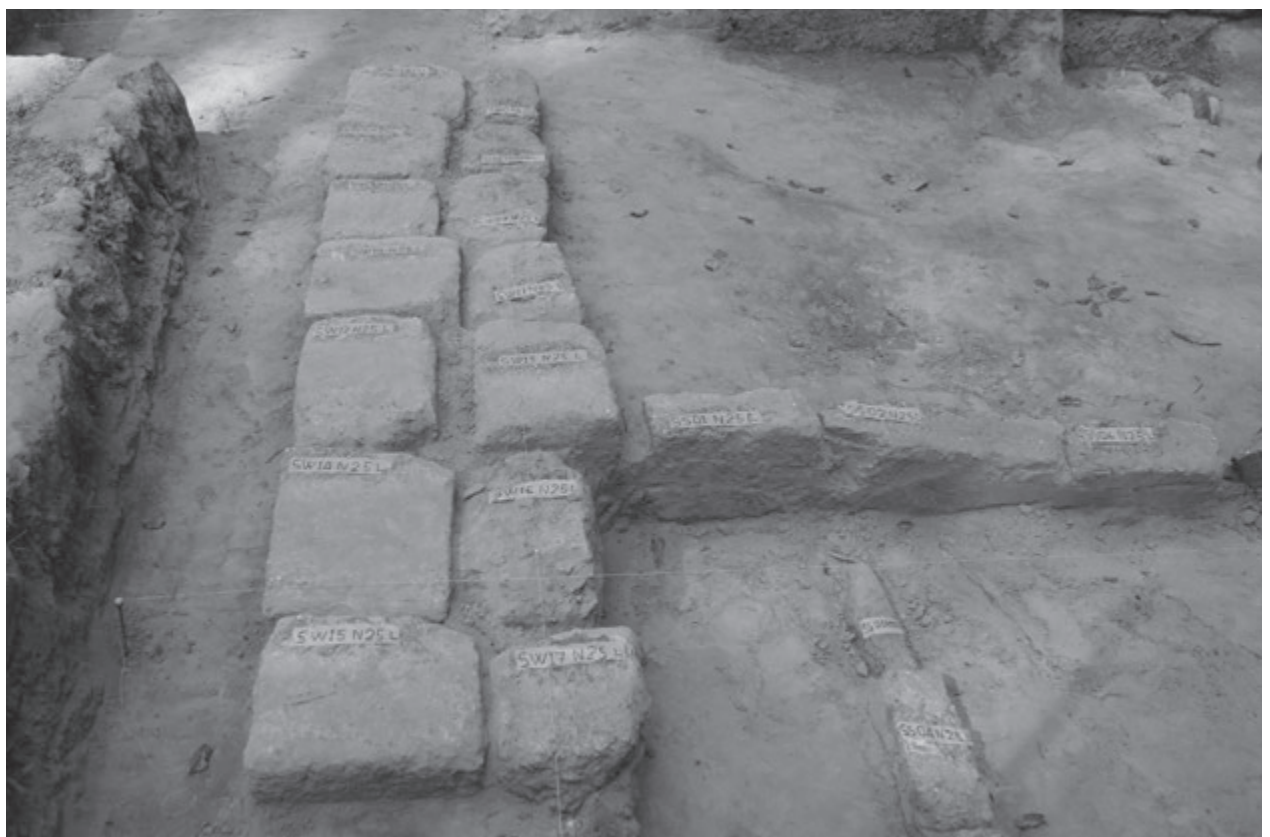
Fig. 36: Stone line on the west side of N25 and the stone line in the foundation
