### Chapter 1 Examination of Restoration Methods for the South Sanctuary of Western Prasat Top

Taisei Geotech Mituharu FUKUDA

#### Section 1 .Structure and Foundation of the South Sanctuary of West Prasat Top

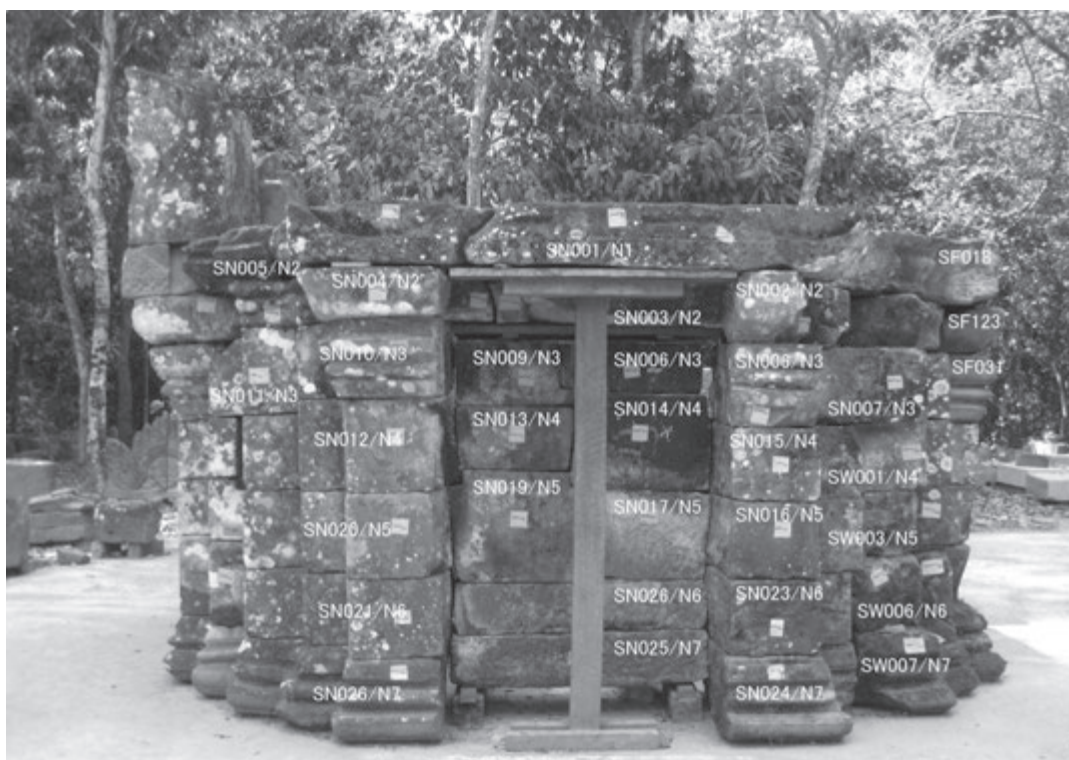
Photo 1: Temporary assembly of the main structure of the South Sanctuary

Among the West Prasat Top remains, the South Sanctuary shall be restored first. The South Sanctuary is composed of an upper foundation and lower platform as shown in Fig. 2, and a main sandstone structure on the upper foundation as shown in Photo 1. The original soil below the lower platform digs into the natural ground at depths below N22, and is composed of three-tiered sandstone side walls and stone lines below the walls, which further dig into the ground to a depth of approximately 80cm. The sandstone side walls of the lower platform stops immediately above the stone lines, below which is a bare hole with no sandstone walls.

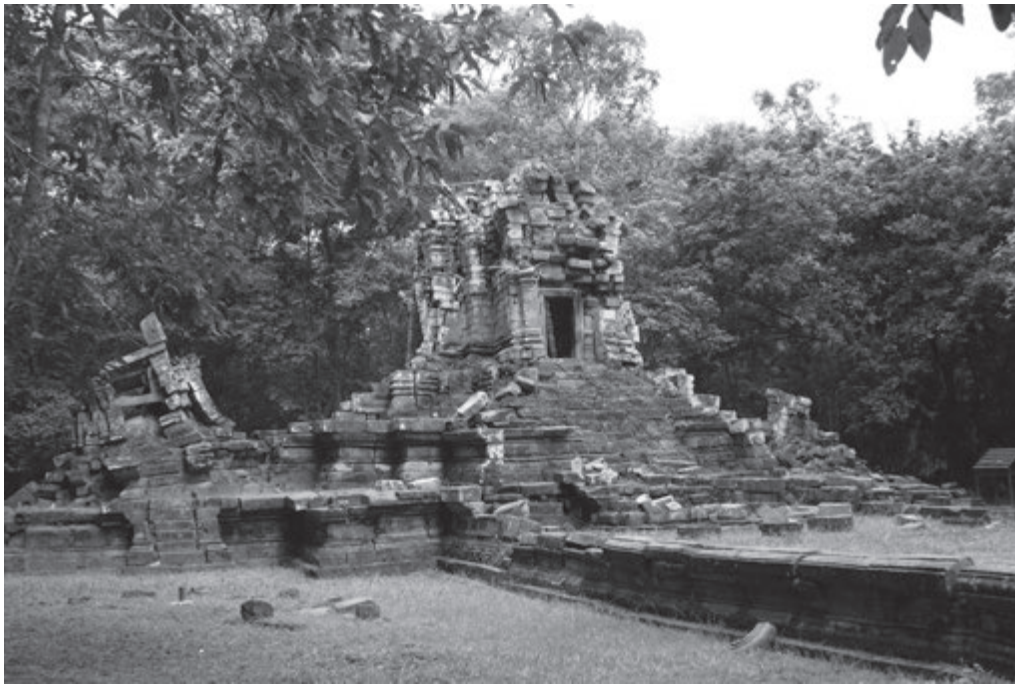
Photo 2: The Central Sanctuary and South Sanctuary viewed from the east

Photos 2 and 3 show the South Sanctuary viewed from the east. On the whole, no major deformation is seen in the height level of the lower platform. The main structure is tilted from the north to the south side, and the upper foundation is also tilted from the north side of the main structure to the south side as though in response to the tilting of the main structure. However, the upper foundation practically maintains a level height from the north side of the South Sanctuary to the north side. There is no major bulging in the east face of the upper foundation, and the tilting is predominantly seen in the north-south direction.

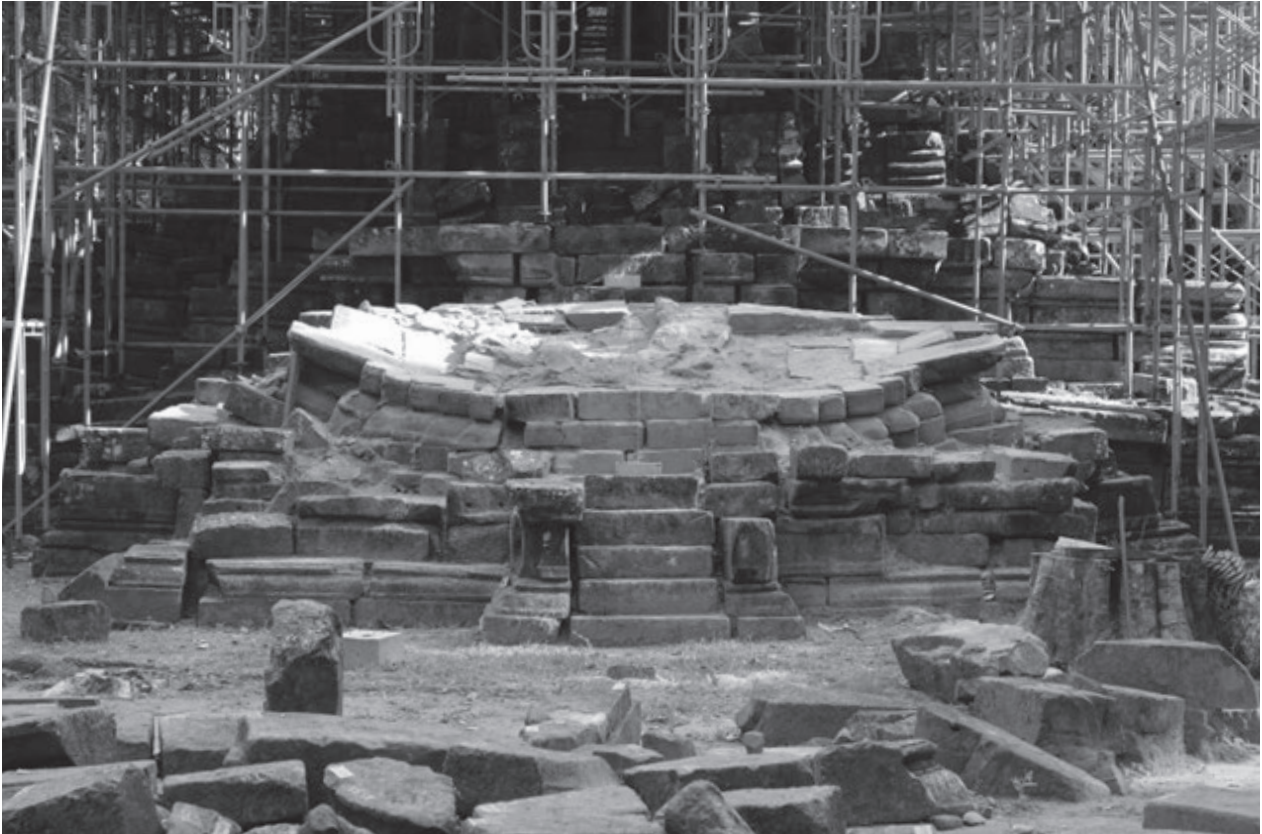
Photo 4: Subsidence of the top surface of the upper foundation

Photo 4 shows subsidence of the upper foundation, and Photo 5 shows subsidence of the central area of the sandstone pavement of the surface of the lower platform. Measured from the sandstone side walls on both sides, it is sunken approximately 56cm at the most. However, the subsidence is minimal on the north side, which connects with the Central Sanctuary. Since it has been found in an excavation survey that the south stairways of the Central

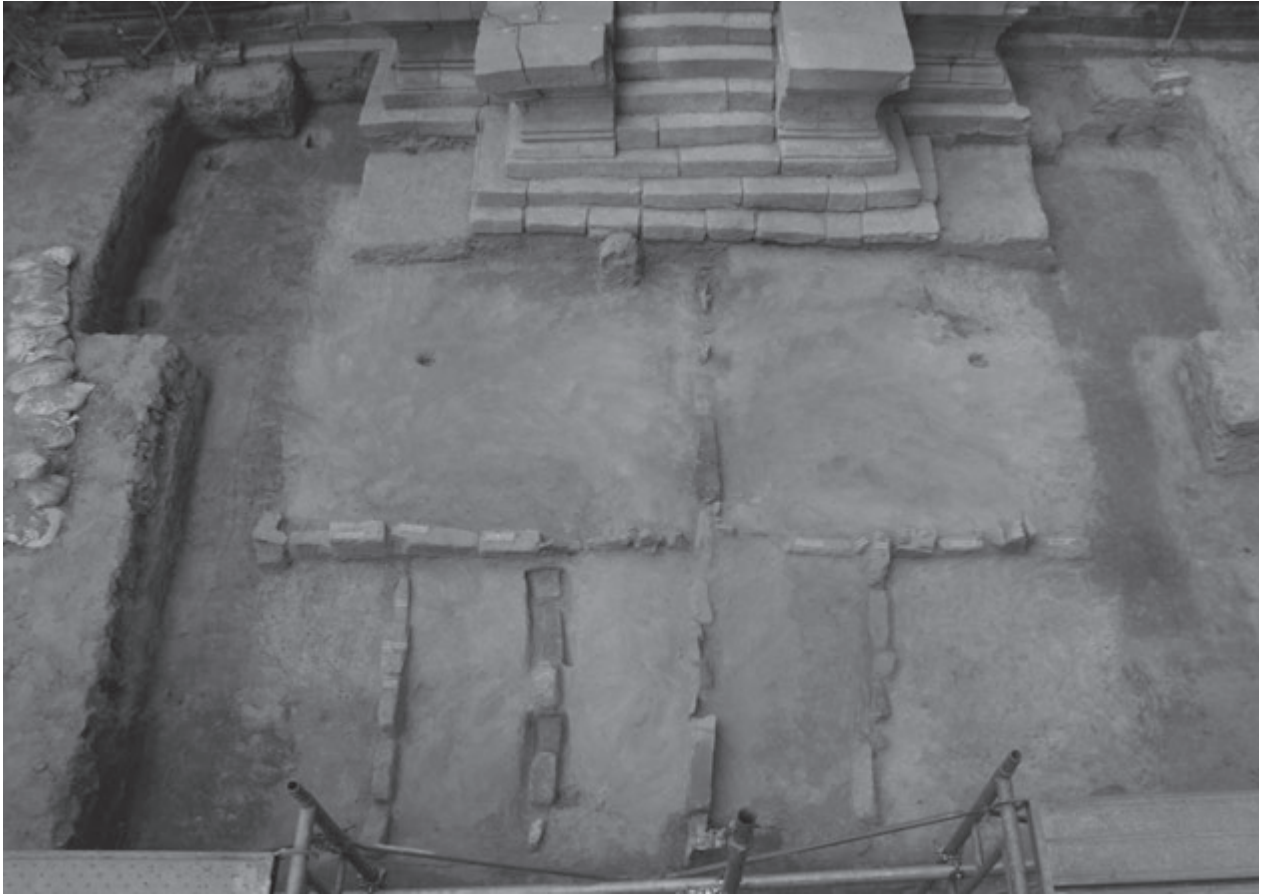
Photo 6: Stone lines directly beneath the lower platform

Photo 6 shows the stone lines below the lower platform. As the natural ground exists approximately 80cm below these lines, the foundation material fills the 80-centimeter space below the stone lines. Irregular-shaped flat sandstone is divided by the stone lines, but no evident signs of subsidence can be observed. The south stairways of the Central Sanctuary to the north of the stone lines basically maintain a level height. Thus, it is clear that the foundation material has subsided on the south side of the south stairways of the Central Sanctuary, from the upper and lower platforms above the natural ground, and that this subsidence is the direct cause of the deformation of the South Sanctuary.

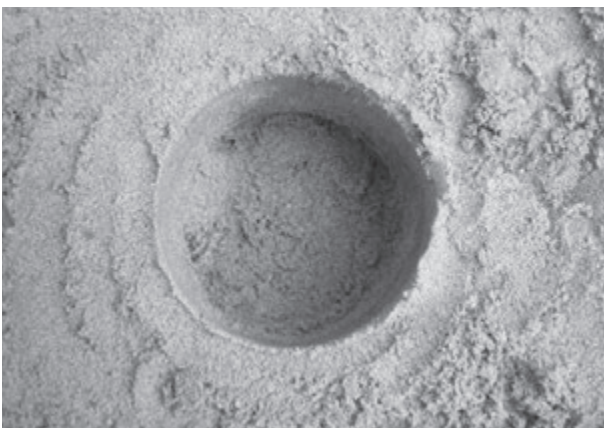
Photo 8 shows the bare hole of a permeability test performed on the lower platform. The hole maintained its shape in wet condition, but when water was quietly applied, the area around the hole eroded as though to melt, and the hole lost its shape.

Photo 8: Erosion of the material of the lower platform

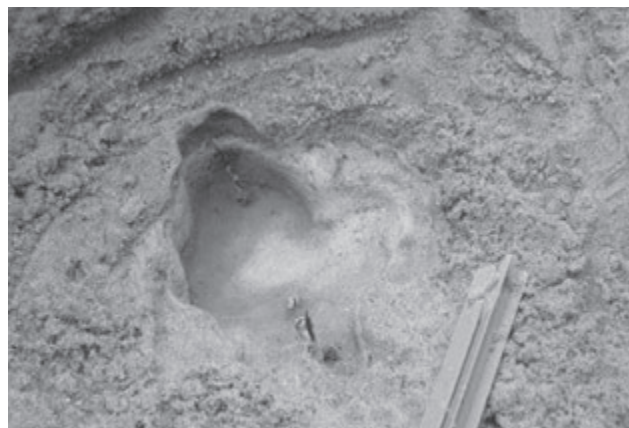
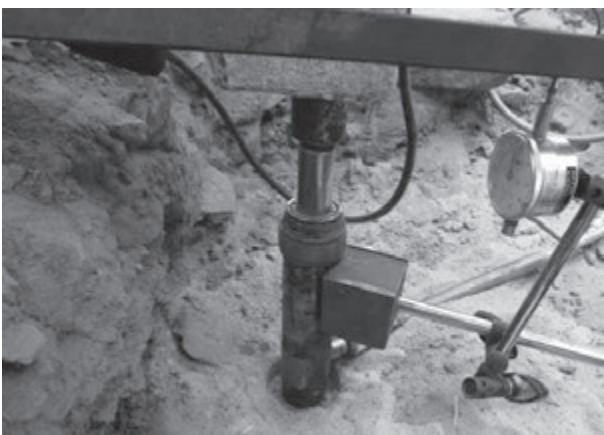
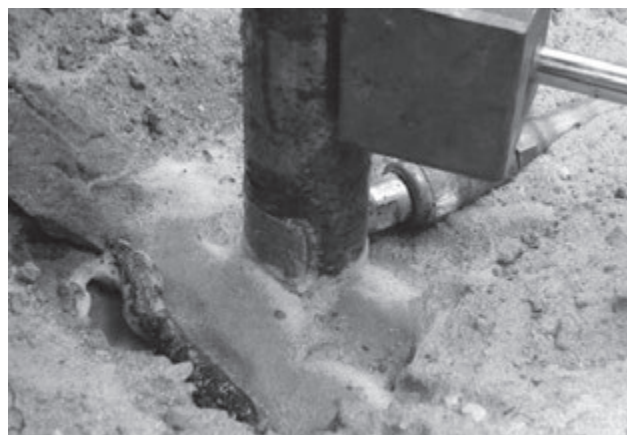
Photo 9 shows a state of compaction by watering. After a loading test was performed in wet condition, sprinkling water around the load plate caused immediate subsidence, or collapse, of the soil.

Photo 9: Water sprinkling around the load plate in a loading test

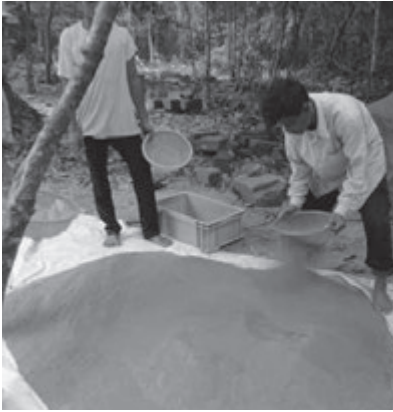
Compaction was performed using a rammer called “elephant’s foot” and a round rammer. Photos 10 to 27 show the progress of the test foundation work. In Photo 10, large rubbles and foreign matters contained in the excavated soil were removed and sifted so that a uniform material is left. The soil mixtures were prepared according to volume ratio, and their initial water content and water absorption were measured.

Photo 10: Removing foreign matter

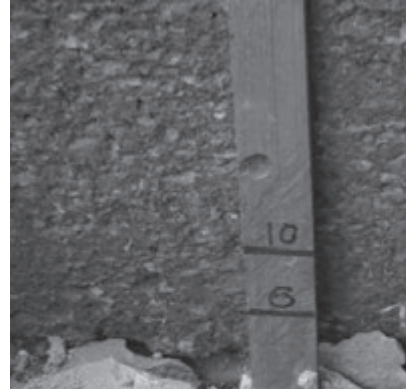
Using a rammer, the test soils were compacted from a spreading depth of 10cm to a compacted depth of 6cm. Then, after compacting the areas that come into contact with laterite, a Yamanaka hardness meter was used to control the degree of compaction. After confirming that the control conditions are satisfied, the soils were applied and compacted in sequence. Once the prescribed thickness was obtained, a simple penetration test, loading test, permeability test and density test were conducted to inspect the quality of the test foundation.

Photo 15: Soil spreading thickness and compacted thickness

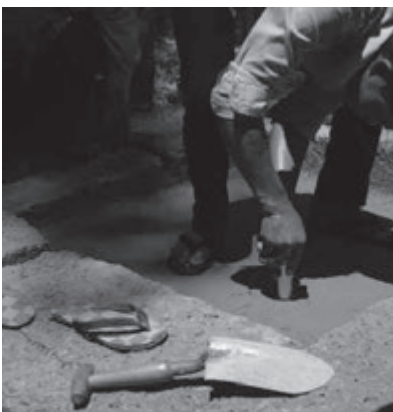
Photo 19: Compaction control using a Yamanaka hardness meter
