## Chapter 1: Research and Restoration Project of the Western Prasat Top Site

### Section 1. Process of the Reconstruction

## Section 2. Reconstruction of the Central Sanctuary

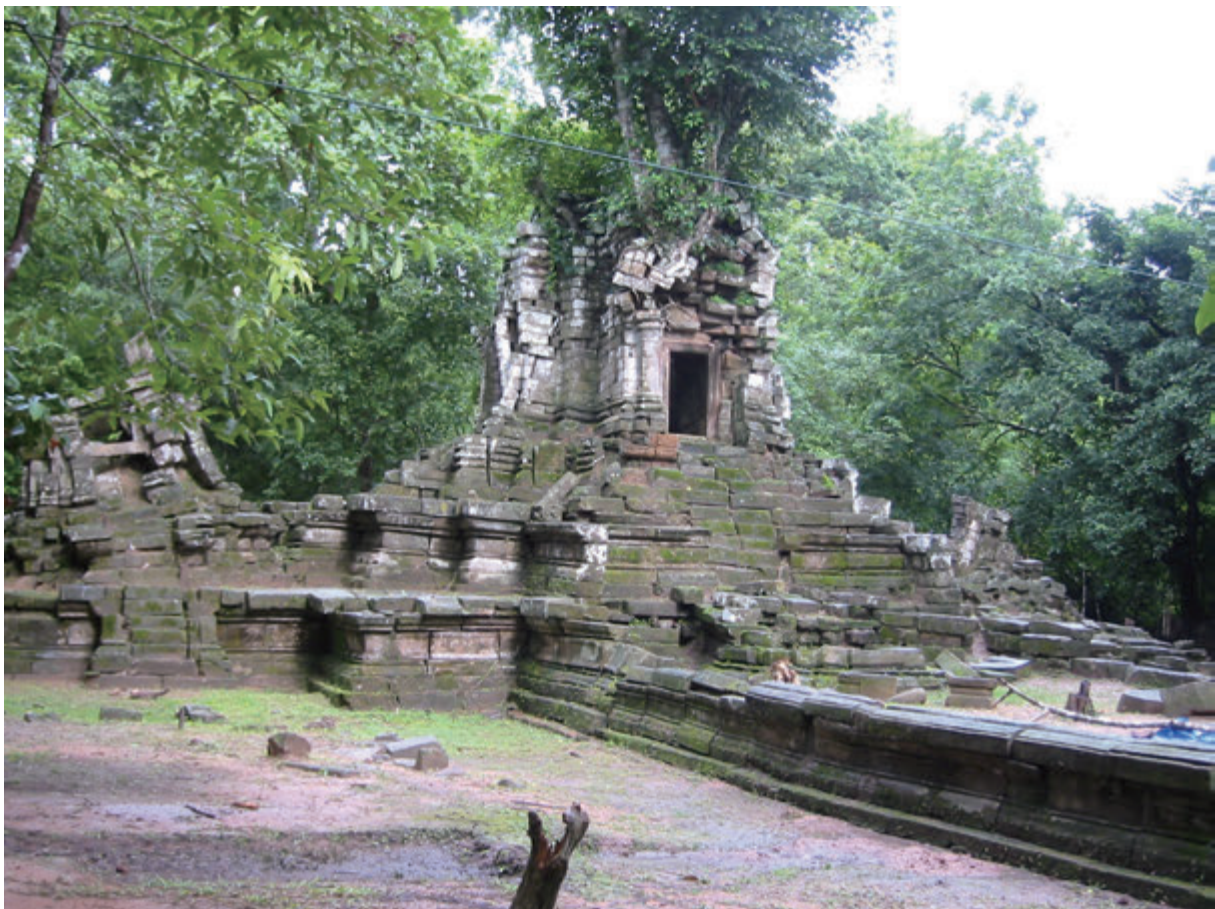
On 26 May 2008, about 40 pieces of stone fell from the east gable of the central sanctuary. It is thought that these stones were destabilised by the felling of trees, which had been growing on the top of the central sanctuary, the year before. The collapse of the stones caused

Fig. 1 Western Prasat Top before the restoration (view from the southeast)

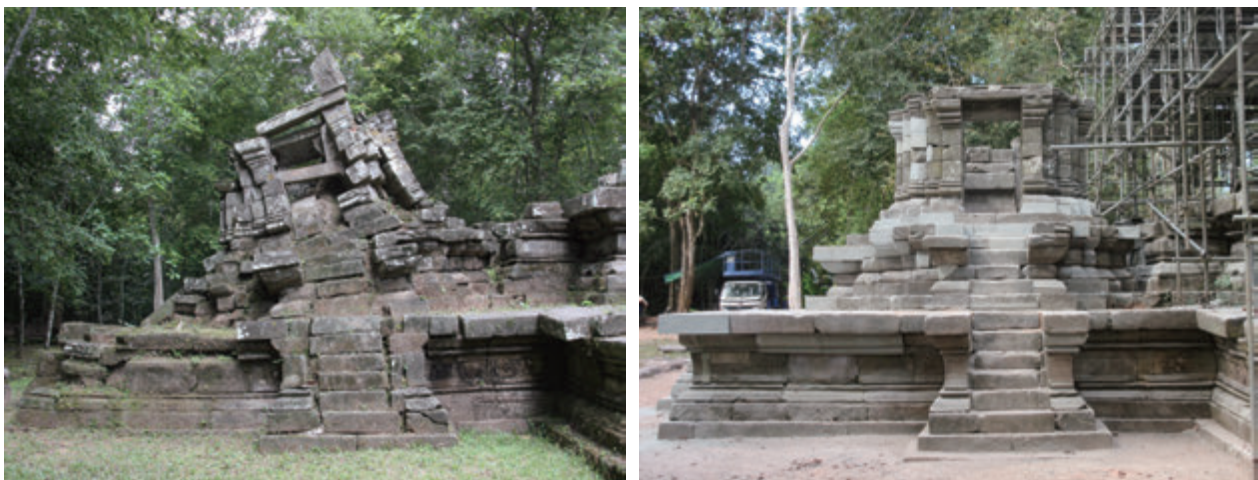
The southern sanctuary consists of the building frame, the upper platform and the lower platform (Fig.2). Most of the roof was lost and the body was tilted 19 degrees to the south. The dismantling of the structure was carried out by a process of drawing plans, numbering the stones, and dismantling one layer at a time, starting from the top. The top surface of the platform was made of sandstone paving stones, but it had sunk more than 20cm, from the centre to the south, due to unequal settlement of the associated fill. When the paving stone layer was dismantled, it was found that the foundation soil was coarse sand. When this soil was excavated, the southern staircase of an earlier platform of the central sanctuary was found in the lower platform of the southern sanctuary. After the dismantling of the lowest level of the platform, the trace of the underground foundation was confirmed from the south side of the lower platform and also the rows of stone blocks were found in the center of the foundation. From October 2014, we started to reconstruct the foundation under the platform and on 23 September 2015, we successfully completed the research and restoration of the southern sanctuary.

Fig. 2 South sanctuary before the reconstruction (left side), after the reconstruction(right side) (view from the east)

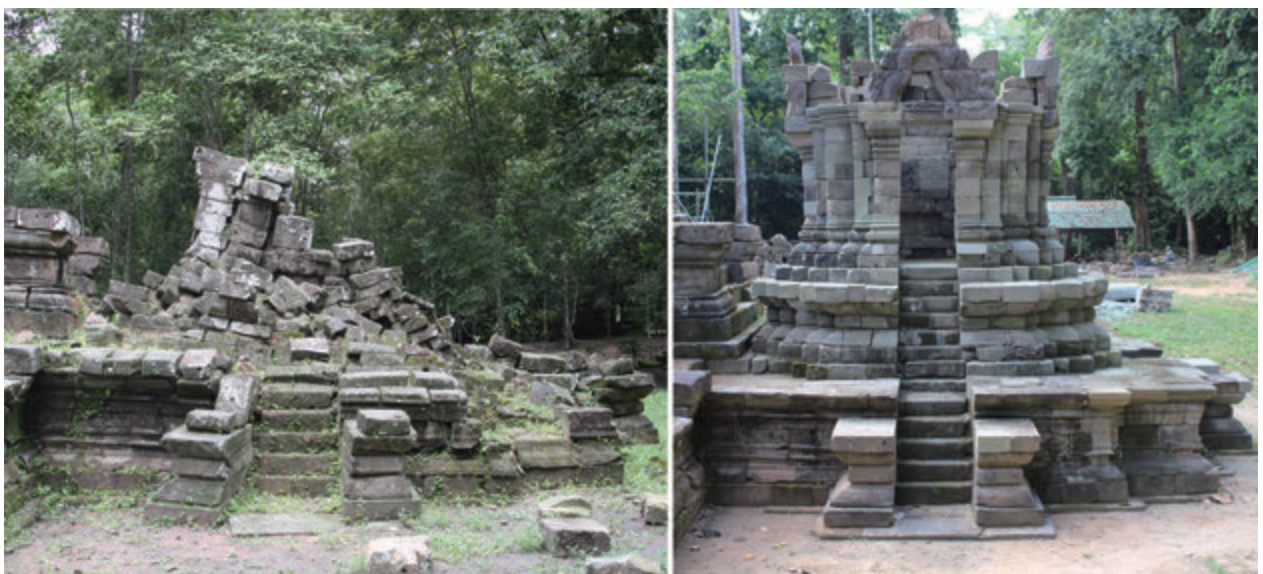
In February 2016 we started the dismantling of the northern sanctuary (Fig.3). By March we finished the dismantling of the structure and the survey of the scattered stones north of the northern sanctuary. The whole structure of the northern sanctuary had inclined to the north and the collapse of the building frame was more severe than that of the southern sanctuary. After the dismantling of the building frame was completed, we started to investigate the platform of the sanctuary.

Fig. 3 North sanctuary before the reconstruction (left side), after the reconstruction(right side) (view from the east)

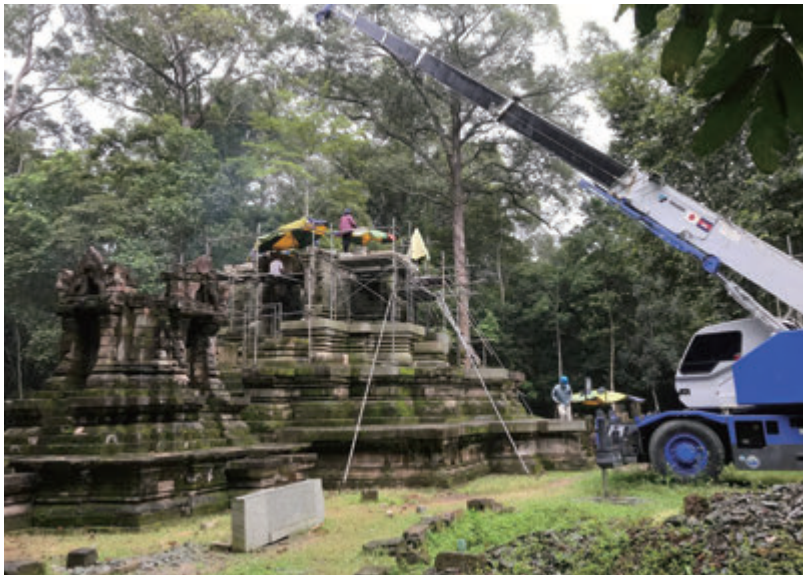
Fig. 8 Reconstruction situation of Central sanctuary (view from the northwest)

The reassembly of the platform of the central sanctuary was carried out in order from the sandstone exterior of the lower platform to the middle and upper platform (Figs. 7 and 8). As the structure differs between the opening and the lintel above it, the work was divided into two parts: the upper part of the building frame and the lower part. In the reconstruction of the lower part of the building frame from the 25th to the 16th layer, the door frames for the openings on the east, west, south, north and south sides were assembled first, and then the walls were built up. Those parts that could not be reused due to damage or deterioration were joined or replaced with new sandstone blocks.

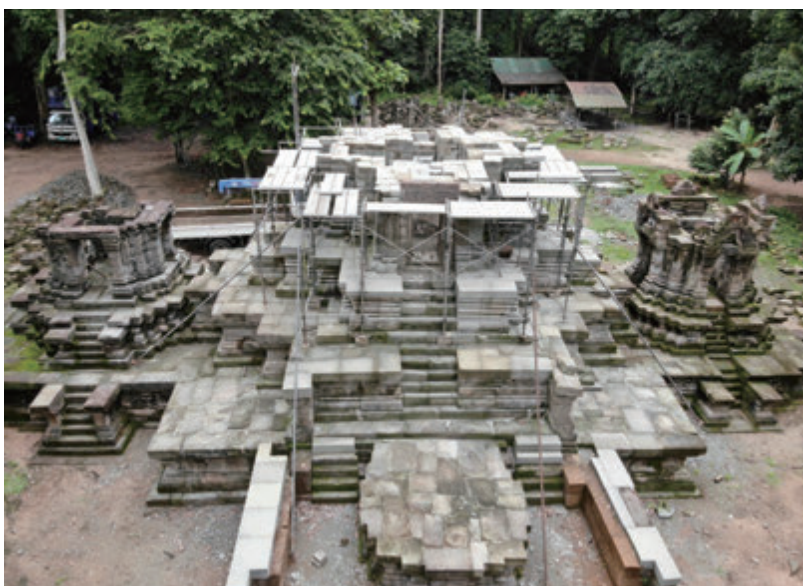
Fig. 9 Reconstruction situation of Central sanctuary (view from the east)

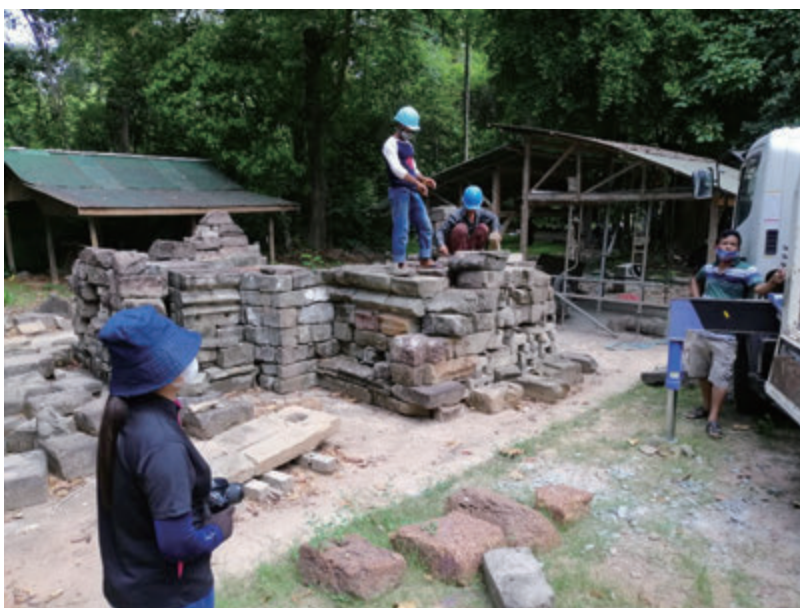
Fig. 12 Trial reassembly of the upper part of the building frame

As there are a number of missing elements in the first pediment, we will continue to search for the appropriate stone material and continue with the temporary assembly of the upper part of the body.

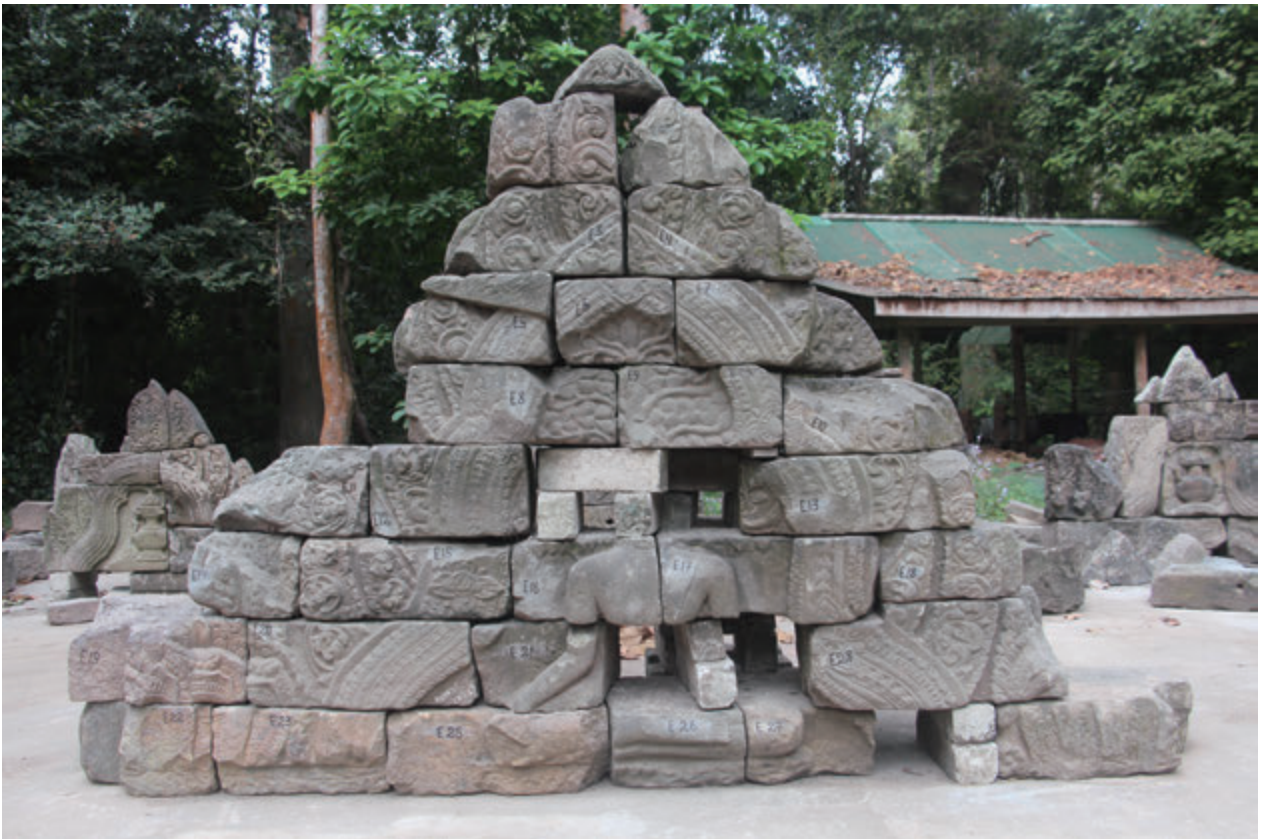
The first pediment, like other pediments found at Angkor, is composed of a carved image of the subject within a niche divided by a band of decoration. At each end of the pediment, there is a relief of five heads of Naga wearing crown-like ornaments, which is the same on all four sides of the first pediment. The east pediment is the only one that can be seen in its original position in old photographs taken by EFEO (Fig. 10). In the niche of the pediment, a seated Buddha image in the *māravijaya* is shown. Above the head of the seated Buddha is a representation of a leaf of the Bodhi tree, with the leaf pattern continuing to the shoulder of the seated Buddha. The stone materials for the head, body and base of the seated Buddha image have not been confirmed at present.

Fig. 13 Trial reassembly of the first east pediment

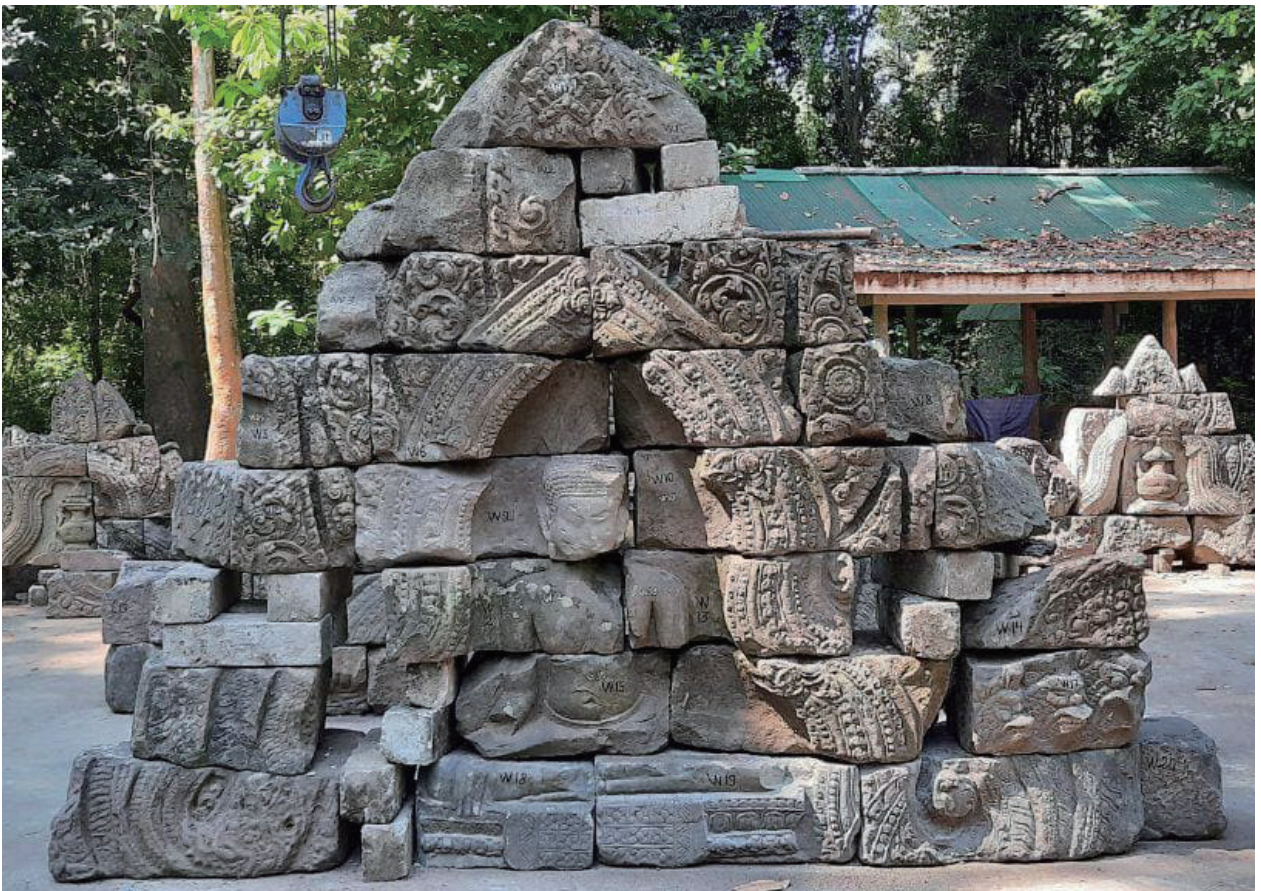
The pediment on the west face could not be seen in old photographs, but we were able to reconstruct it almost completely by finding the relevant parts among the scattered stones. Inside the niche is a seated Buddha image in *māravijaya*, but without the Bodhi tree seen on this pediment. The face is obscured in places by wear and tear, but the eyes are long and slanted, and the eyebrows are slightly arched. The pedestal on which the seated Buddha sits is composed of three layers of patterned bands. The upper layer is decorated with a flower design, the middle layer with a double-petalled lotus design, the lower layer with a lotus bud-shaped design, and in the centre of the pedestal is a square decoration with a floral motif.

Fig. 14 Trial reassembly of the first west pediment

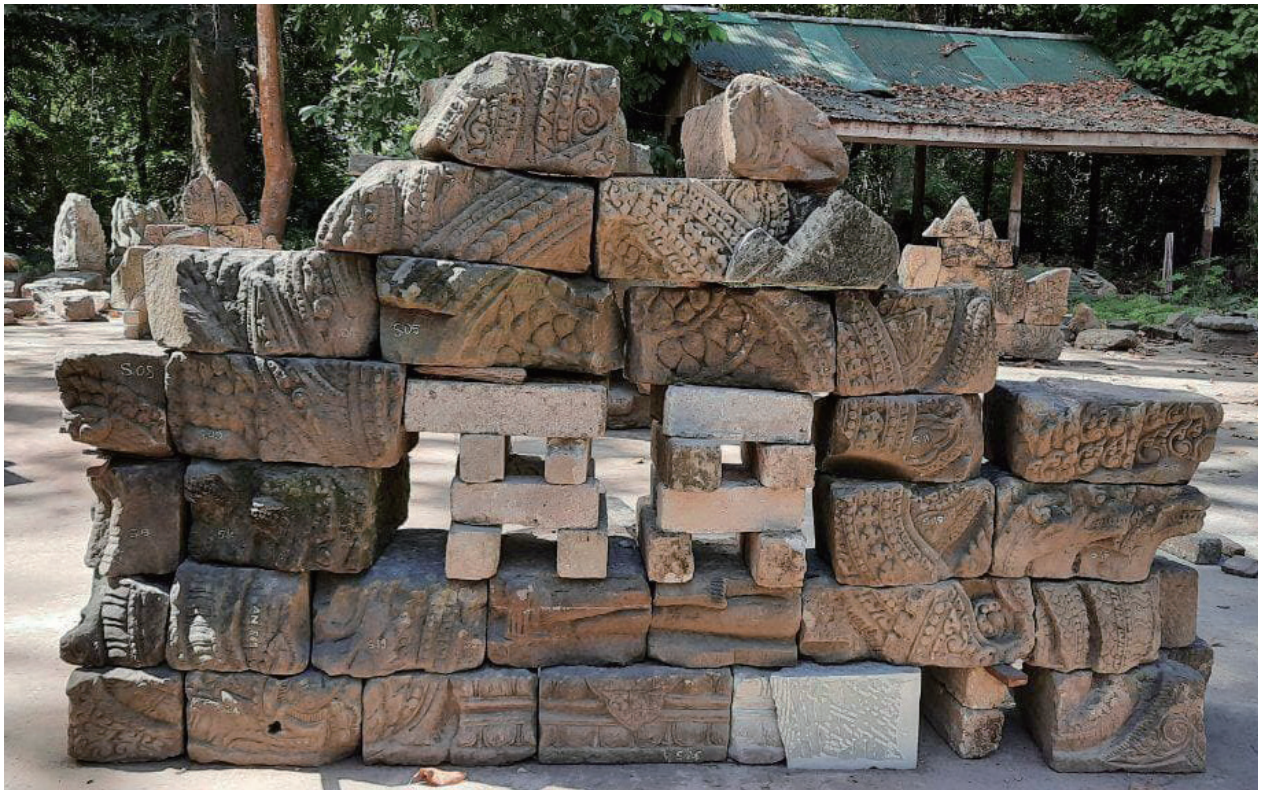
The south pediment was also not recorded in the old photographs. For the legs of the seated Buddha image, we have been able to find the appropriate stone material, but unfortunately we have not been able to find any stone material above the body of the seated Buddha. From the expressions on the legs, it can be assumed that the seated Buddha was represented in *māravijaya*, as on the other sides. The upper part of the seated Buddha image is carved with leaves of the Bodhi tree. The pedestal is decorated with upwards lotus petals in the upper part and downwards lotus petals in the lower part, and the central part of the pedestal is adorned with floral designs in the form of an inverted triangle.

Fig. 15 Trial reassembly of the first south pediment

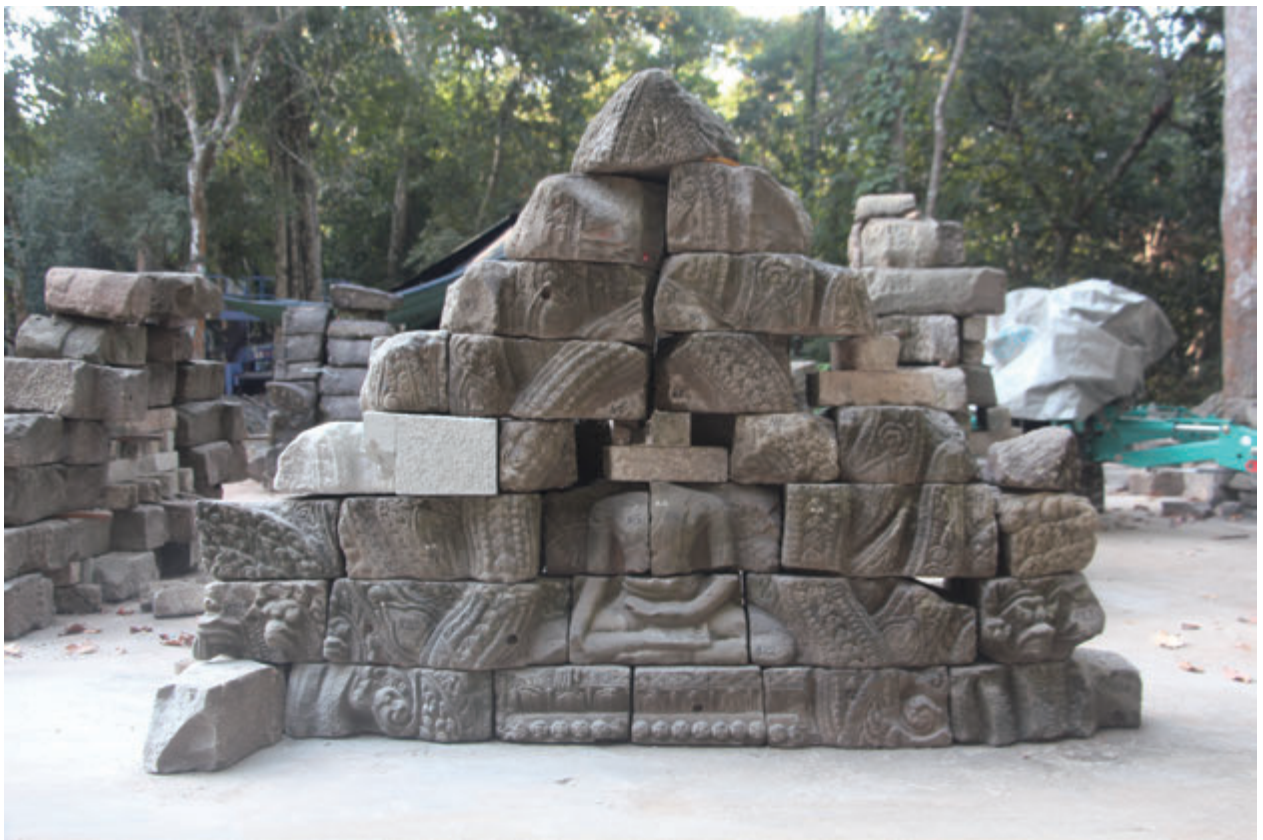
Although the north face could not be confirmed by old photographs, it could be almost completely reconstructed except for the head of the seated Buddha image. The seated Buddha image sits on a pedestal in *māravijaya*. As in the west face, there is no representation of a bodhi tree on the upper part of the seated Buddha image. The pedestal has a similar structure to that of the west face, with three layers of patterned bands: a flower patterned band on the upper layer, a double-petalled lotus band on the middle layer, and a lotus bud band on the lower layer. There is no representation of fabric or ornamentation as seen on the western pediment.

Fig. 16 Trial reassembly of the first north pediment
