## Chapter 1: The 10th Year of the Research and Restoration Project of the Western Prasat Top Site

### Section 1: Survey of the Western Prasat Top site

## Section 3: Reconstruction of the southern sanctuary

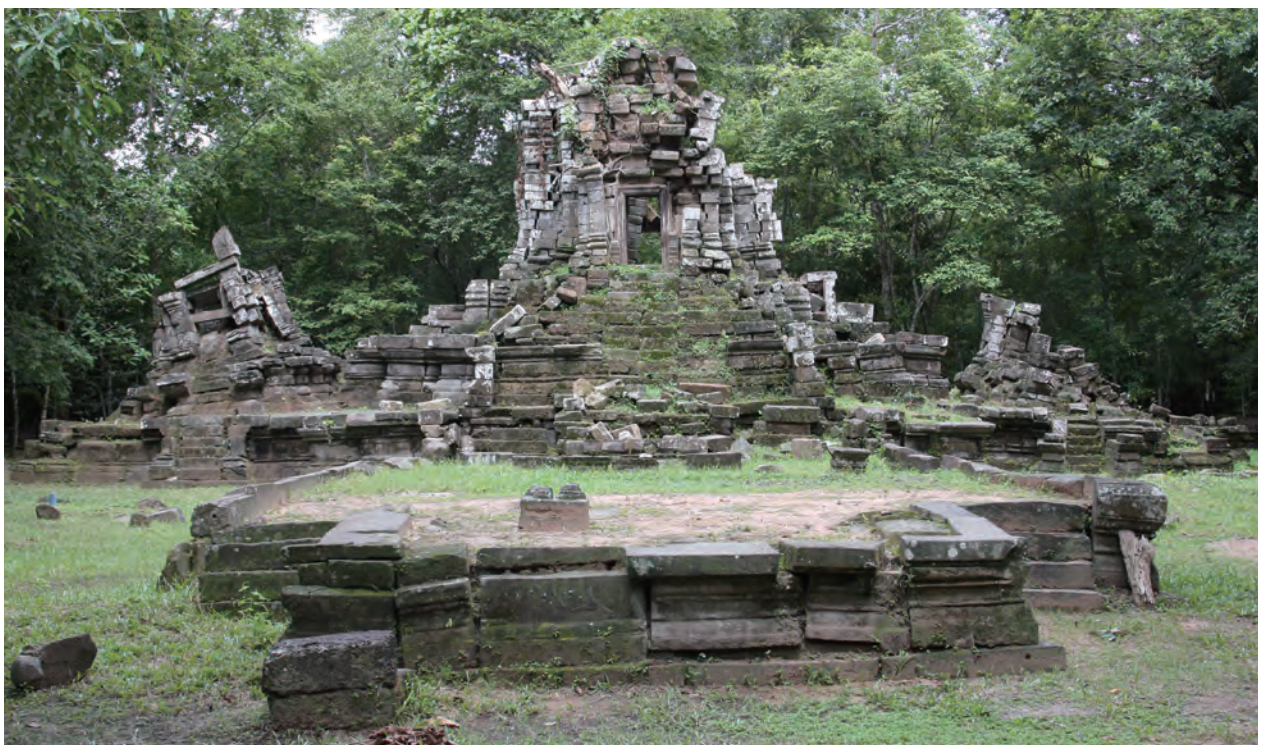
Fig. 1 Western Prasat Top before the restoration (view from the east)

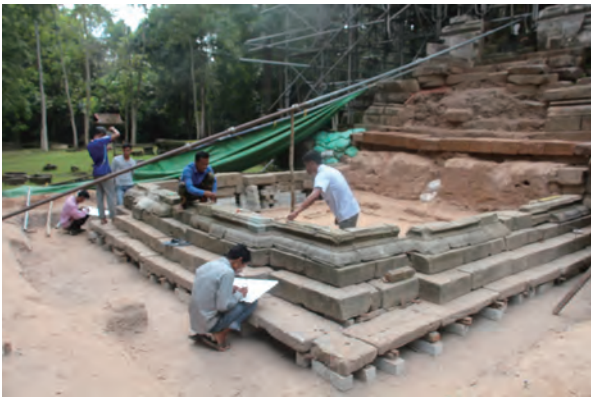
Fig. 14 Reassembly of the northern sanctuary

After conducting a detailed survey of the underground brick chamber, it was backfilled with the original reddish-brown soil (Fig. 14) to preserve the remain. We then started to reconstruct the north sanctuary. The aim of the reassembly was to find the original elements among the surrounding, scattered stones and return them to their original place. In the process, it was possible to reconstruct the standing images of Buddha. The west and south faces were originally known from the archives of the EFEO in the early 20th century (CAM\_01481,01482), but by the time we arrived in the 2000s, they were no longer in their original state.

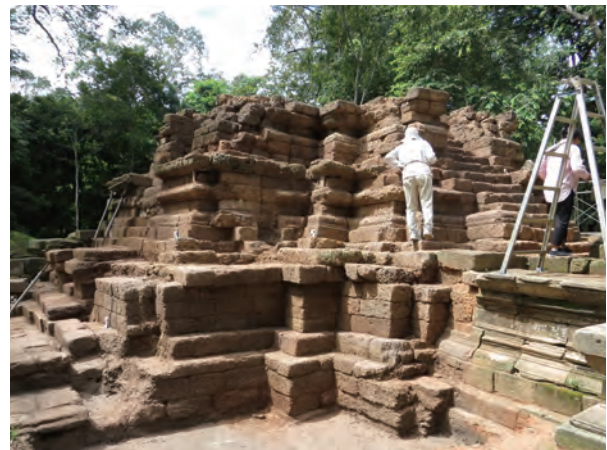
Fig. 22 Survey of the laterite platform (view from the northeast)

stone exterior of the central sanctuary platform (Fig. 22). For this reason, we decided to dismantle the sandstone exterior one quarter at a time and investigate the exposed laterite platform. Firstly, the south-east quarter was partially dismantled to see how much of the laterite platform remained, and then the south-west and north-west quarters were dismantled.
