Survey and Restoration of Western Prasat Top

Interim Report 10

Reassembly of the Platform of the Central Sanctuary

The Authority for the Protection and Management of Angkor and the Region of Siem Reap
Nara National Research Institute for Cultural Properties

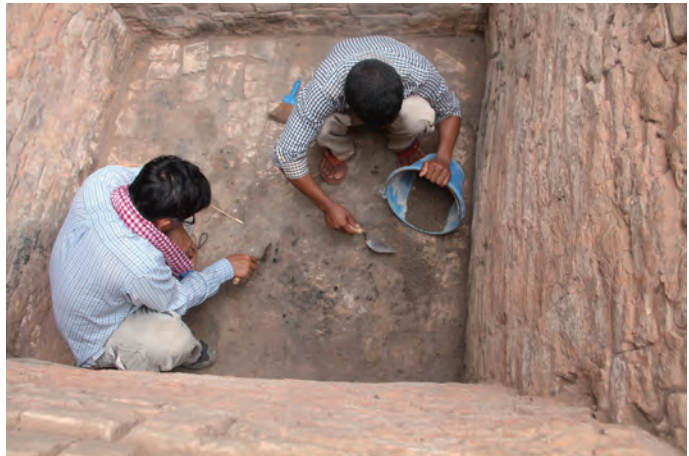
Fig. 12 Excavation of the underground brick chamber

In July 2016, with the dismantling of the platform underway, an east-west trench was also set up to investigate the condition of the brickwork in the cross trenches in order to clarify the composition of the brickwork. In August, we excavated the soil fill inside the brickwork (Fig. 12) and carried out photography, measurements and 3D surveying. It revealed that the brickwork was an underground brick chamber. In this underground brick chamber, metal objects such as gold, crystal, glass beads, and burnt bone fragments were excavated. Traces of heat exposure were also found on the surface of the brick chamber and artifacts, and a number of carbon samples were also recovered. For details of the results of the analysis of these remains and excavated artifacts, please refer to Interim Report of Western Prasat Top 5 (Nabunken 2018)

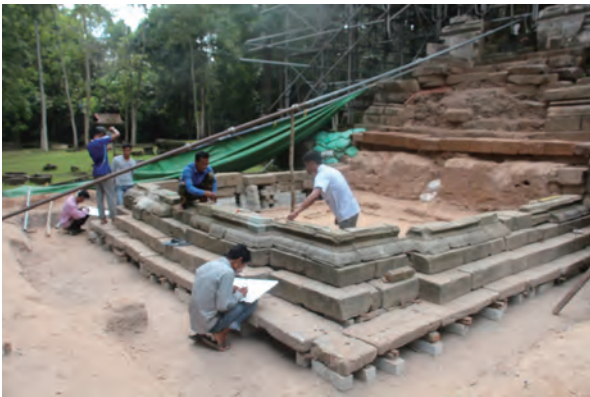
Fig. 14 Reassembly of the northern sanctuary

In 2017, after the reassemblage of the platform of the northern sanctuary had been completed the reconstruction of the building frame was started. The building frame of northern sanctuary had collapsed to a greater extent than the

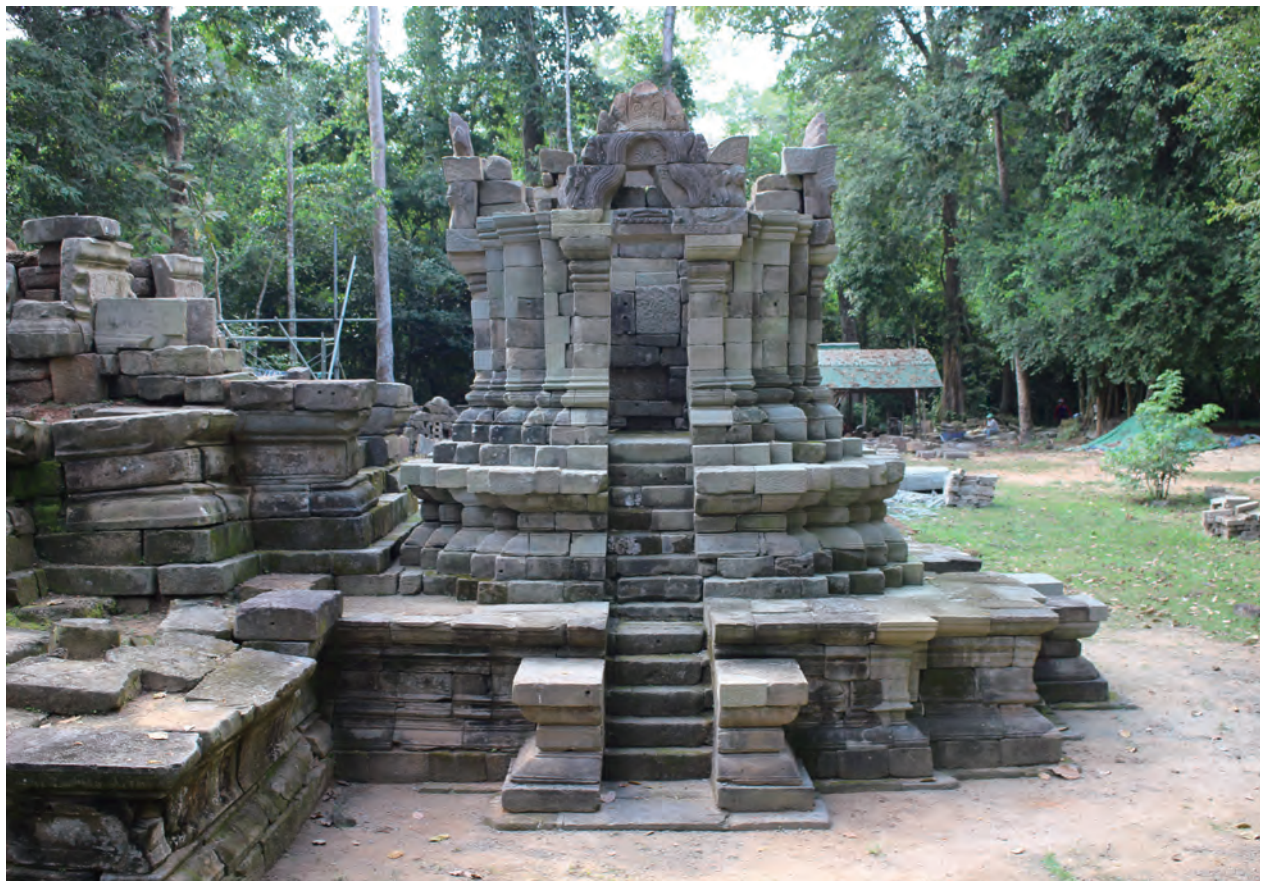
Fig. 19 Reassembled northern sanctuary (view from the east)

southern sanctuary. We searched for scattered stones from the surrounding area. The work was completed in December 2017 (Fig. 19).

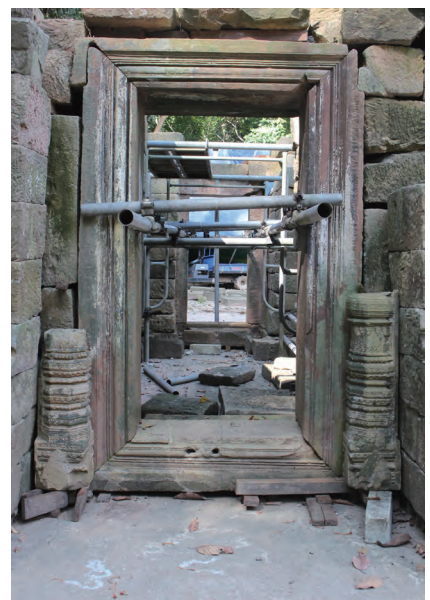
2.1.a. Eastern Door Frame (Fig.6)

Fig.6 Eastern door frame (during reconstruction)

The eastern door frame blocks are completely made of red or pink sandstone. There are in total four blocks, such as the: lower frame; vertical right frame; vertical left frame; and, upper frame. Both vertical frames were almost the same height and thickness. The lower frame was short in length and thickness, but its width was bigger than the vertical and the upper frame. The inner side had two holes cut into it for the wooden door jambs and door. The upper frame is longer than the lower frame. Originally, the north-west edge of this frame was already broken before it was installed on the vertical frames. These four frames seem to have been produced and installed together in the original period of construction since, when we reinstalled them, the connection points were also almost fixed in shape.

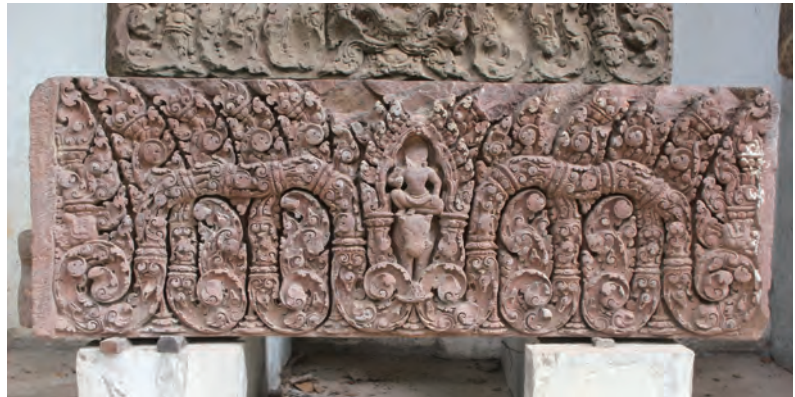
2.3.a. Eastern Lintel (Fig.13)

Fig.13 Eastern lintel

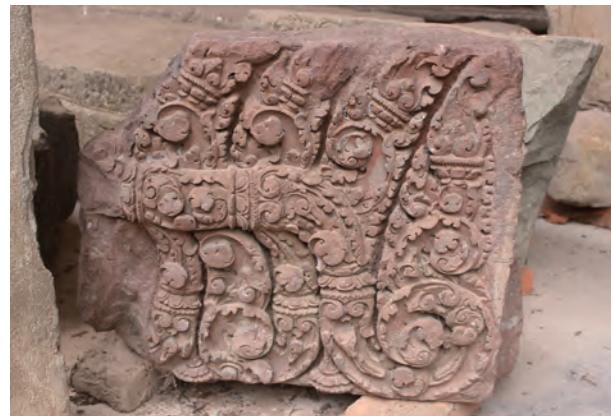
2.3.b. Western Lintel (Fig.14)

Fig.14 Western lintel
