鎌倉の埋蔵文化財 26

令和 3 年度発掘調査の概要

令和 5年 (2023) 3月
鎌倉市教育委員会

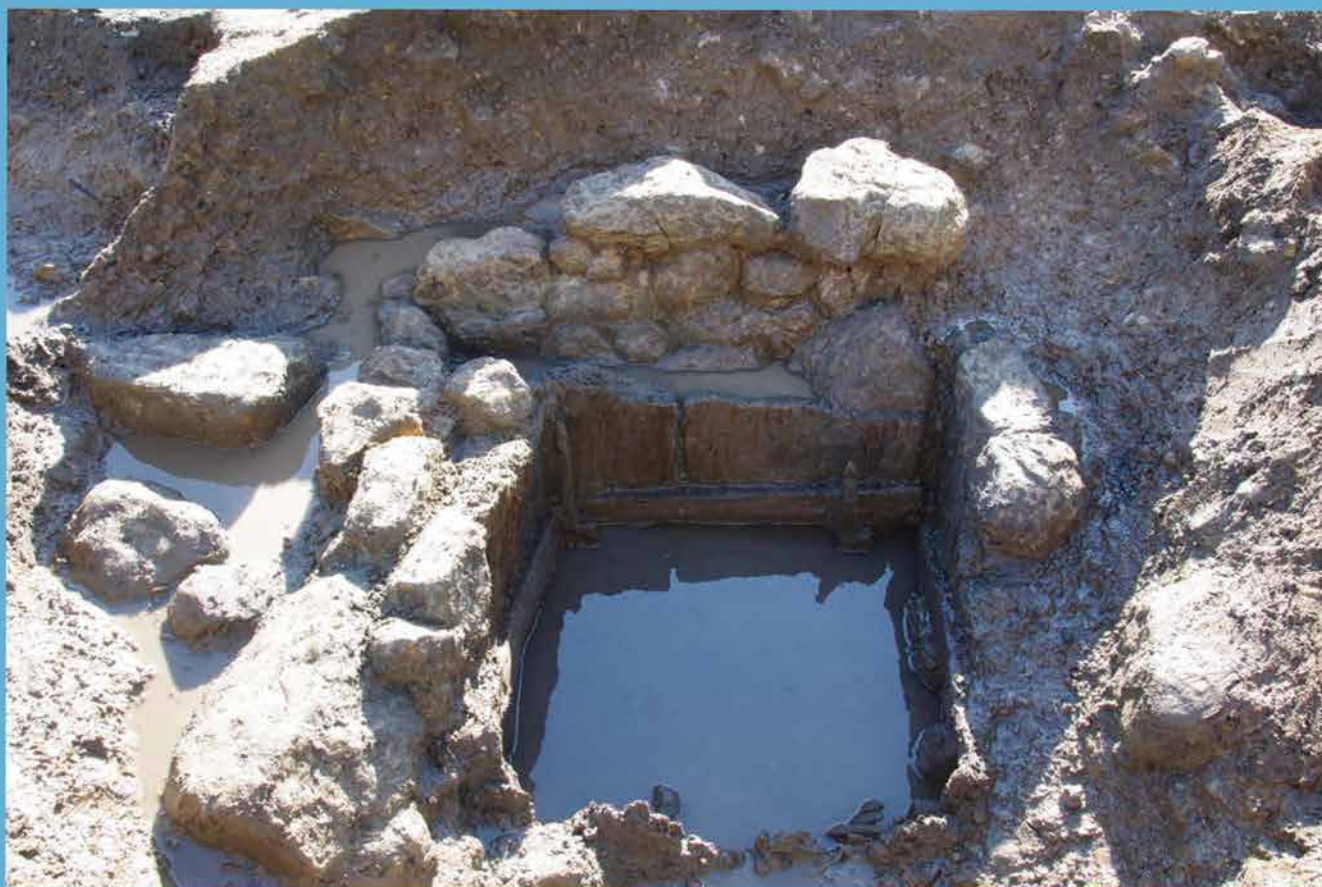
《表紙写真》 武蔵大路周辺遺跡(扇ヶ谷三丁目 444 番地点)で発見された井戸跡。井戸の木枠が状態よく残ります。また井戸枠の裏側には泥岩が充填されていました。竖穴を掘り、木枠を配置しその裏込めに泥岩を充填しており、井戸の作り方がよくわかります。

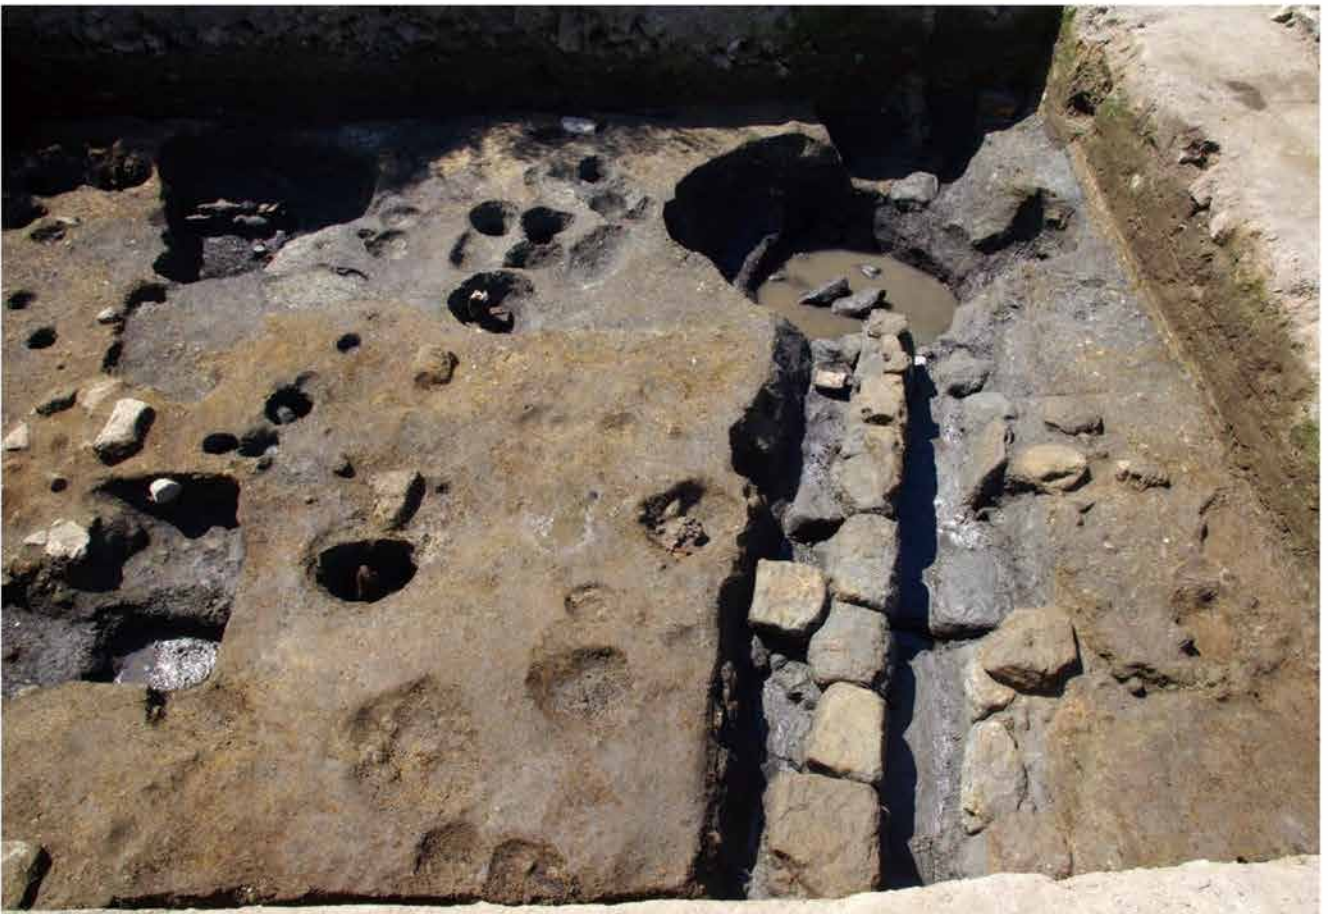
写真3 西側調査区の水積み護岸の溝

(photo 3) Masonry revetment ditch in the west side survey area

史跡亀ヶ谷坂の南側のこの調査地点では、鎌倉時代中頃から室町時代(13世紀中頃～15世紀)の10面にも及ぶ生活面を確認しました。中でも鎌倉時代後半から室町時代に至る生活面から、南北に延びる溝が何度も作り直された状況が発見され、連綿とした土地利用があったことが判明しました。鎌倉時代末から南北朝時代頃には、凝灰岩の切り石を数段積み上げて護岸にした溝が2条平行して作られています。両溝の間は砕いた凝灰岩を突き固めた硬い地面となっており、幅約6～7mの道路であった可能性があります。溝は何度か同じ場所に作り直され、溝が埋められた後には、木枠の上に凝灰岩の切り石を並べた井戸が作られました。この井戸が埋まった後に、再び溝が位置を変えて作られています。

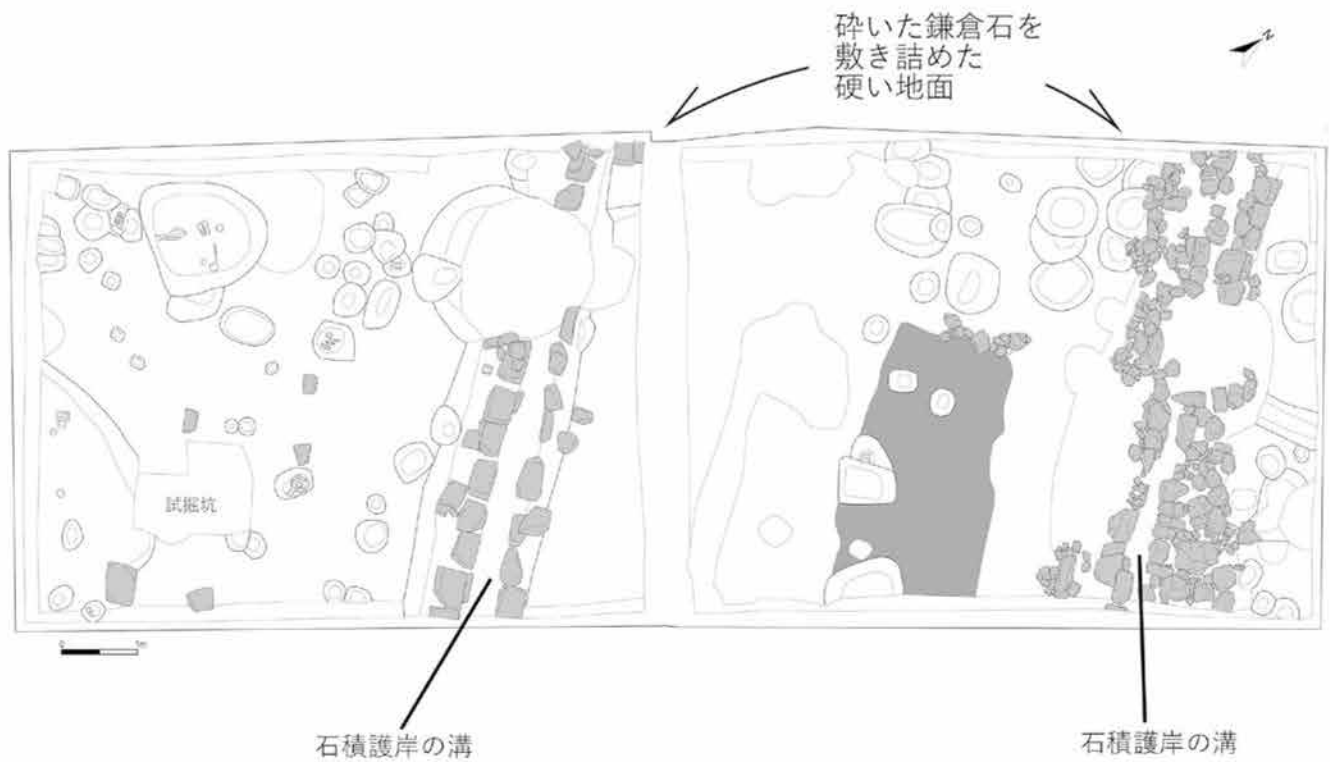
図 1 鎌倉時代の遺構概略図
(fig. 1) Schematic illustration of remains in the Kamakura period

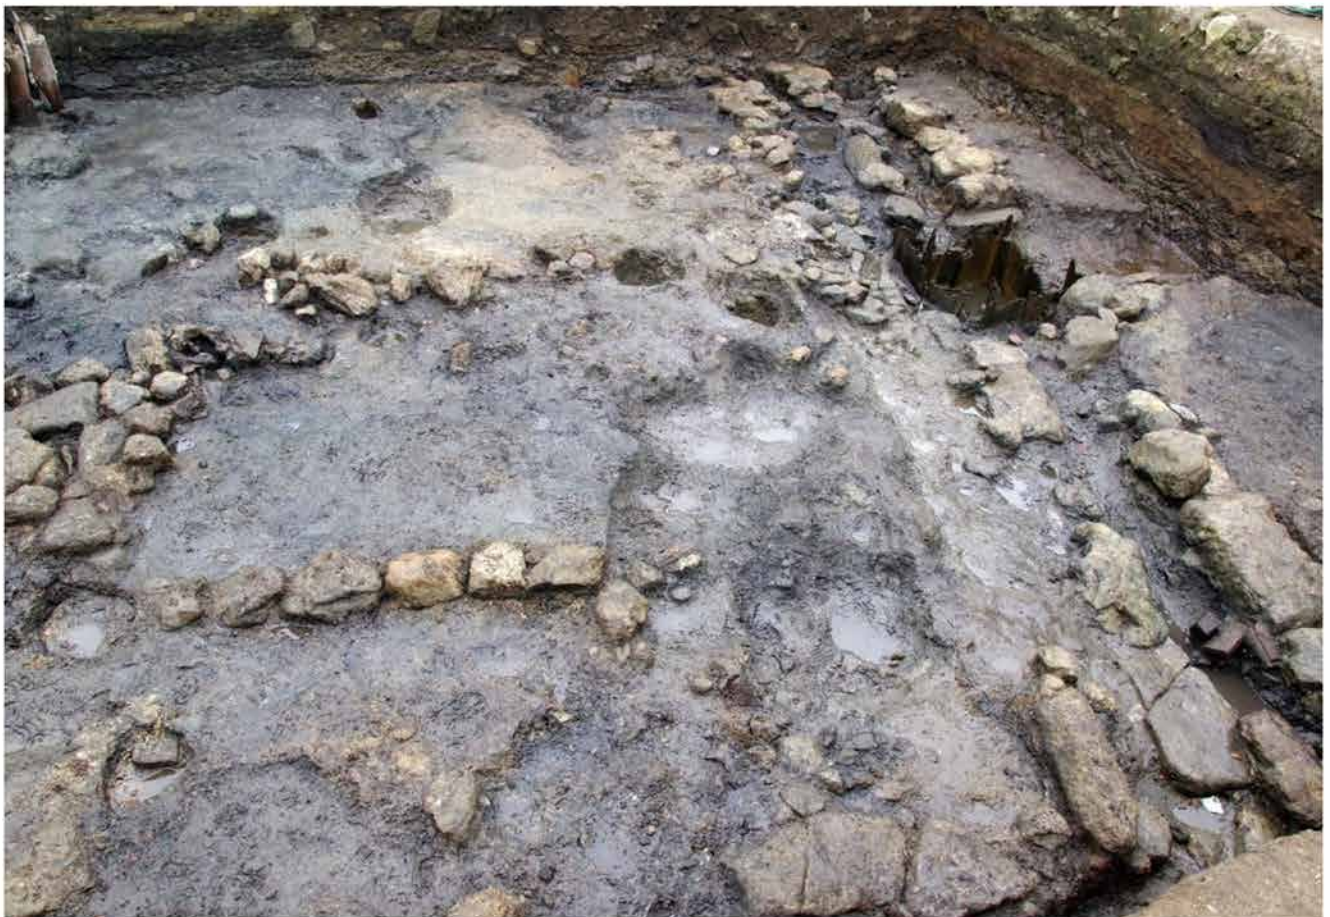
写真 4 東側調査区の石積み護岸の溝
(photo 4) Masonry revetment ditch in the east side survey area

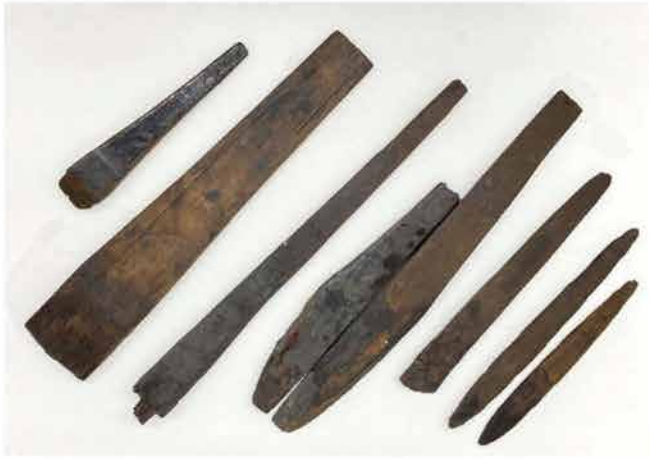
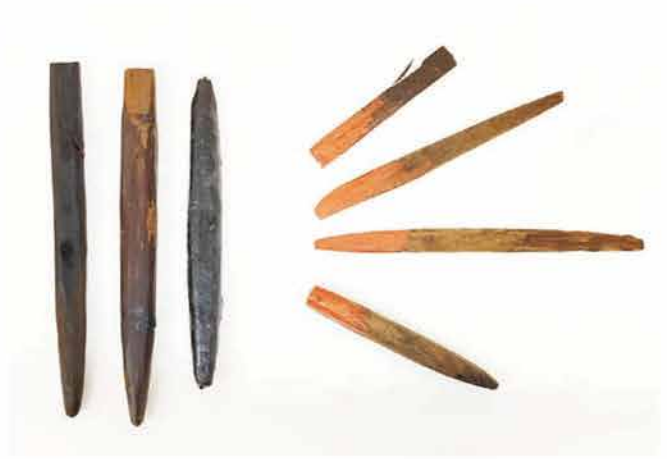
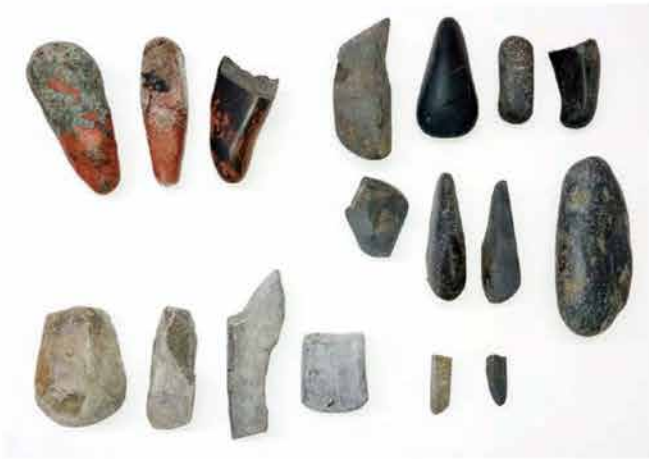
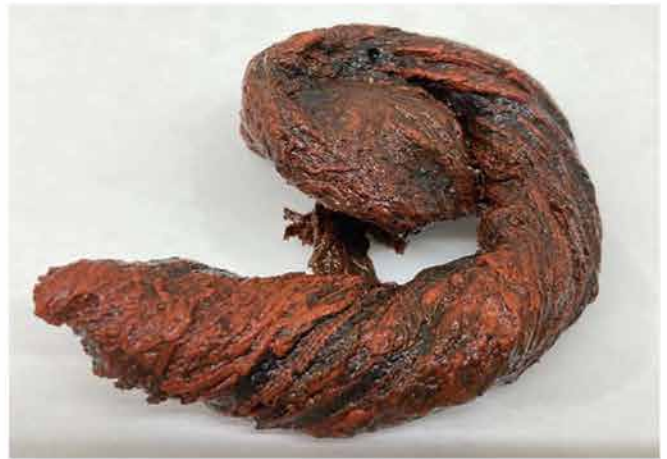
写真6 出土した漆工具

上段の2枚の写真はヘラ。黒漆と朱漆が付着します。形状は様々で練りや塗り等の用途によって使い分けられていたと推測されます。2段目左は長細い玉石に漆が付着しており、これも漆を練るための工具と考えられます。2段目右及び3段目は漆の漉し布で、漆がしみ込んでいたため、硬化し土中に残っていました。このような布の出土事例は極めて珍しいものです。

また、注目すべきは、鎌倉時代後期の地層から漆工芸に使用された工具類がまとまって出土したことです。建物との関係ははっきりしませんでした。付近に漆器制作の場があったことが想定されます。

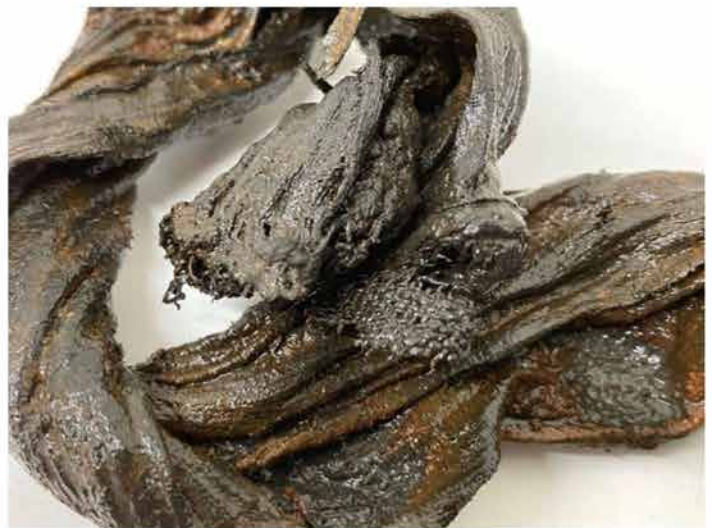
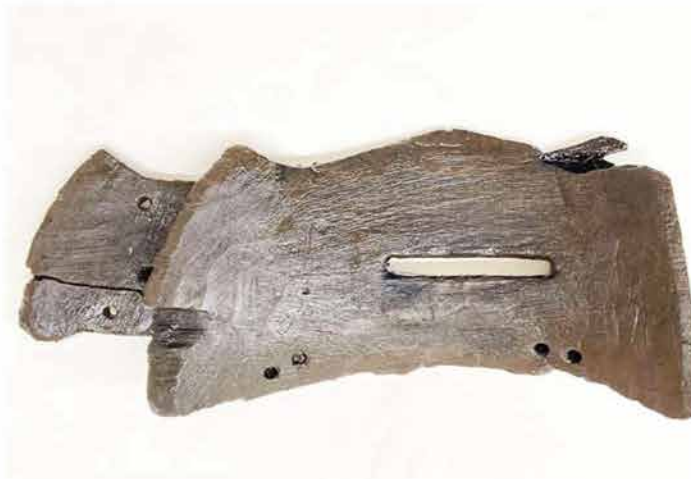
写真7 出土した鞍の一部

左の写真は木製の鞍の部材で、騎乗者がまたがる居木という部分です。左側が前方（馬の頭の方向）で前輪が、右側（後方）には後輪が取りつき、鞍となります。居木の細長い溝には、力革が垂れ下がり、その先に鐙が取りつきます。漆などは塗られていないため、白木の鞍と考えられます。ただし、本地点からは漆工具が多量に出土しているため、これから漆を塗られるものだったのかもしれませんが。

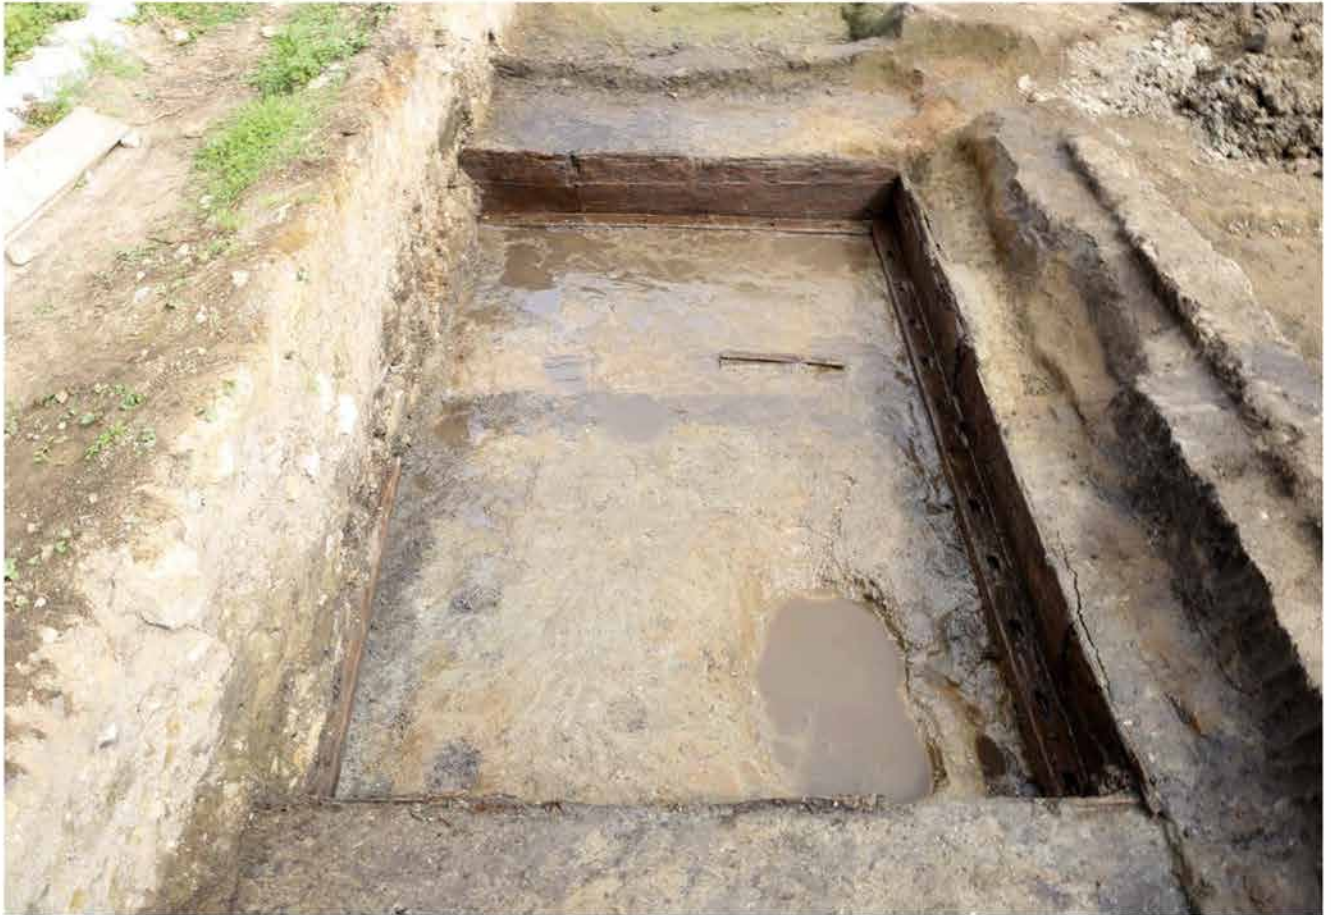
写真 9 土台角材や壁板の残る半地下式倉庫
(photo 9) Half-underground warehouse where foundation square timbers and wall panels remain

中世の半地下式の倉庫は堅穴建物とよばれる建物形式で、地面を深さ1mから2m程度を掘りくぼめ、その底面から建物を組み上げます。地上部分は未詳な部分がありますが、地表からみると、建物は半分地中に埋まった半地下式の建物であったと推定されています。本調査では、堅穴建物が何度も同じ場所で作り替えられており、木組み構造の堅穴建物が、大型のものに建て替えられ、さらに底に凝灰岩の切り石を敷き詰めたものに変遷することが分かりました。時代を経るにつれ建物が、より強固に、大きくなっていったと推定されます。

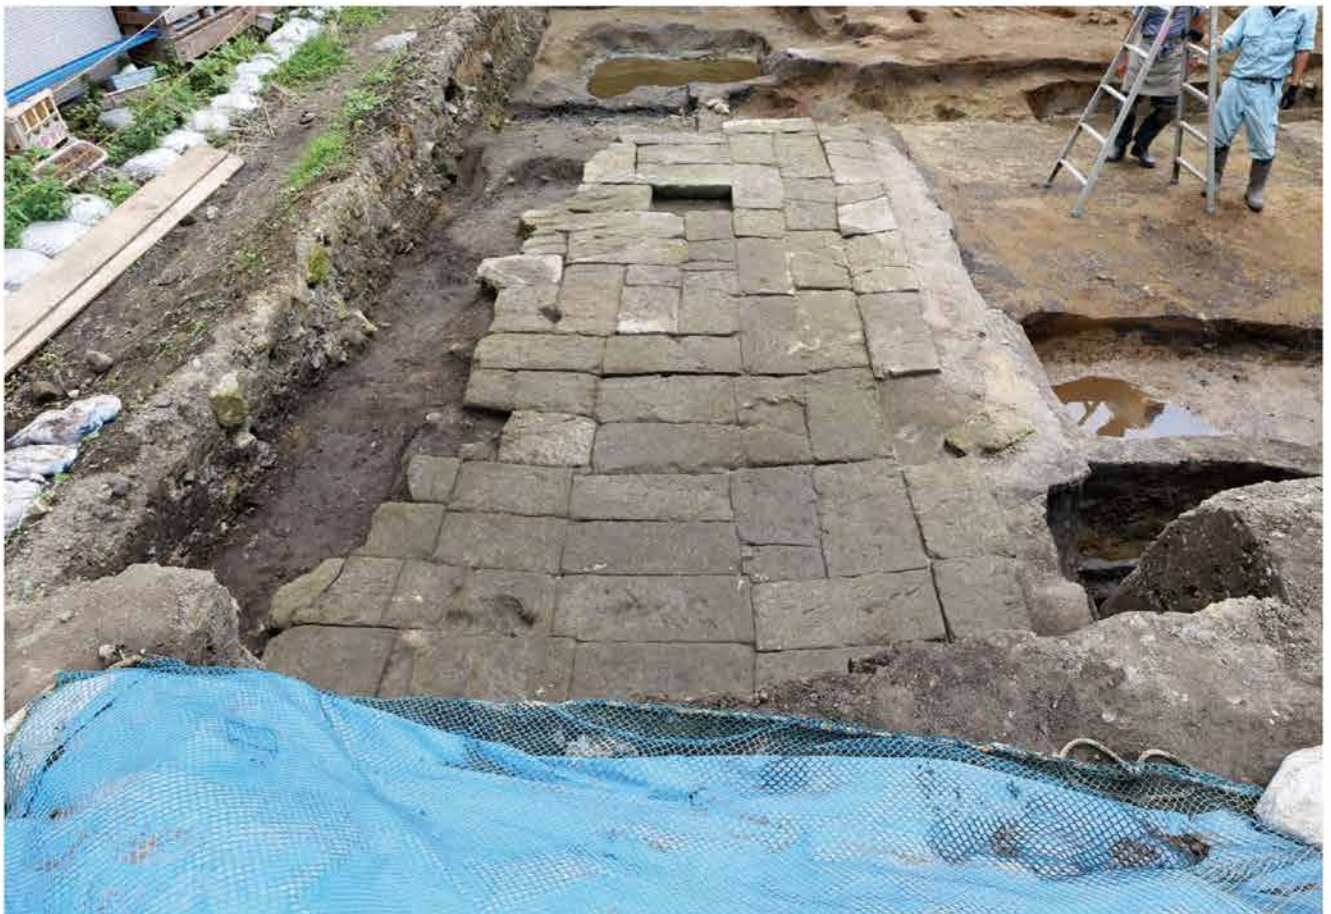
写真 10 底面に石材が敷かれた半地下式倉庫 上の写真の倉庫が埋められて造られていた
(photo 10) Half-underground warehouse with stone laid on the bottom
