鎌倉河程武文化財9

Buried Cultural Properties in Kamakura 9 平成15~17年度発掘調査の概要

1. 北条義時法華堂跡 Hojo Yoshitoki Hokedo site

鎌倉幕府第2代執権の法華堂跡(墳墓堂)

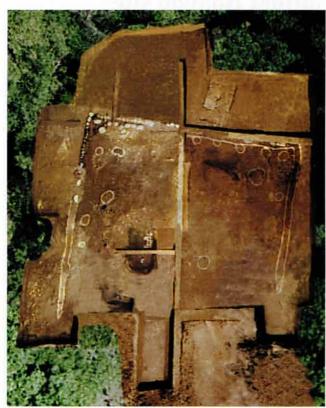
北条義時法華堂跡発掘調査区全景 Aerial view of Hojo Yoshitoki's Hokedo site excavated

北条義時法華堂跡は鶴岡八幡宮の東方、国指定史跡「法華堂跡(源頼朝墓)」東隣りの山の中腹に所在します。この場所は平成17年度に実施した発掘調査によって、基壇上に建つ礎石建物跡が発見されました。縁の礎石の一部と雨落ち溝の石列があり、残っていた縁の礎石と建物本体の礎石の抜き跡から、一辺が8.4mの正方形で、屋根の軒の出が12.4mの規模の三間堂と推定できました。また、出土遺物の年代から推して、建物の廃絶時期は13世紀末から14世紀初頭頃と思われます。

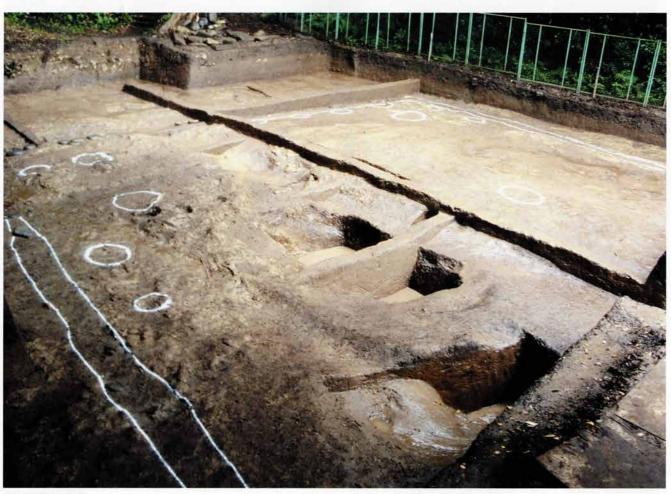
発掘調査区近景 View of the excavated site

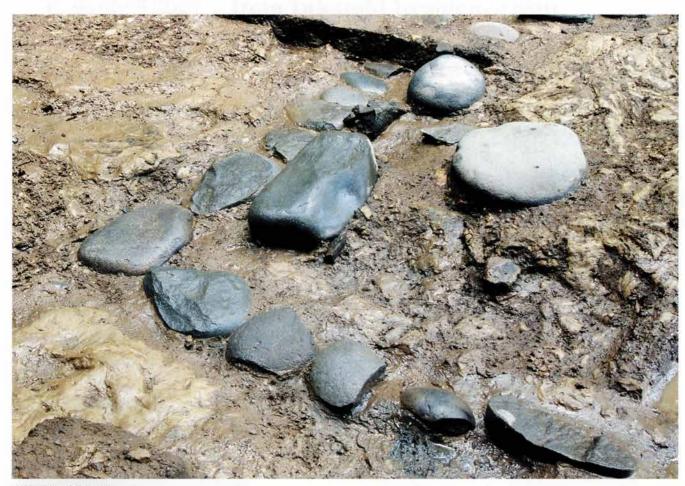
雨落ち溝(北西角) Rain gutter ditches (north-west corner)

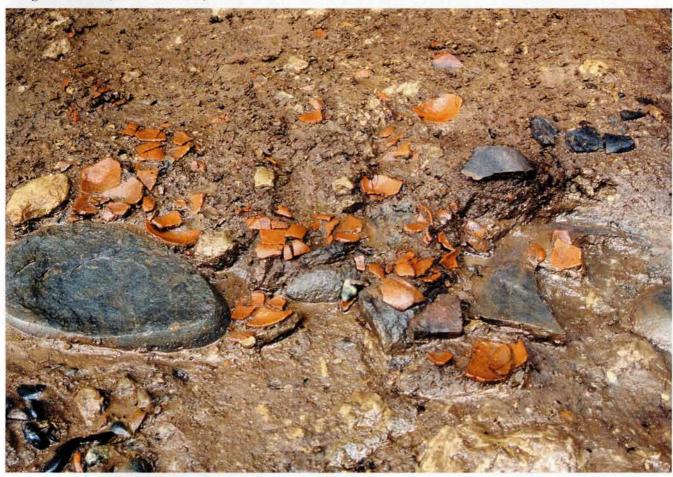
かわらけ出土状態(北西角) Kawarake earthenware unearthed (northwest corner)

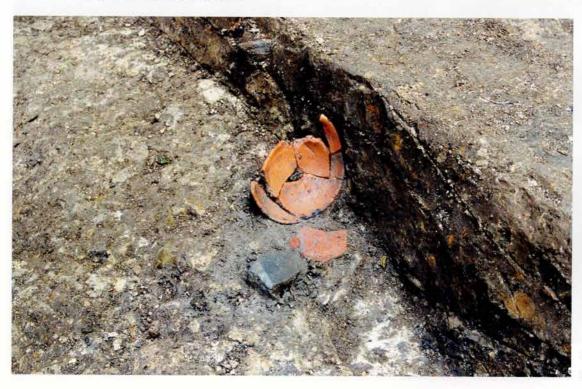
かわらけ出土状態 (西側) Kawarake earthenware unearthed

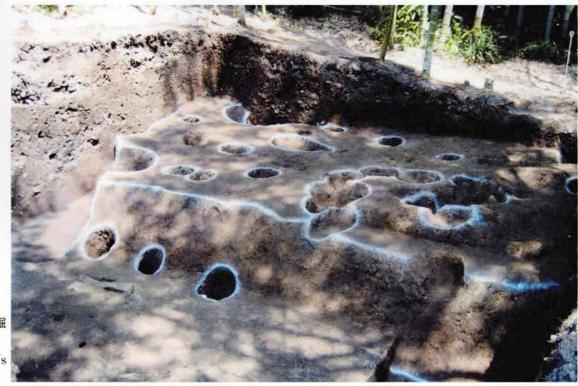
北条高時邸跡発掘 調査区全景 View of Hojo Takatoki's residence site

北条高時邸跡は鶴岡八幡宮の東南、宝戒寺とその周辺地域といわれています。調査地は同寺境内の南東奥で、ここでは平成 16 年度に実施した発掘調査によって、13 世紀~14 世紀中頃の遺構が発見されました。幅が 4 m以上になると思われる大規模な溝が調査区南半分の東西に伸び、溝の西壁と調査区北側には柱穴などが見られます。また、この調査区からは'かわらけ'のほか、中国製磁器などが出土しました。

今回の調査では、大きな溝のほか、建物の存在を確認しました。溝については、その規模が大きいこ

とから敷地を画するためのものと考えられ、北条高時 の屋敷の範囲を考える上で貴重な発見といえましょう。

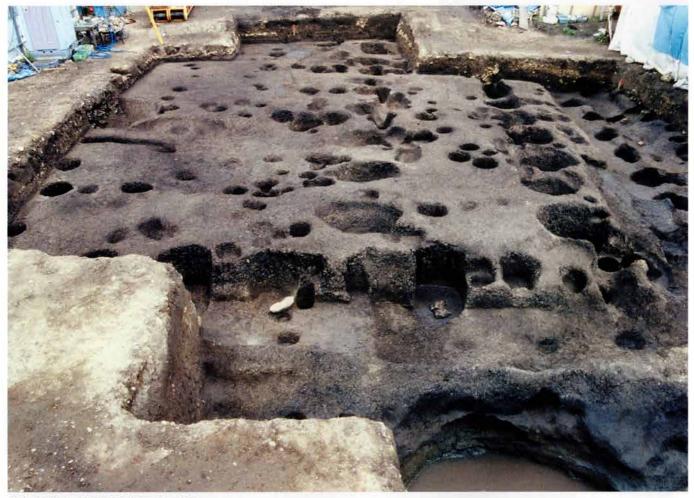
若宮大路周辺遺跡群発掘調査区全景 View of sites surrounding Wakamiya-Oji

平成 15・16 年度に実施した発掘調査の結果、ここからは 13 世紀前半から後半にかけて 4 つの遺構面が見つかりました。とくに第 2 面で発見された南北方向の柱穴は直径が 60 cm程の大きなもので、大規模な掘立柱建物跡であることが想像されます。また、青磁や白磁などの中国製磁器のほかに、国産陶器や漆器等も出土し、屋敷地であった可能性もあります。

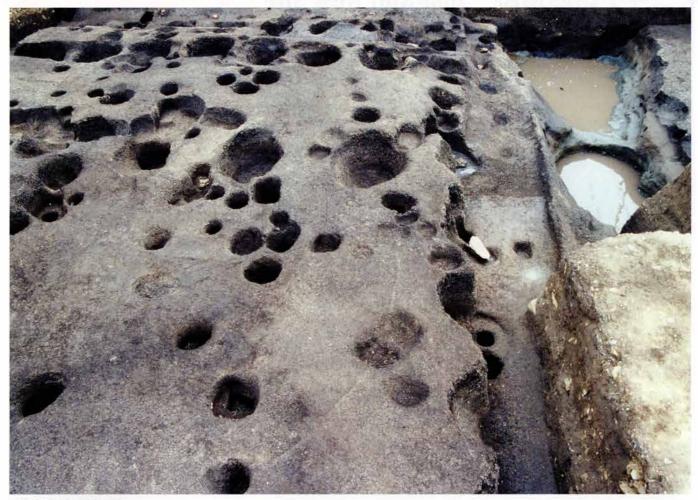
溝と柱穴等(第3面) Ditches and postholes (3rd layer)

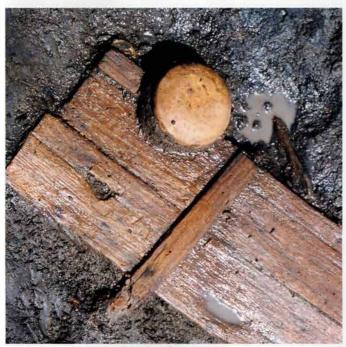
溝の護岸材及びかわらけ出土状態(第2面) Wooden packing materials for the ditch and kawarake earthenware *in situ* (2nd layer)

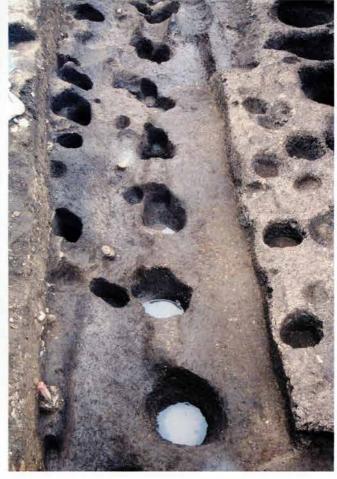
柱穴(第2面) Postholes (2nd layer)

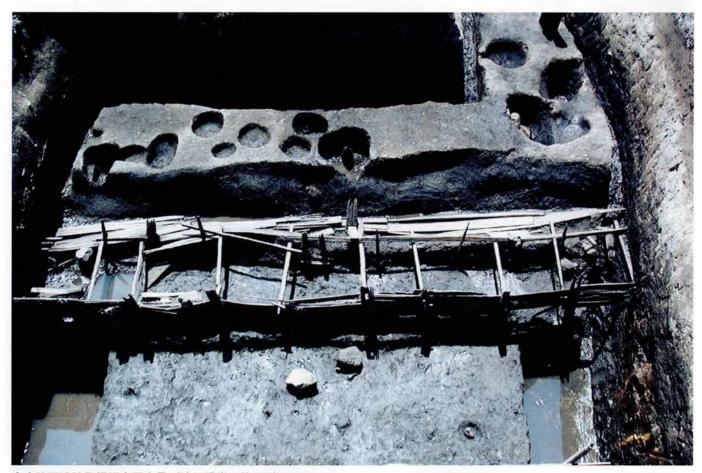
今小路西遺跡発掘調査区全景(池と護岸・第3面) View of Imakoji West site (Pond and packing materials of the pond)

とくに中世の第2面からは多くの中国製磁器の破片が、第3面からは大きな池がそれぞれ確認され、武家屋敷の一角であったことが推定されます。このほか、池からは舟形や独東・草履などの木製品とともに、木製傀儡人形の 'カシラ'が出土したことから、中世鎌倉で操り人形を用いた多様な雑芸を営む人びとがいたことがわかり、注目されます。また、調査区最下面の奈良・平安時代の遺構では、複数の溝や穴があり、「瓦が出土しました。詳しいことはわかりませんが、ここから150m程離れた御成小学校敷地内では奈良・平安時代の鎌倉郡役所の跡が見つかっているため、それにかかわる施設があったことが推測できます。

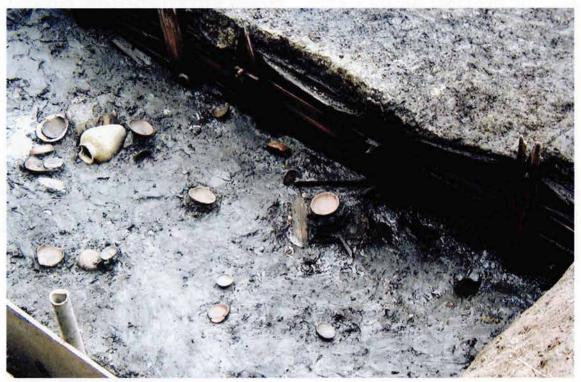
遺物出土状態(池・第3面) View of the artifacts *in situ* (pond: 3rd layer)

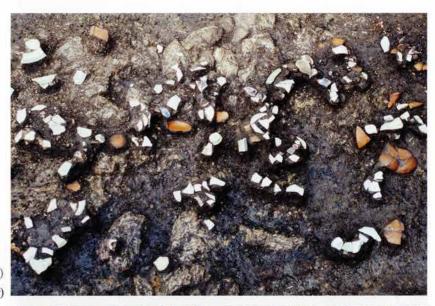
磁器等出土状態(第2面) View of the porcelain *in situ* (2nd layer)

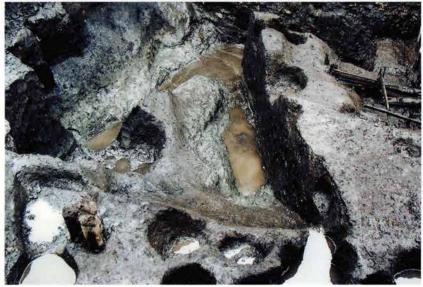
中世以前の遺構 Archaeological layer dating before the medieval period

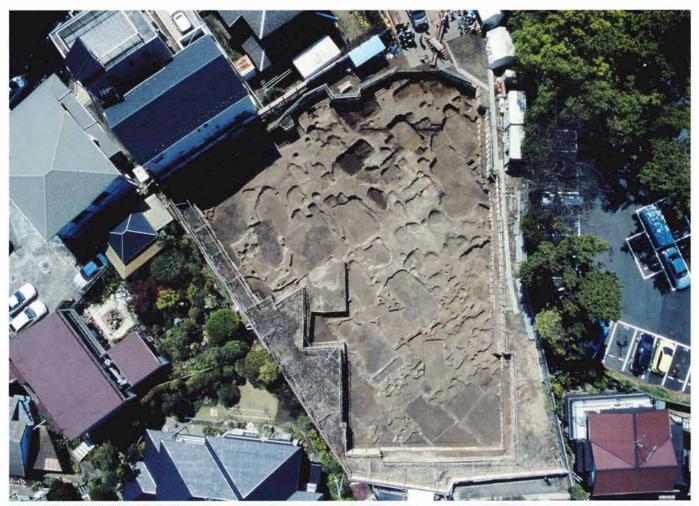
長谷小路周辺遺跡発掘調査区全景 Aerial view of sites surrounding Hase-Koji

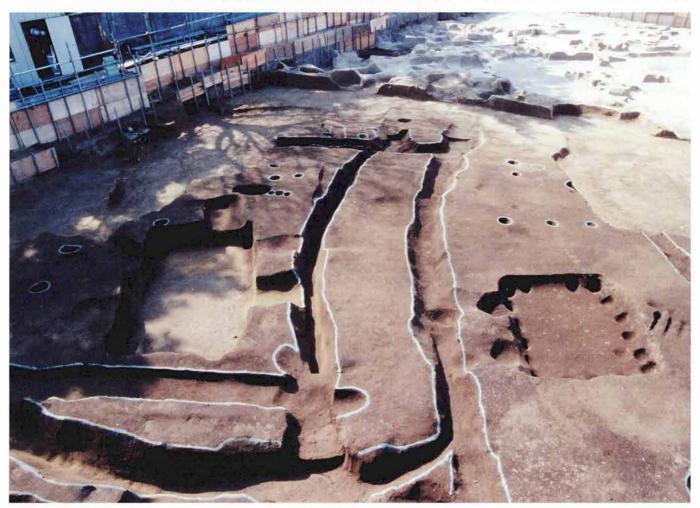
溝と方形竪穴建築址(第2面) Ditch and sunken featured square pit building site (2nd layer)

12世紀末から13世紀初頭とされる第1面は溝によって区画され、13世紀前半から14世紀前半とされる第2面からは方形竪穴建築址と呼ばれる半地下式の建物跡や穴などが切り合った状態で見つかっています。また、出土遺物の中に獣骨が見られますが、このうちイヌはほぼ完全な状態で出土した反面、ウマやウシなどは部分的で、中には解体する際に生じたと思われる痕跡や、加工の痕が見られました。さらに、サイコロや笄・装飾品などの骨製品、釘や刀子等の金属製品、鞴の羽口なども出土しており、この場所が鎌倉の中で生産の場であったことが想像されます。

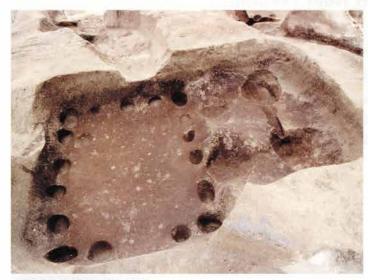
方形竪穴建築址(第 1 面) Sunken-featured square pit building (1st layer)
