鎌倉の埋蔵文化財10

平成17年度発掘調査の概要

平成19年3月
鎌倉市教育委員会

1 わかみやおおじしゅうへんいせきぐん 若宮大路 周辺 遺跡群 (小町一丁目276番18ほか地点)

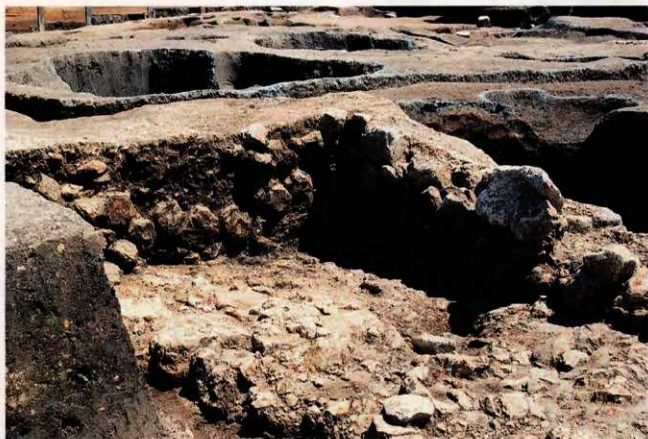
方形竪穴建築址 5

The sunken square pit dwelling remain No. 5

若宮大路周辺遺跡群は、若宮大路を中心として東は滑川、西は今小路までひろがる都市遺跡です。調査地は、若宮大路と横須賀線が交差するガードの東側、扇川の左岸脇に所在します。ここでは平成17年度に実施した発掘調査によって、13世紀初頭から14世紀にかけての遺構が発見されました。方形竪穴建築址は鎌倉で度々発見されますが、今回発見された方形竪穴建築址5と名付けられた遺構は、地下部分の壁に土丹をきれいに積み重ね、床面にも土丹を敷き詰めたものであり、これまで類例はありません。このほか、本調査地点では土丹を敷き詰めた方形竪穴建築址が発見されています。また、調査地点は、東西が溝で区画されています。土丹を使った方形竪穴建築址が溝の西側に集中していることも、当時の土地利用を考えるうえで大きな特色といえましょう。このほかに、井戸や土坑などが発見され、韓半島からもたらされた高級な磁器や国産の陶磁器、「かわらけ」、漆器、鑄造に使ったと考えられる鋳型などが出土しました。

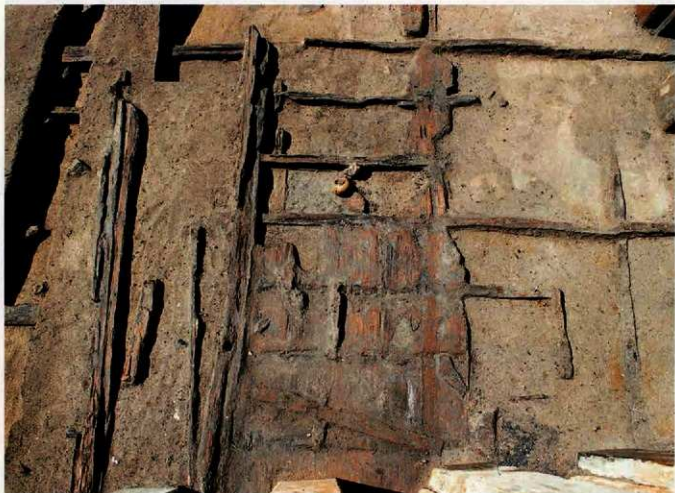
方形竪穴建築址

A sunken square pit dwelling remain

2～4ページでご紹介した調査地点と同じ若宮大路周辺遺跡群の範囲内ですが、この発掘調査地点は今小路をはさんで御成小学校の向かい側になります。この場所は、平成17年度に実施した発掘調査によって、68棟もの方形竪穴建築址が発見されました。これら建物は、出土した遺物からみると13世紀後半以降に建てられたと考えられ、このことから、今回の調査地点付近は13世紀後半になってから急速に土地利用が進んだことがわかりました。以降、15世紀にいたるまでの遺構・遺物が見つかりました。

本地点の周辺は、縄文時代頃から形成されたと考えられている砂丘の上に立地しています。砂丘の上に数多く建てられた方形竪穴建築址からすると、調査地点一帯は、中世の商人たちが物流の拠点としていたと考えられます。このほかにも、井戸が6基、地面に穴を掘って遺体を埋めた土墳墓と呼ばれるお墓が2基など、さまざまな遺構が発見されました。

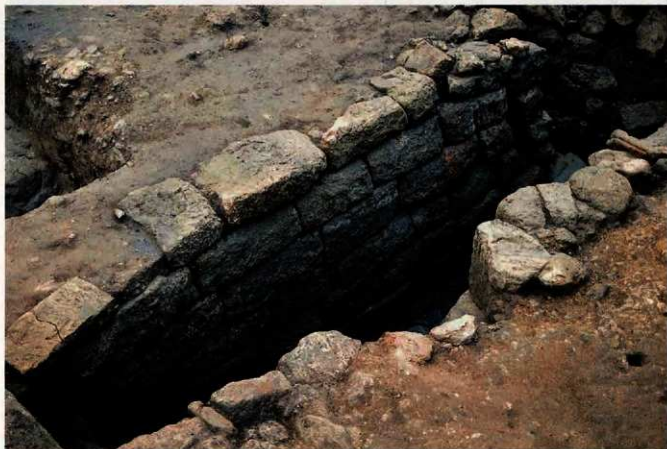
溝石積み

A gutter of piled stones

発掘調査の結果、^{かまくらいし} 鎌倉石の^{きりいし} 切石を使用した溝が発見されました。溝の西側は丁寧に切り出した切石を^{せいぜん} 整然と積み重ねていますが、東側はやや雑な積み方になっています。その理由として、溝の東側に道路と考えられる土丹を敷き詰めた跡が見つっているため、西側の石積みは道路から立派に見せるための視覚的効果をねらったことが想像されます。逆に東側は、人目につかないことから雑な積み方にしたのかもしれない。

A ditch that used Kamakura stones was discovered. Though carefully quarried stones were laid neatly on the western side of the ditch, stones were somewhat laid in a disorderly manner on the eastern side of it. As a reason for this, it is assumed that there might be a road paved with dotans on the eastern side of the ditch, and the western side of the piled stone wall was built carefully to give a good visual effects, in order to show it magnificently from the road. On the contrary, it seems that the wall of the eastern side was laid with less care as it was not observable from the roadside.

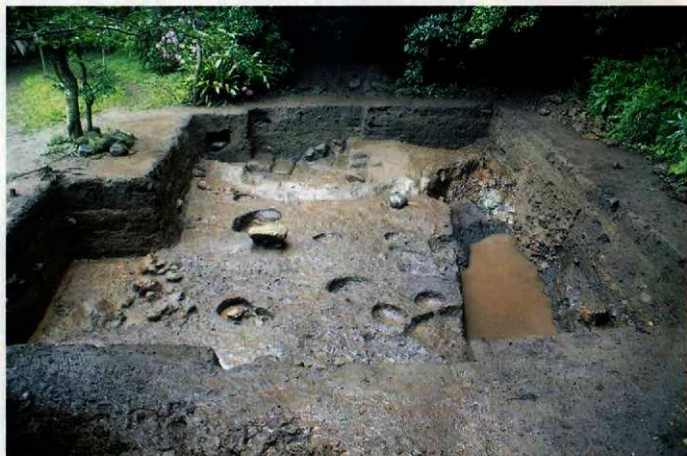
宝蓮寺跡発掘調査区全景

Full view of the excavated area in the site of Hourenji Temple

遺構としては、鎌倉石を使用し、13世紀中頃に営まれたと考えられる礎石建物^{きそいしたてもの}が発見されました。重量のある立派な建物があつたのでしょうか、中世で礎石建物⁽²⁾というとき寺院建築^{じいんけんちく}が考えられますので、調査地点周辺の谷戸の土地利用に寺院が関わっていたことが想像されます。ただ、その寺院を宝蓮寺と断定することはできません。このほか、調査区北側では石切場の跡が見つかっており、谷戸が切り拓かれていく様子がうかがえます。13世紀の終わりになると礎石建物はなくなり、南北方向に土塁状^{どるいじょう}の遺構⁽³⁾がつくられます。土塁状遺構の側面は、両方とも基礎部分に大型の土丹が並べられ、その内側は土丹と土をつき固めながら盛土しています。遺物としては、「かわらけ」、陶磁器^{とうしき}、石製品^{せきせいひん}、鉄製品^{てつせいひん}、銭^{ぜに}などが出土しました。
