鎌倉大仏周辺の発掘調査

～大仏造営手法と大仏殿の推定～

◎本誌には平成12年度と13年度に実施した「鎌倉大仏」周辺の発掘調査報告書の概要を掲載しました。

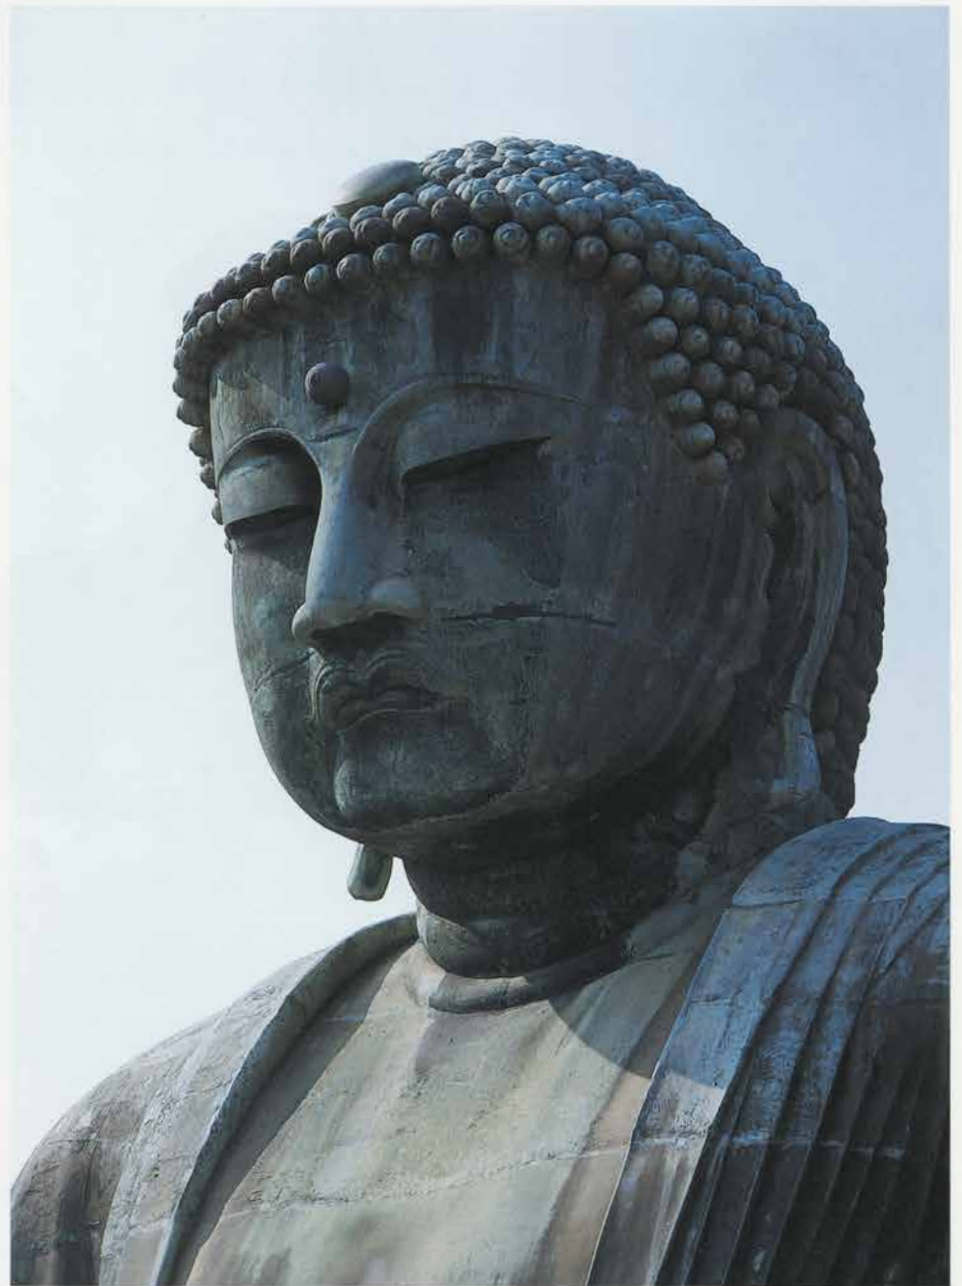
鎌倉大仏 The great statue of Buddha in Kamakura.

鎌倉大仏は正式には国宝銅造阿彌陀如来坐像といい、像高11.39m、重量約122 t、奈良東大寺の大仏（像高14.85m）に次いで、現存する坐像としてはわが国2番目の巨大なみほとけです。

東大寺の大仏は江戸時代に鑄直されたものですが、鎌倉の大仏は修理が加えられているものの、鎌倉時代に鑄造された中世の姿をそのまま残しています。

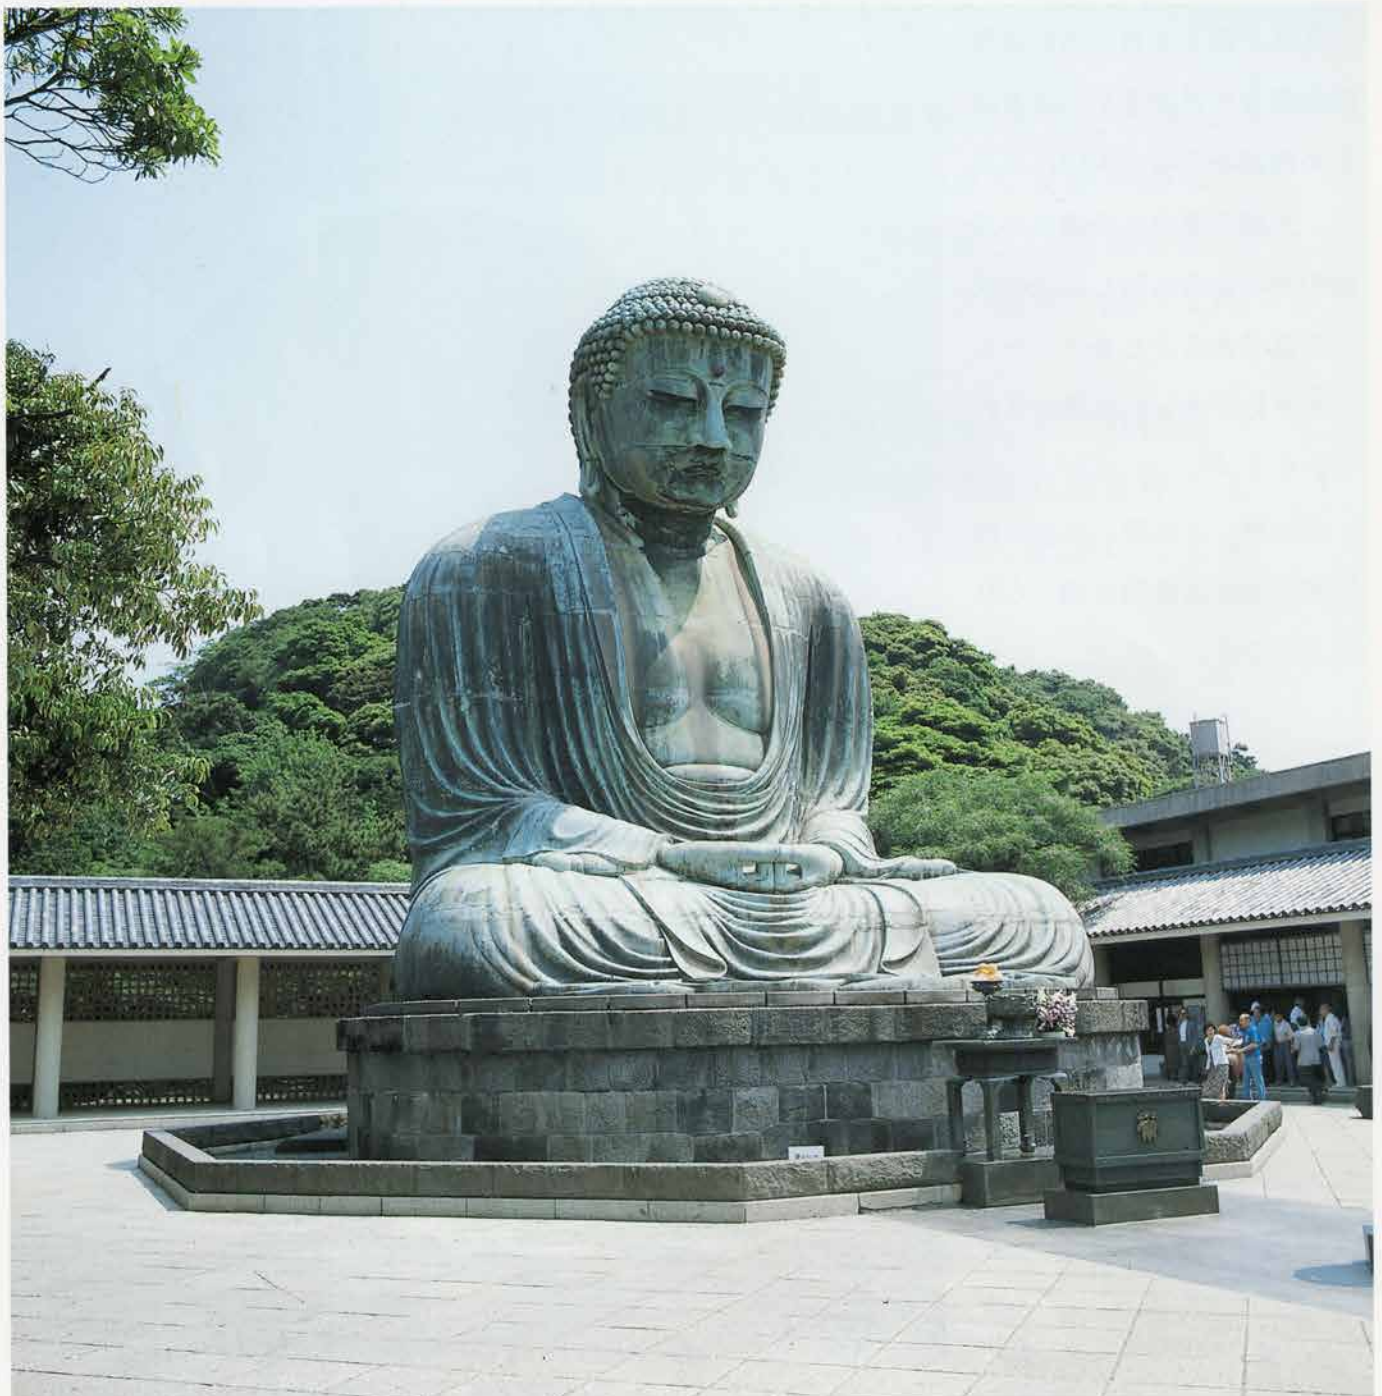
鎌倉大仏 The great statue of Buddha in Kamakura.

まず像の姿をみると、衣で両肩をおおう通肩^{つうげん}とし、腹の前で定印^{じやういん}を結んで結跏趺坐^{けつがふざ}しています。

作風については、肩幅が広く厚みのある体部と深く力強い衣文に、仏師運慶・快慶の流れをくむ慶派の作風が感じられます。一方で猫背気味の姿勢、体部に比べ大きな頭部などに、前の時代にみられない特色があります。これは中国・宋代の作品である横須賀・清雲寺観音菩薩坐像、京都・泉涌寺観音菩薩坐像などに通じる作風で、大仏もこうした中国の新しい様式の影響を受けたと考えられます。

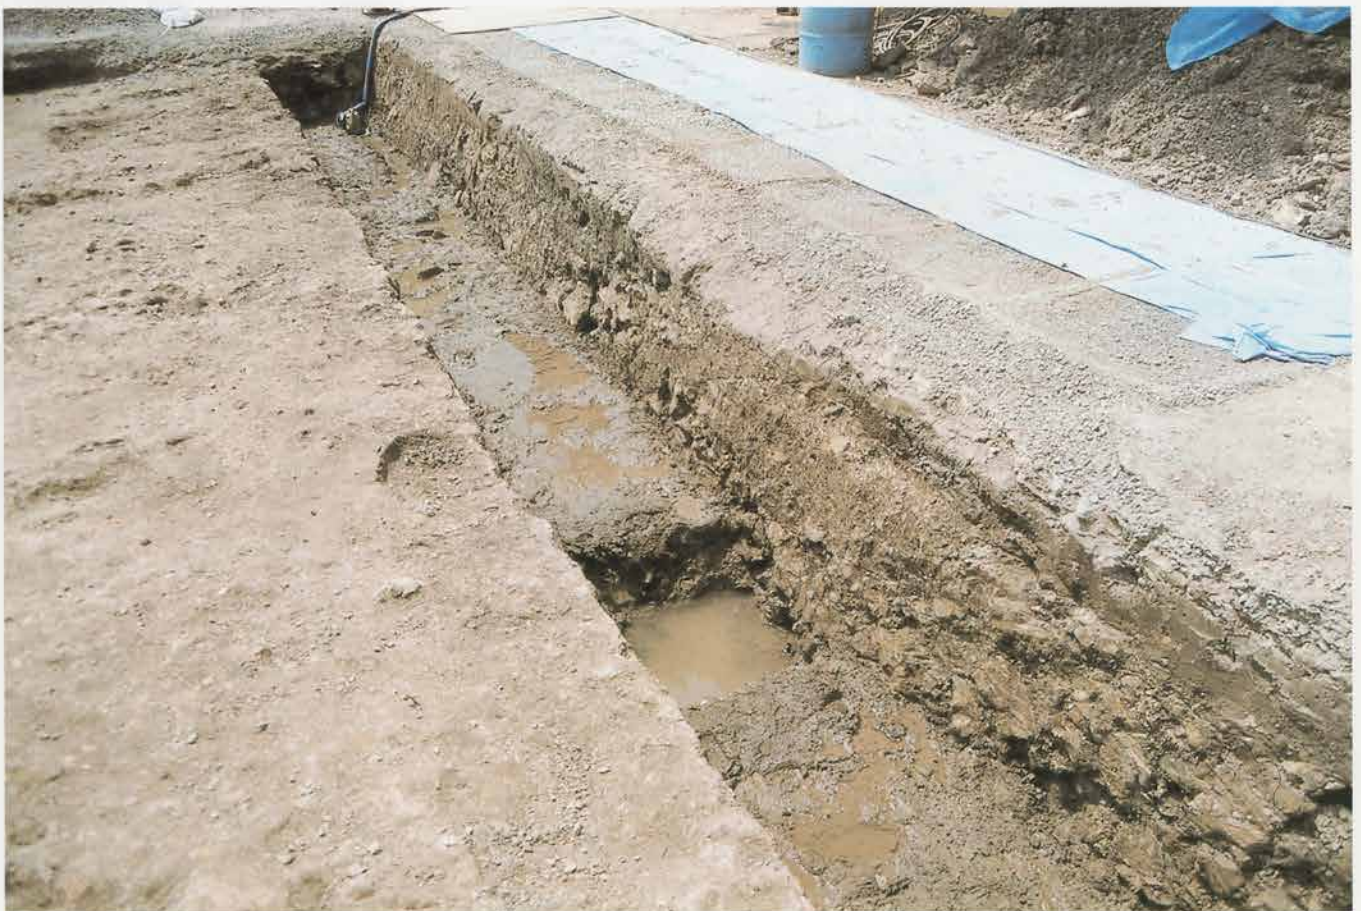
12年度1区 斜面堆積 2000 years No.1 district oblique accumulation.

これら水平に整えられた地面の上部には、調査区1区から5区まで像に向かって高くなるように斜めに堆積する土層が確認されました。

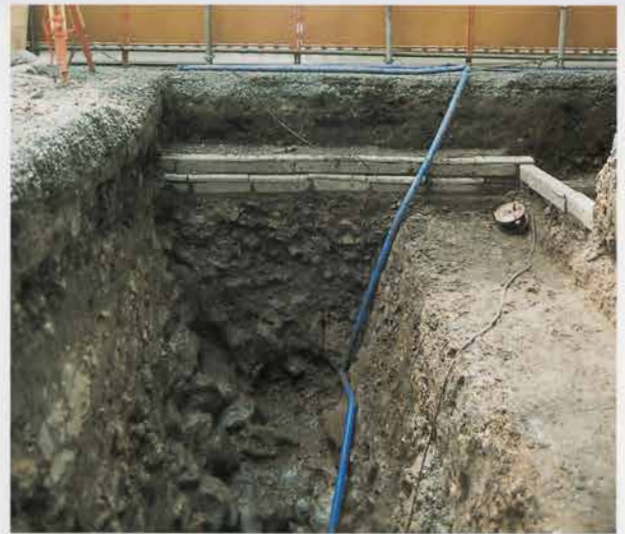
12年度 4 区の発掘調査
2000 years No,4 district excavation investigation.

まず、像側面、現在の廻廊^{まわらう}の西外側に設定した調査区の3区の西隅では、現地表下約3m、標高11.3mのところまで平らに削られた岩盤を確認しました。像背面、廻廊北外側で調査した4区では海拔11mで水平に削られた地山^{じやま}が、また、像南側の参道石畳^{さんどういしだたみ}の西側に設定した1区などでは、ほぼ同じ高さに土や土丹^{どたん}を固めて構築した面がみつかりました。この事から大仏の周辺は大仏鑄造に先立ち、標高11.3mで整地作業が行われていたことがわかりました。

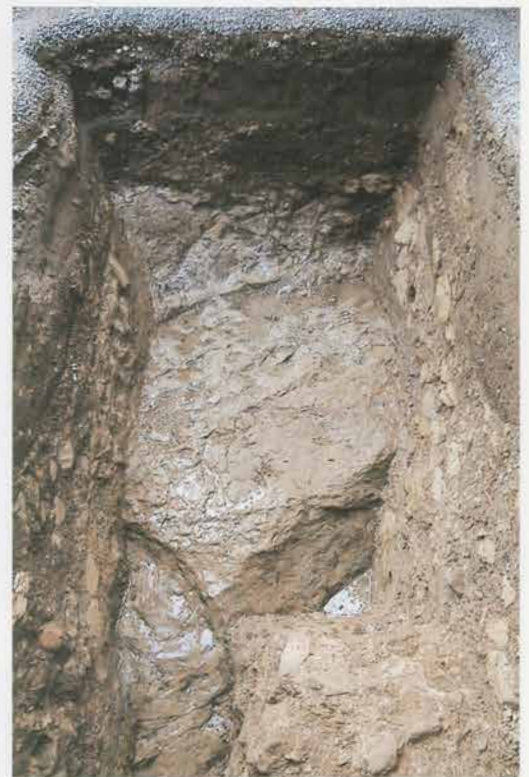
12年度 3 区 岩盤面
2000 years No,3 district rock shave side.

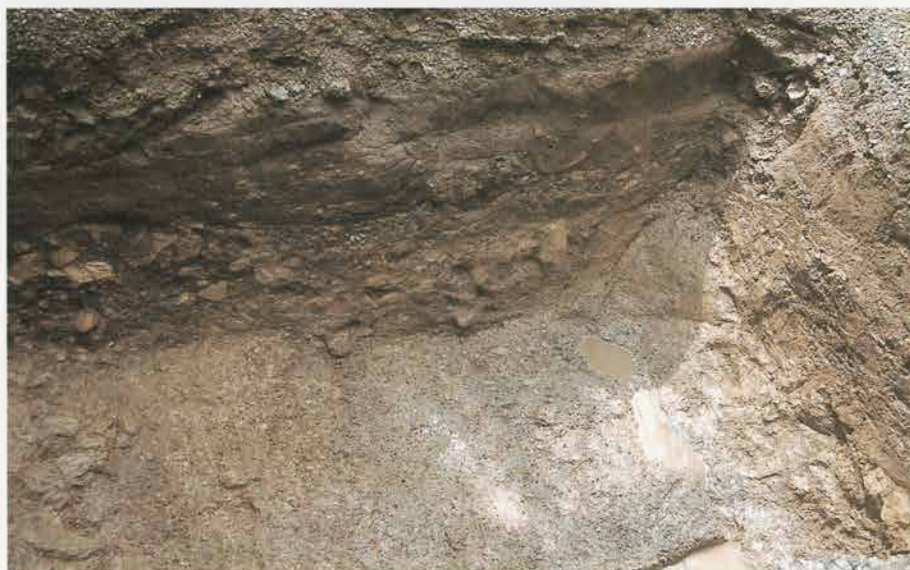
12年度 3区 かわらけ溜り断面

The section of 2000 years No.3 district unglazed eathenware concentration points.

なお、3区からは14世紀前半代のかわらけが多量に出土し、斜めに堆積する土層からは溶けた銅片やふいごの羽口^{はねぐち}、銅を溶かすための炉の破片など、鑄造にかかわる多くの資料が埋まっていました。

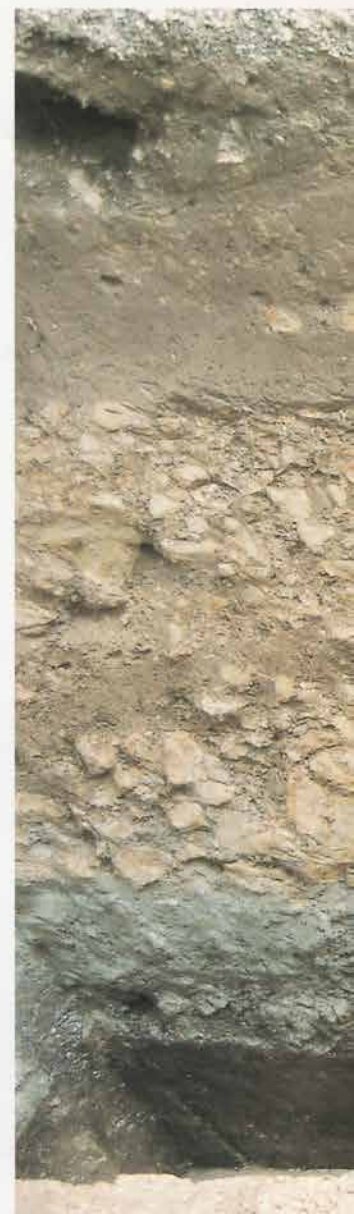
大仏周辺根固め遺構模式図 Ceremony figure of the base mark around of the Buddha great statue.

発掘された大仏殿の遺構は直径約3 m、深さ約2 mの穴の中を砂利と土丹を交互につき固めたもので、礎石の下を固めた「根固め」と考えられています。こうした「根固め」遺構は平成12・13年度の発掘調査で10箇所みつかっており、これから復元される大仏殿の規模は東西145尺（約44 m）、南北140尺（約42.5 m）です。

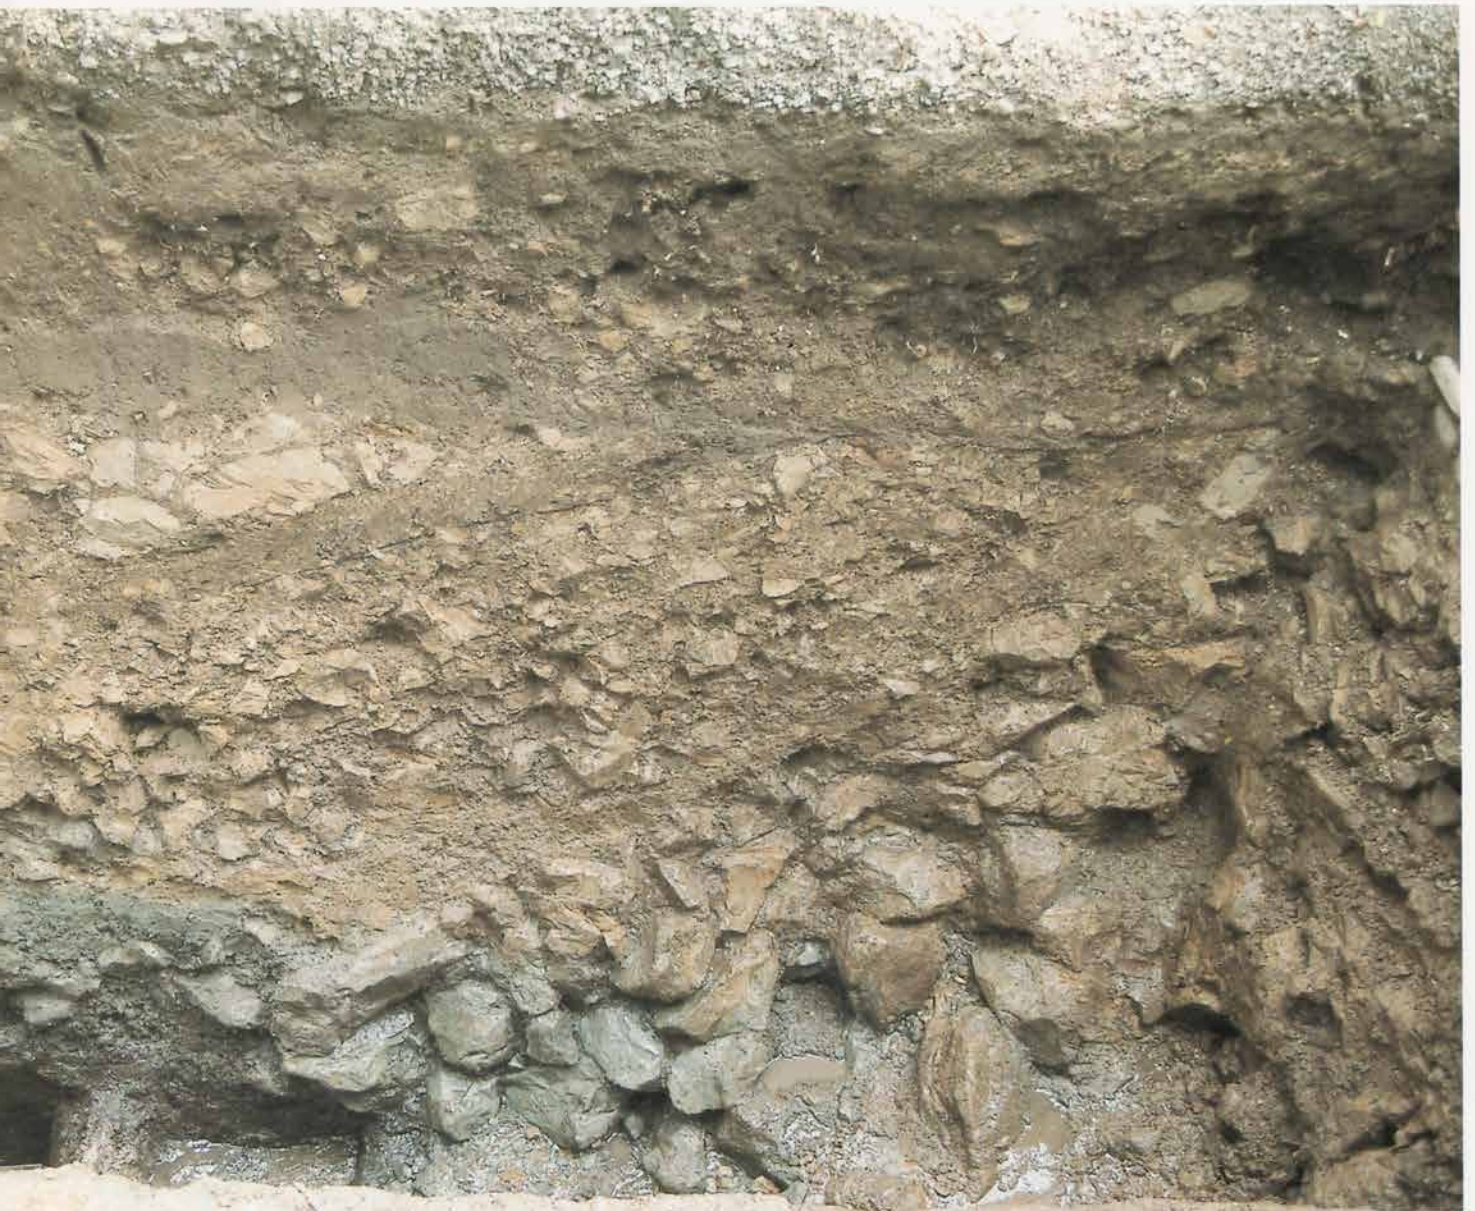
12年度 4区 斜面堆積 2000 years No.4 district oblique accumulation soil layers.

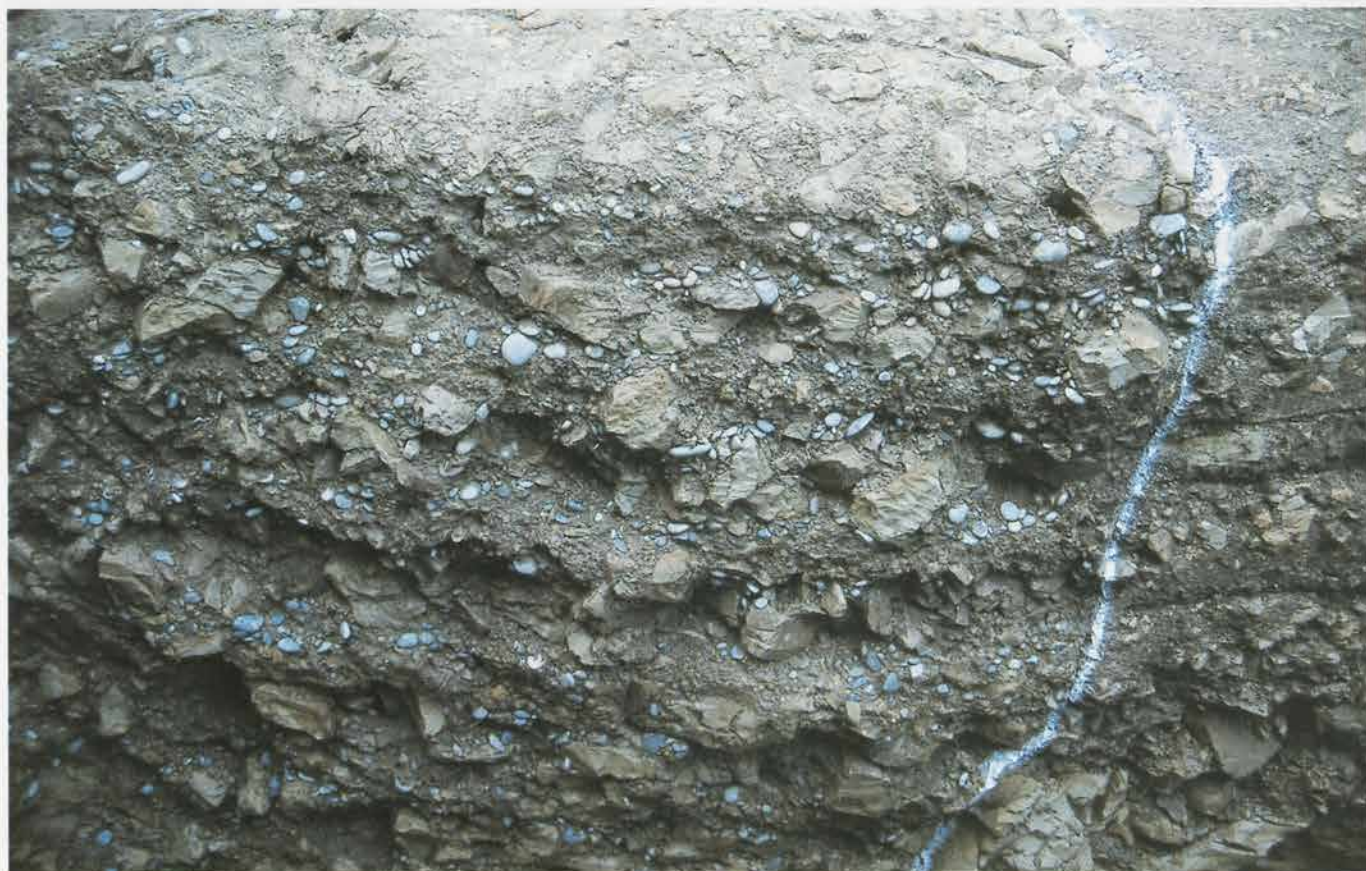
12年度2区 大仏殿礎石下の根固め遺構

The mark of the base under the foundation stone at No.2 district in 2000 years.

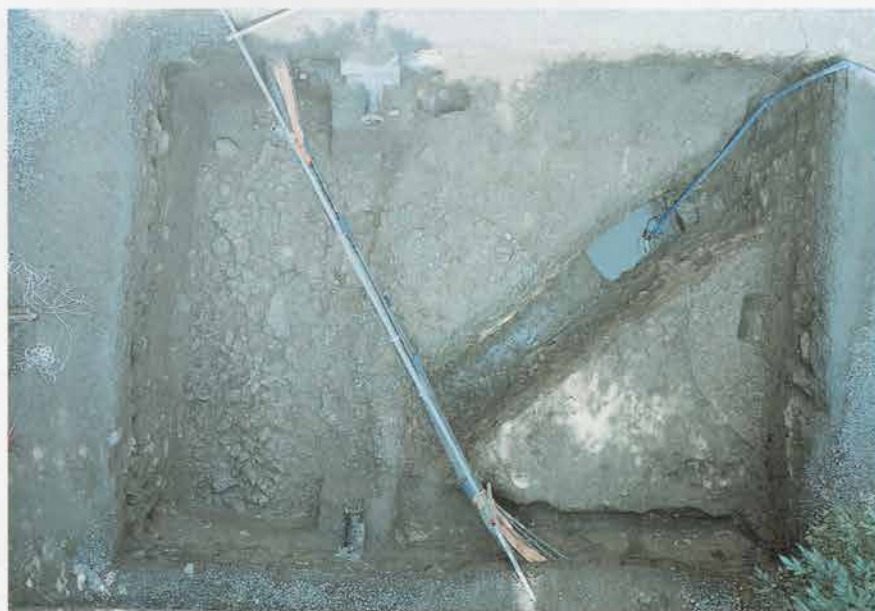
12年度2区全景
大仏殿礎石下の根固め遺構
The panorama at No.2 district
in 2000 years.

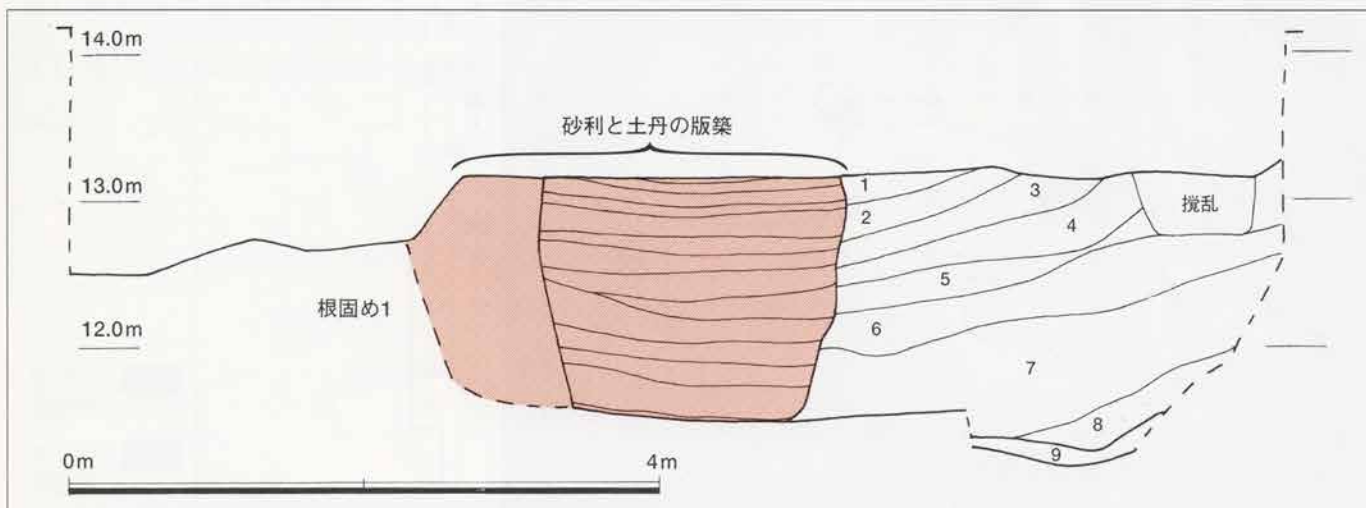
大仏殿礎石下根固め遺構の断面図
The cross section of the mark of the base under the foundation stone of Daibutu-den.

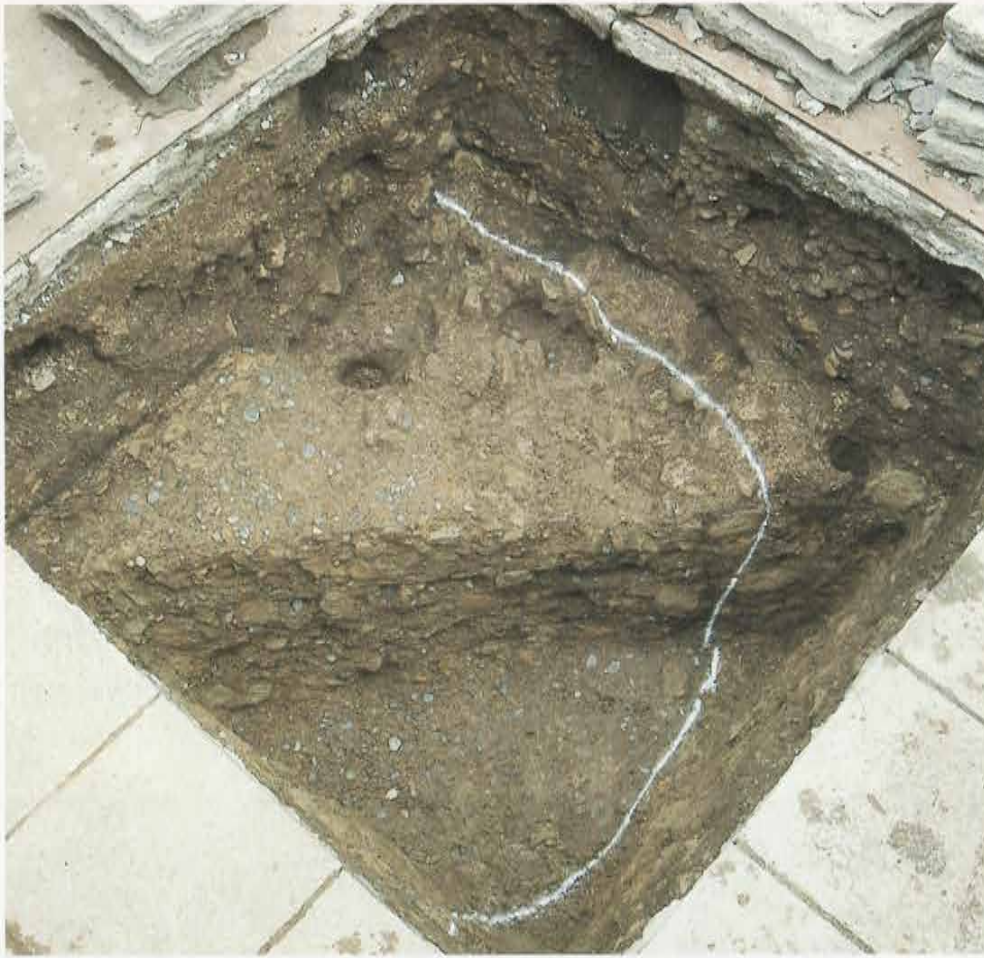
13年度3区で発見された
根固め遺構

The mark of the base that it
is discovered in 2000 years
at No.3 district.

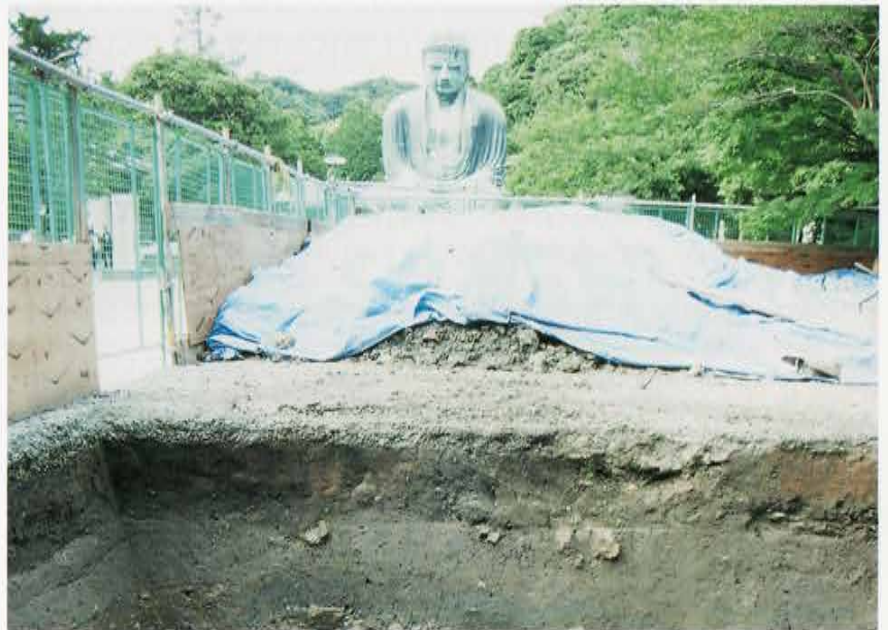
13年度9区から大仏を望む
The great statue of Buddha is seen from No.9 district in 2001 years.

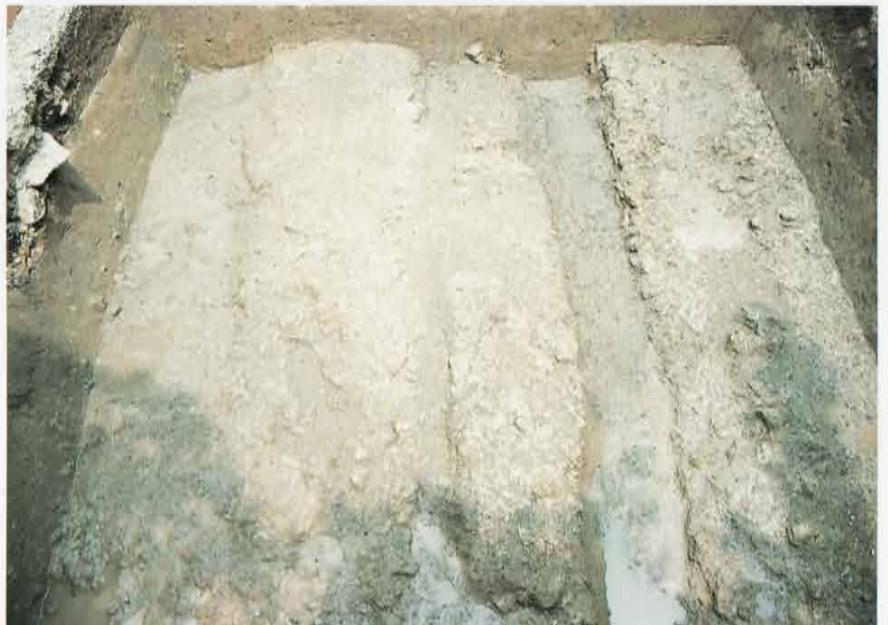
13年度9区 参道と思われる遺構
It is thought an approach at NO.9 district in 2001 years.

大仏周辺の調査では、大仏殿創建時の像周辺の状況がわかりました。像の前面は大谷戸・小谷戸・大仏坂方面の水系が合流する沼地や湿地帯でしたが、前面の築地の北側は現地表下約3mで大仏造営時の地面が確認され、13世紀末に埋め立てられて参道がつけられたことが地層や出土品から推定できます。東側の築地南東側（駐車場北側）は中世に行われた埋め立ての上に江戸時代の再興時にも土が盛られ、そこから像の修理で用いられたと考えられる鋳物のくずなどが出土しました。境内南東隅の山門東側にあたる場所は江戸時代になって湿地を埋めて現在の高さになり、大仏殿の西側にあたる部分では山が屋根の軒先近くまでせり出していた様子がうかがえます。

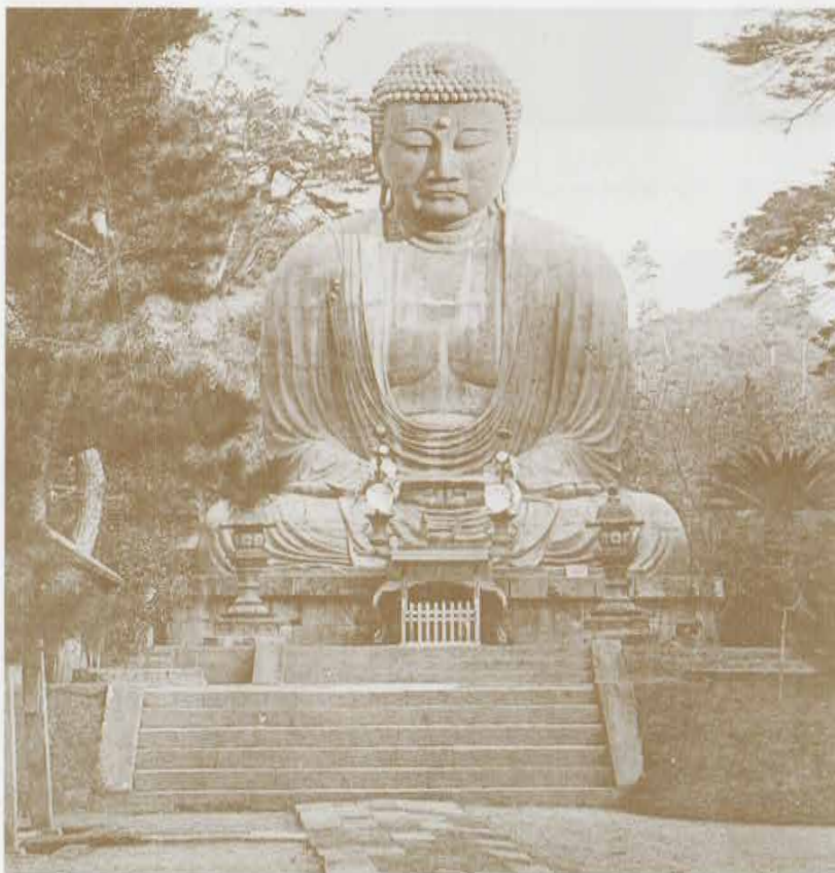
明治20年代の鎌倉大仏 (古写真)
Kamakura great statue of Buddha
(an old photograph) in fee, the 20th
year of Meiji period.

なお、明治20年代頃の古写真（13頁）には、像の前方1段下の平場に整然と据えられた平らな大石が見えます。この平場が今回調査した標高約13mのところにあるとすれば、古写真に写された大石は旧大仏殿の礎石であった可能性も考えられます。
