MORIOKA CASTLE SITE I

MORIOKA CITY OFFICE

Report of Stone Wall Restoration Work

盛岡城跡 I
— 第1期保存整備事業報告書 —

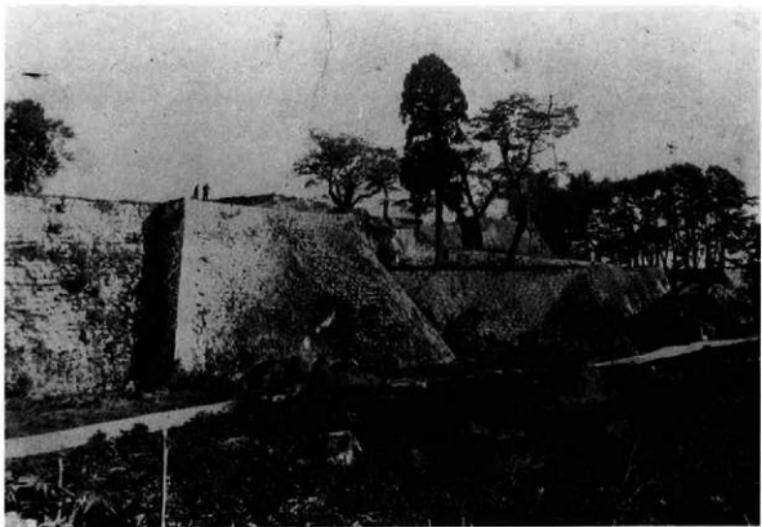
彎曲輪
二階櫓石垣
(S→N)

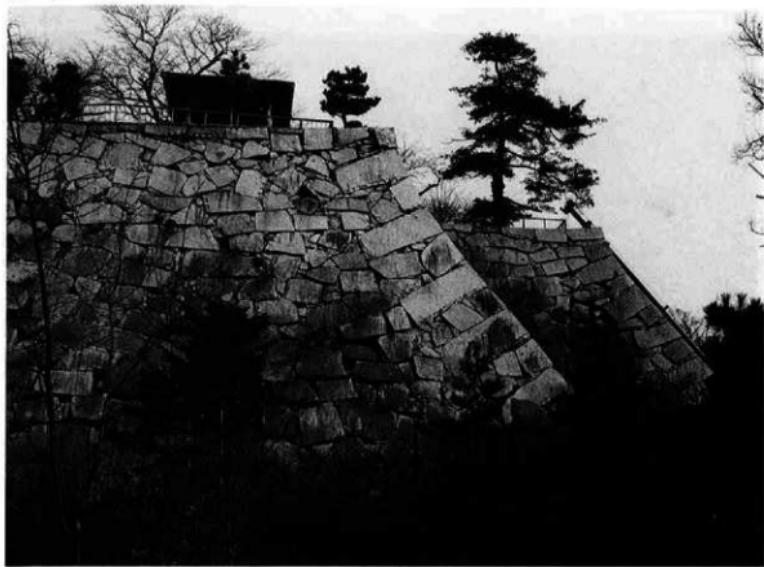
二ノ丸
三ノ丸石垣
(W→E)

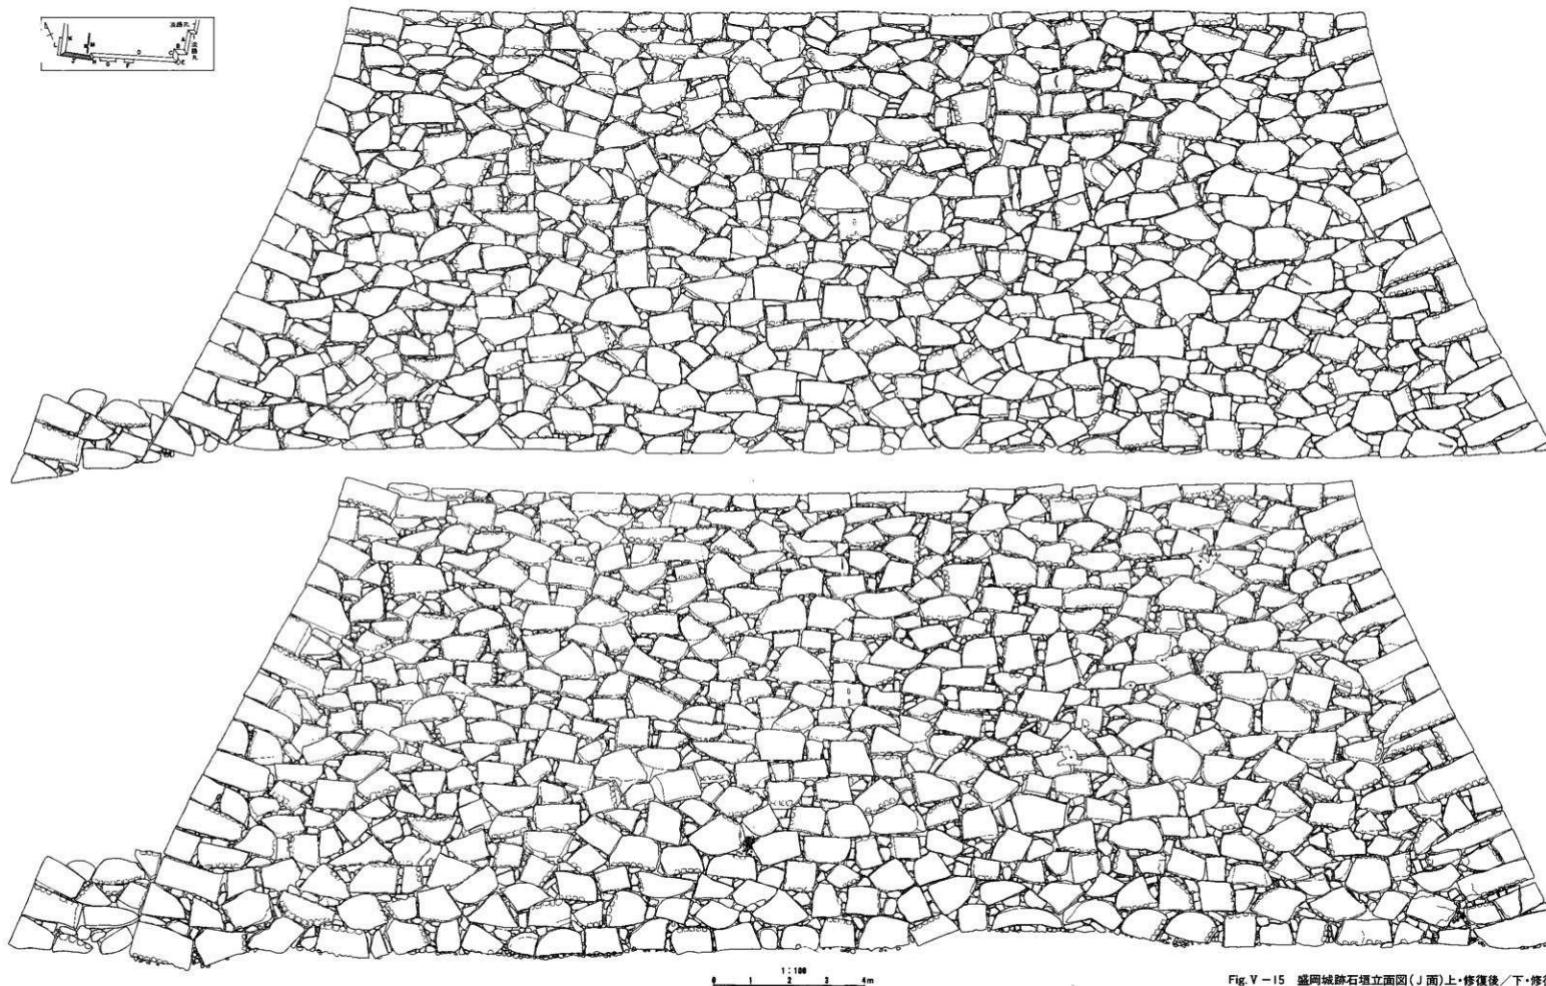
Fig. V-15 盛岡城跡石垣立面図(J面)上・修復後／下・修復前

■ 新石に交換
石の加工(ハツリ)
■ 石の加工(切削)
