# 史跡 備中松山城跡本丸復元整備記録

## DOCUMENTATION ON THE RESTORATION WORK AT BITCHU MATSUYAMA CASTLE SITE,a Historic site

**史跡備中松山城跡本丸復元整備工事報告書**

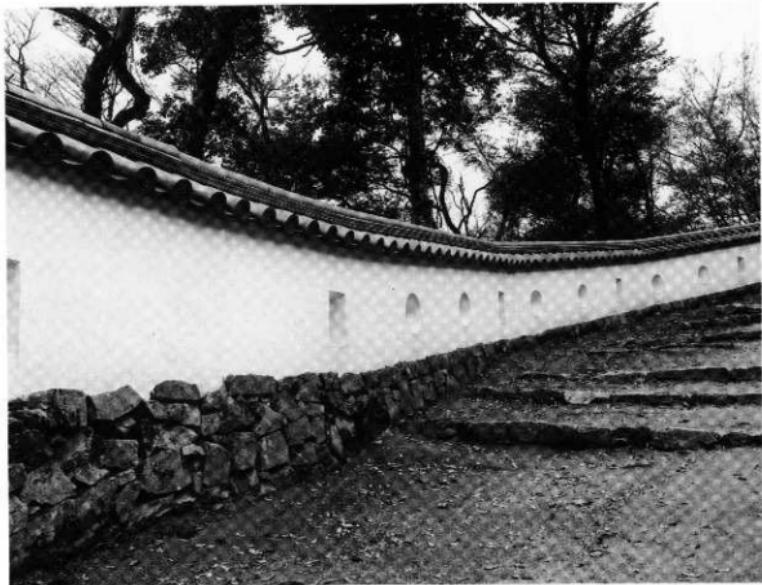
23. 三の平櫓東復元土塙全影

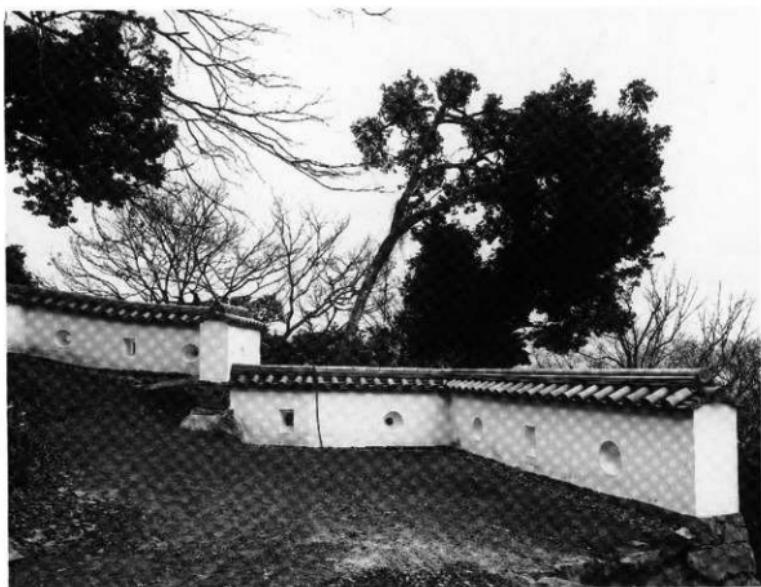
24. 厥曲輪東隅復元土塙全影

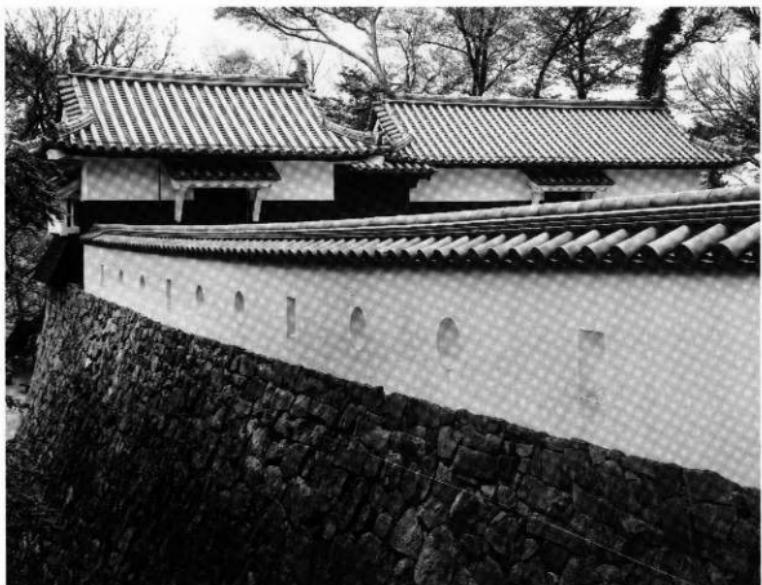
25. 本丸東面復元土塙全影

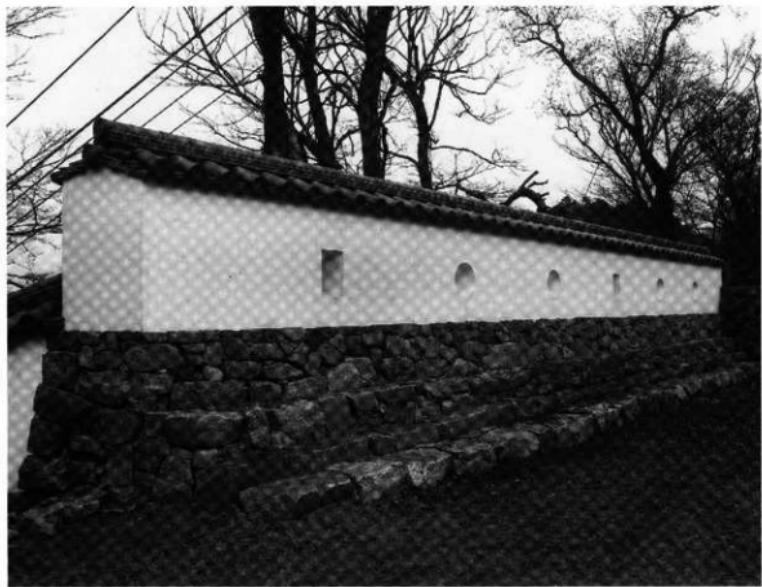
26. 本丸西面復元土塙全影

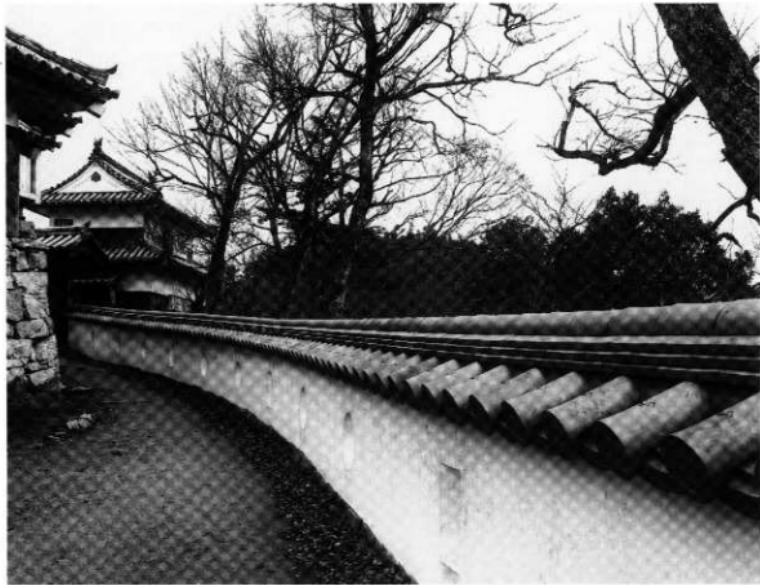
27. 天守東側復元土塙全影

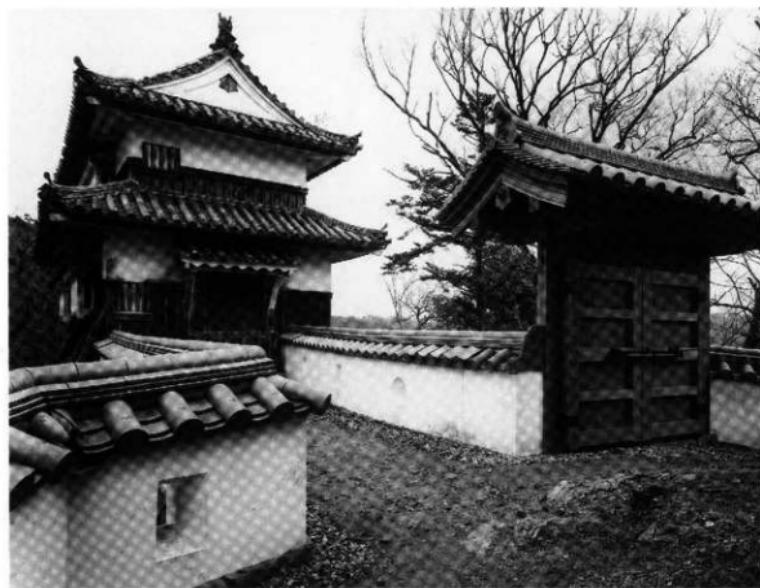
28. 二重橋前西面復元土塙全影

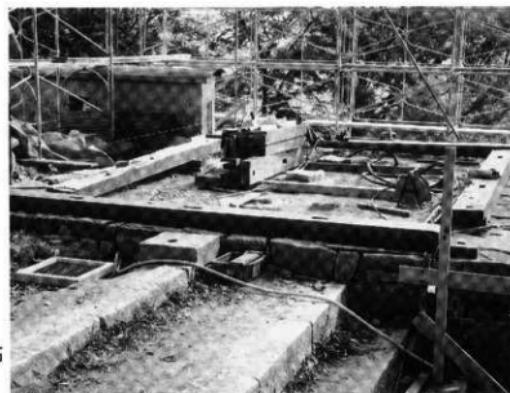
38. 五の平櫓土台取付  
下端石垣天にひかり付け高  
低差を修正する。

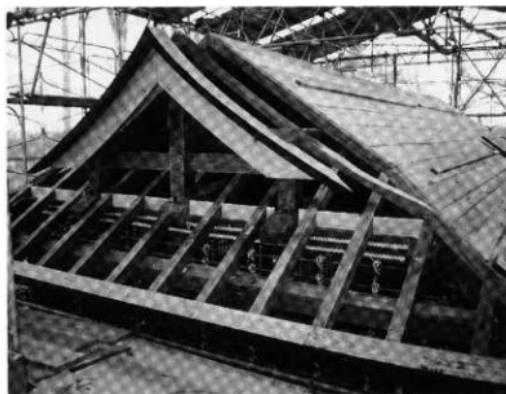
46. 五の平檜東妻破風板  
取付状態

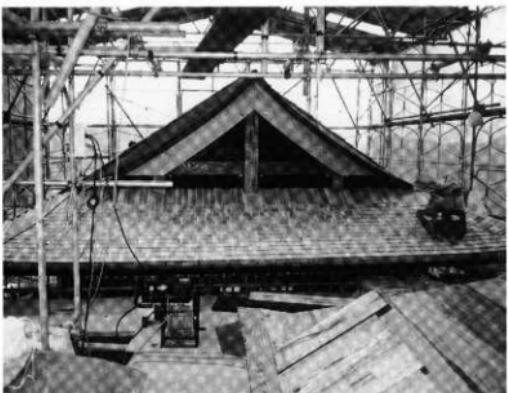
48. 五の平檜西妻土居葺施工  
檻手割板で葺上げる。

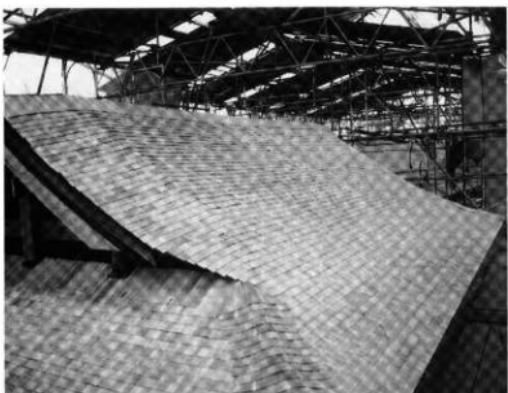
49. 六の平檜土居葺完成全影  
檻の手割材で葺足 6 cm で  
葺上げる。

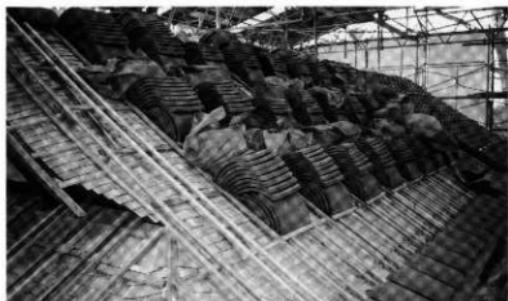
51. 六の平檜平瓦葺施工状態  
平瓦葺には筋置土を用いる。

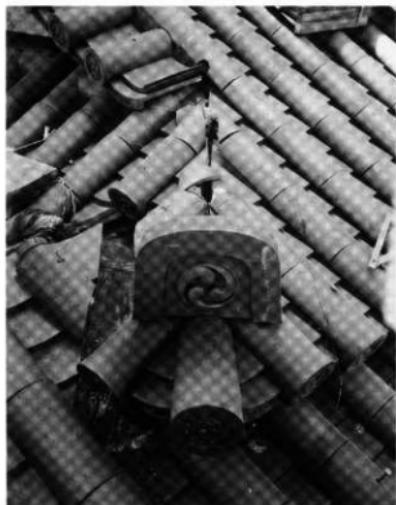
53. 六の平檜隅鬼瓦取付状態  
(鬼瓦は発掘されたものを復元する。)

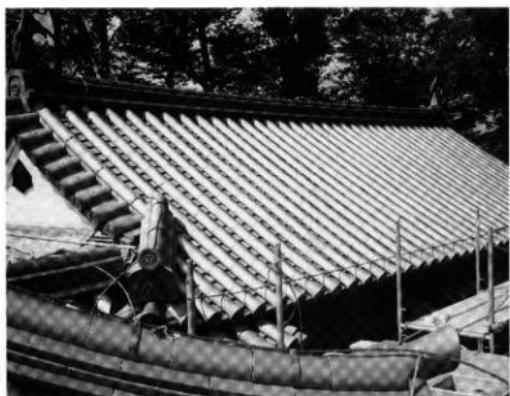
55. 六の平檜本丸瓦完了状態  
棟、軒先は、避雷針銅帯取付施工状態

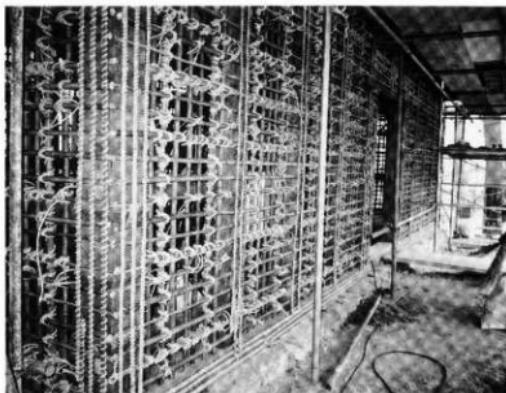
57. 六の平樋大壁小舞搔き状態  
(縦横小舞とも丸竹を用いる。)

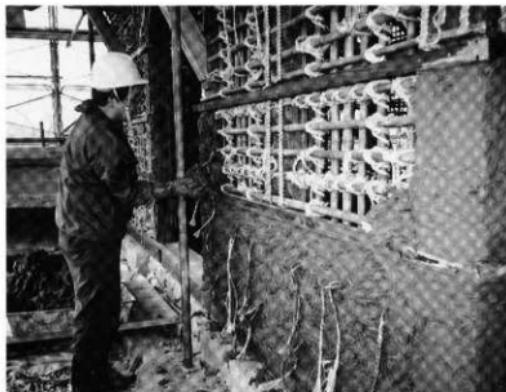
58. 五の平樋荒壁付け施工  
(15cm大に丸めて小舞に押し  
込めて塗上げる。)

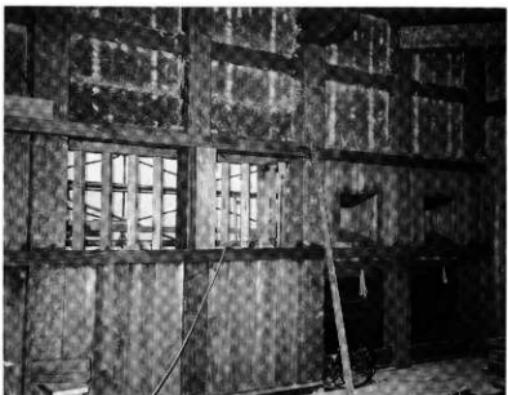
67. 六の平樁南面出窓、鉄眼木  
造り

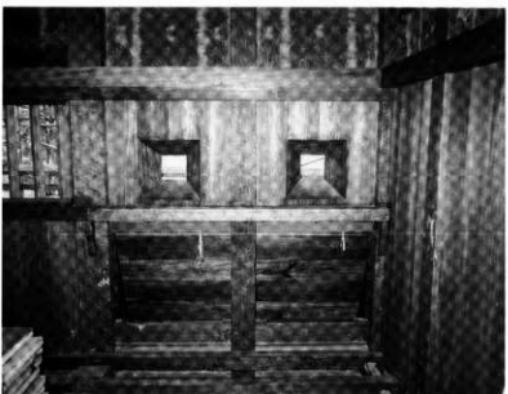
68. 六の平樁南面西寄り銳眼石  
落し個所

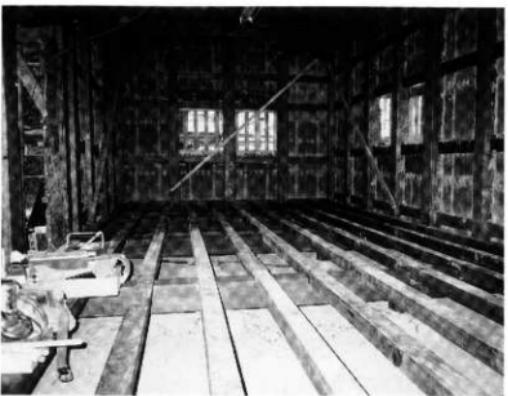
69. 六の平樁根太取付状態

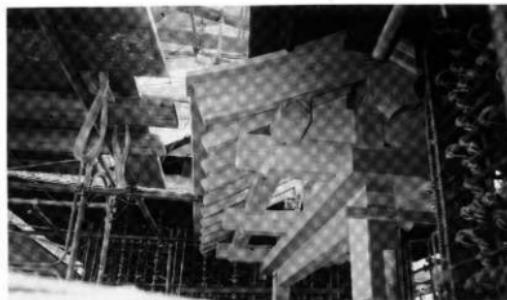
70. 本丸南御門軒廻り取付

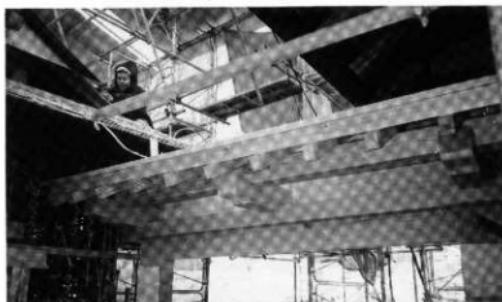
71. 同上平軒廻り状態

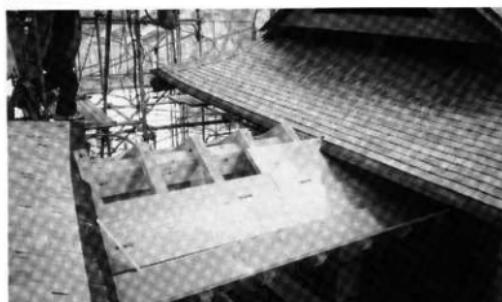
72. 同上化粧裏板張り状態

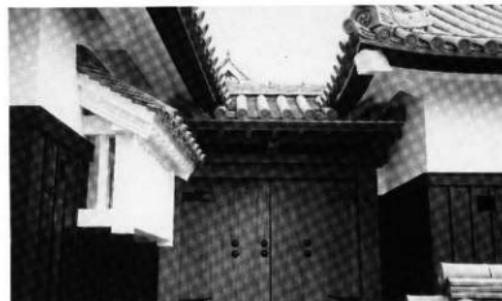
73. 同上完成状態（正面）

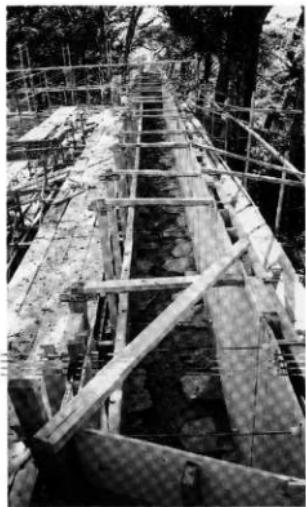
74. 土塀仮枠組立状態

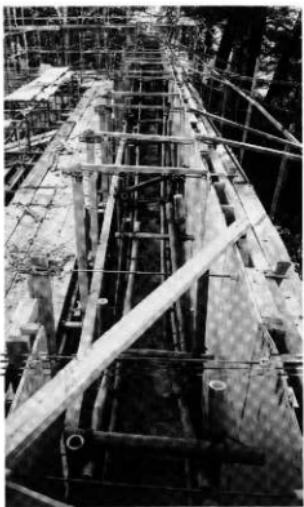
75. 土塀内部の丸竹補強入状態

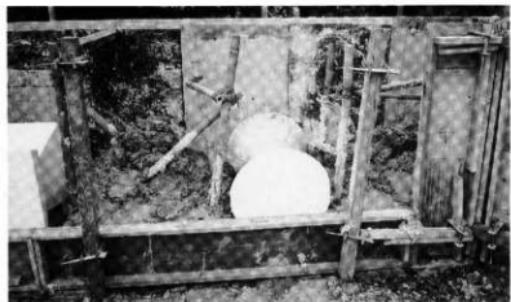
76. 土塀鍛眼型棒取付状態

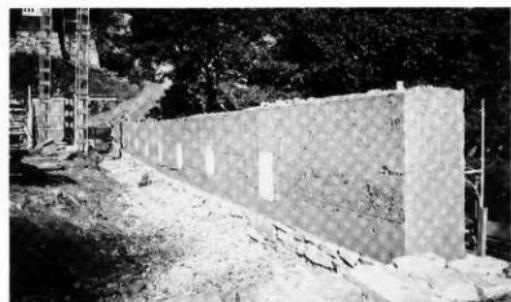
77. 本丸東面土塀板枠取はずし状態

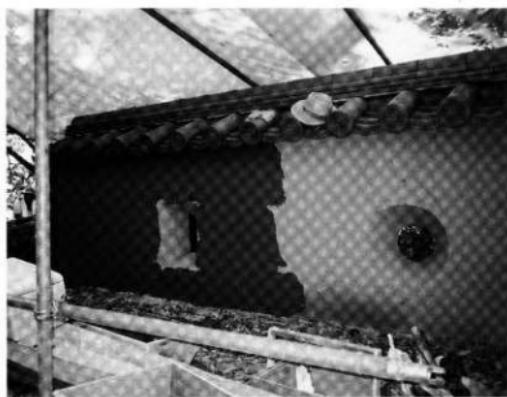
78. 土塀屋根葺、斑直し  
施工状態

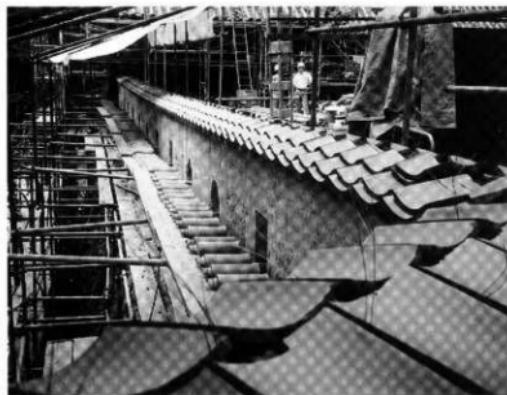
79. 土塀屋根葺施工状態  
(本丸東面五の平櫓に取付く)

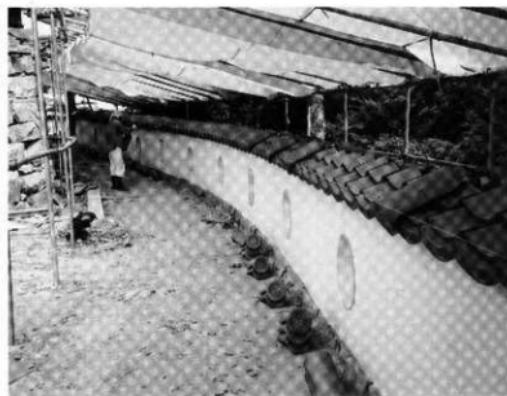
80. 土塀屋根瓦葺施工状態  
(天守東面で腕木門に続く)

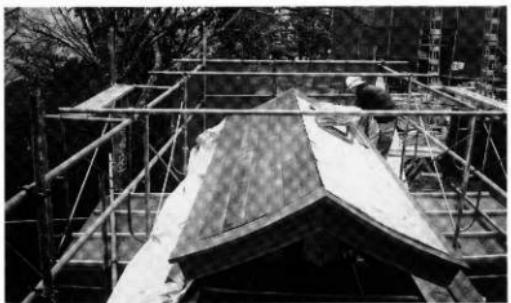
81. 東御門土居葺施工

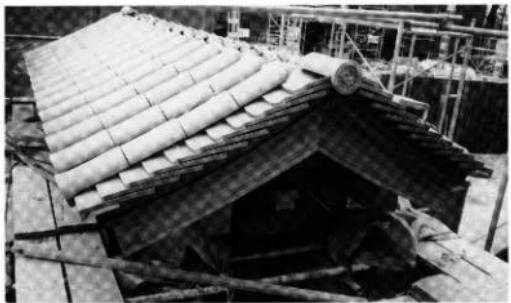
82. 東御門屋根瓦葺施工

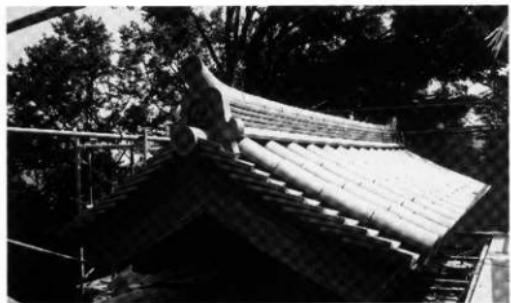
83. 東御門屋根葺完成状態

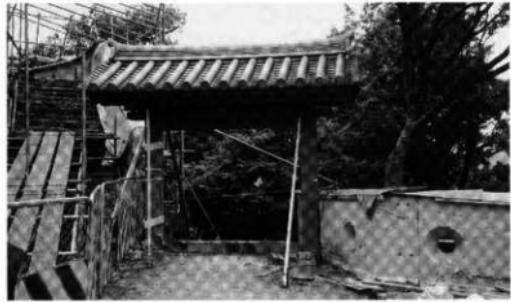
84. 東御門全影

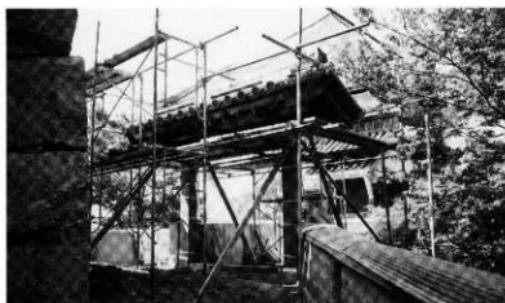
85. 脱木御門組立状態

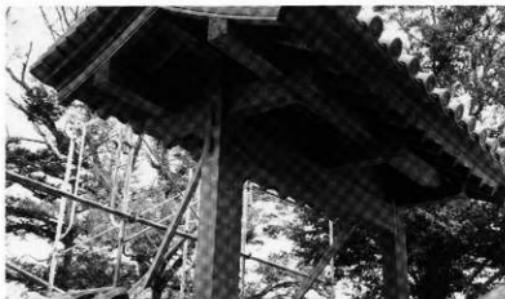
86. 同上化粧軒裏見上状態

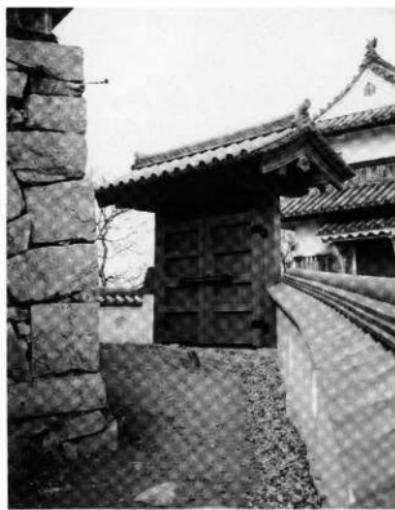
87. 同上完成状態

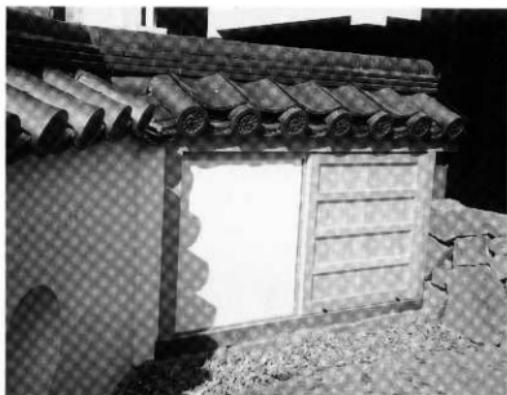
94. 路地門完成状態
